MONITORING YEAR 5 ANNUAL REPORT

BUCKWATER MITIGATION SITE

Orange County, NC
Neuse River Basin
HUC 03020201
DMS Project No. 97084
NCDEQ Contract No. 006829
USACE Action ID No. 2016-00873
DWR Project No. 2016-0406v2

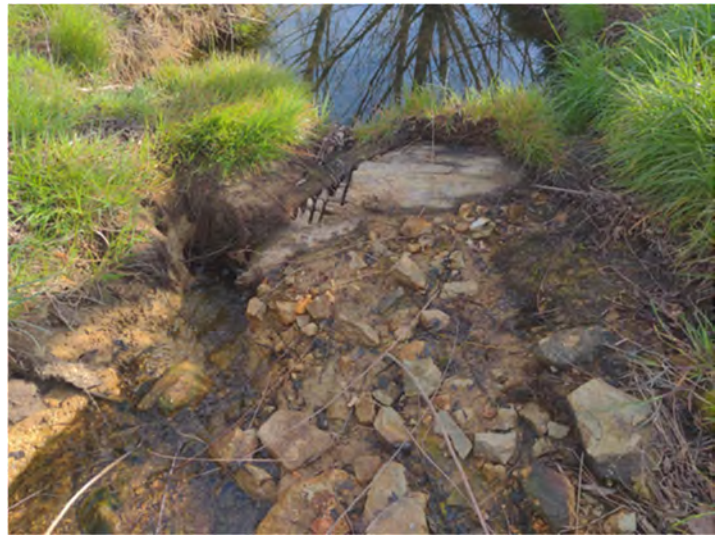
T3 R2 STA 314+20 - 314+30 – Piping Rock Sill (3/24/2023)

Reach	Start Station	End Station	Length (LF)	Description	Planned 2023 Management Action
T3 Reach 2	314+20	314+30	10	Piping rock sill; souring left bank. Riffle upstream of piping sill is stable and providing grade control.	Remove rock sill and tamp down left bank.
	314+40	314+70	30	Piping angled log riffle due to log sills being improperly keyed in. Riffle material is providing grade control.	Remove angled log riffle, rebuild as native riffle.
T4	408+42		N/A	Perched culvert due to piping rock sills below.	Rebuild rock sill structures downstream to upstream and remove boulder toe along banks.
	408+42	409+20	78	Nine piping rock sills. Original construction of rock sills were built upstream to downstream preventing proper sealing of structures.	
T4B Reach 1	451+40	451+70	30	Six piping rock sills. Original construction of rock sills were built upstream to downstream preventing proper sealing of structures.	Rebuild rock sill structures downstream to upstream.

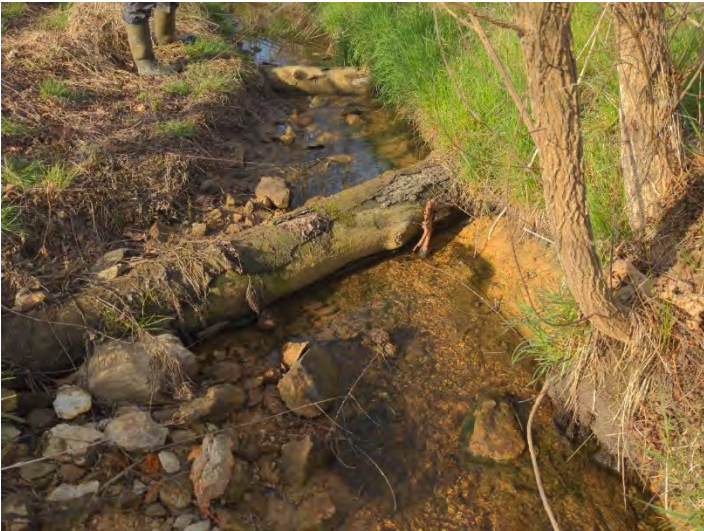
T3 R2 STA 314+40 - 314+70 – Piping Angled Log Riffle (3/24/2023)

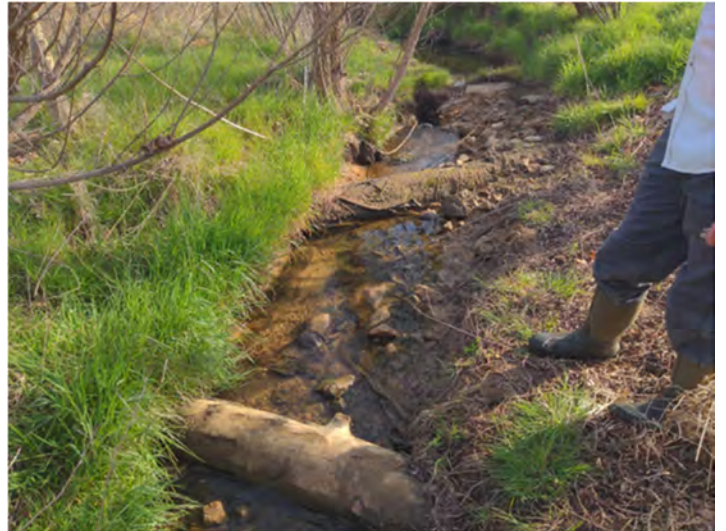
T3 R2 STA 314+40 - 314+70 – Piping Angled Log Riffle (3/24/2023)

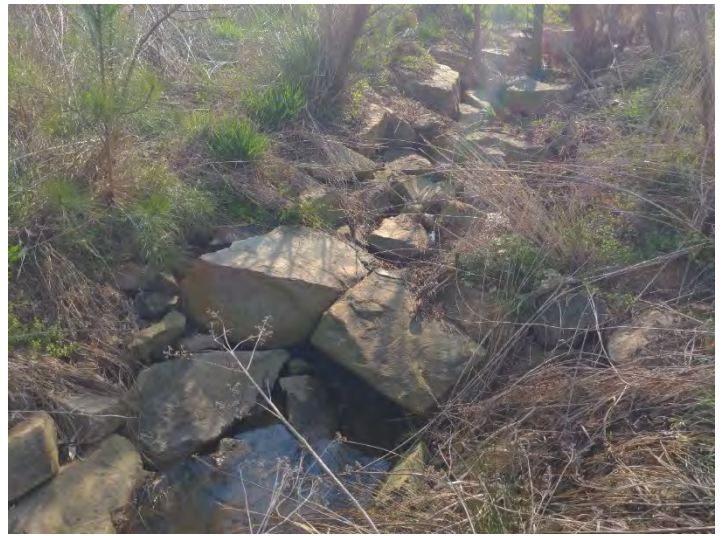
T4 STA 408+42 – Perched Culvert (3/24/2023)

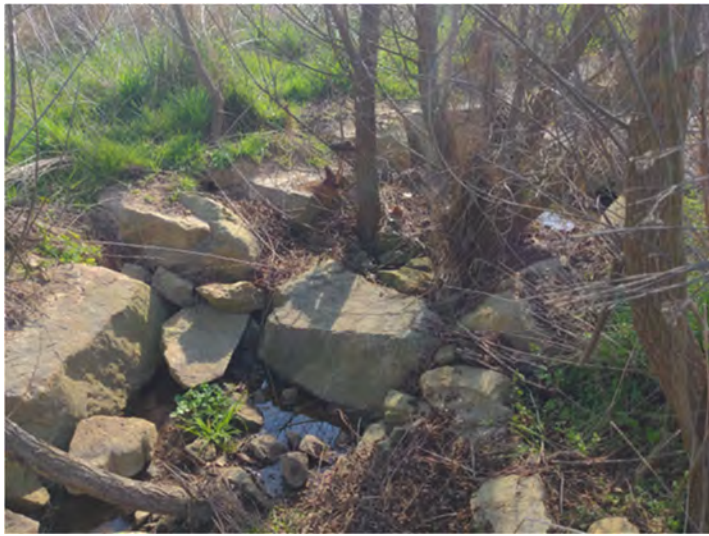
T4 STA 408+42 – 409+20 – Piping Rock Sills (3/24/2023)

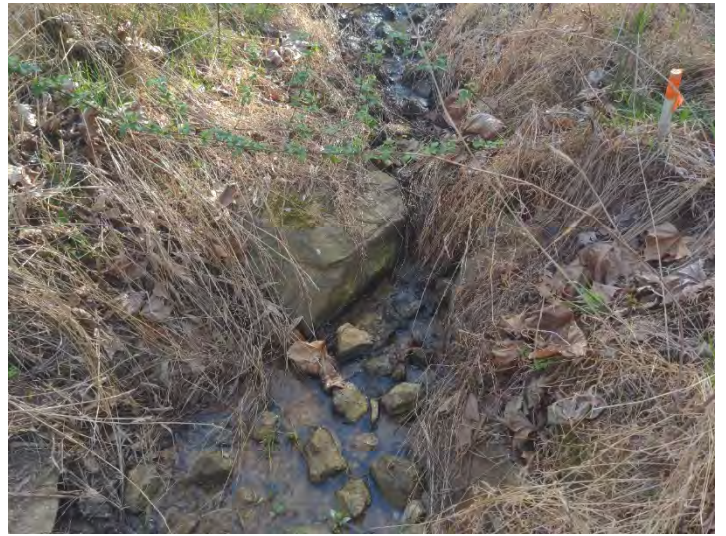
T4 STA 408+42 – 409+20 – Piping Rock Sills (3/24/2023)

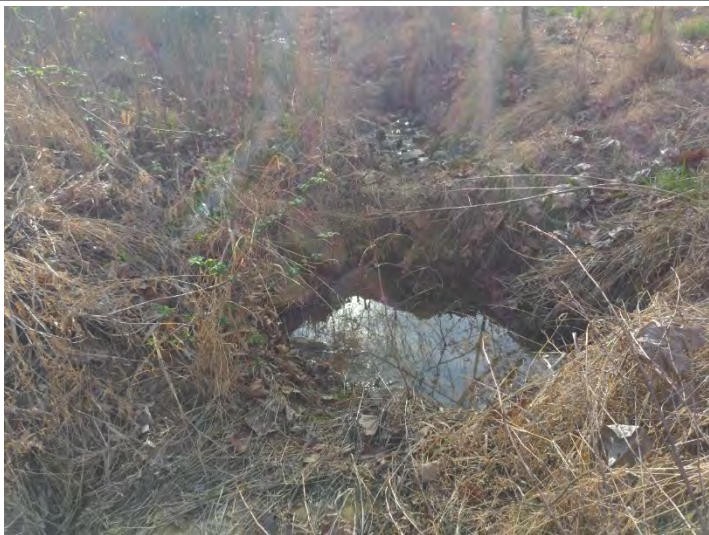
T4B R1 STA 451+40 – 451+70 – Piping Rock Sills (3/24/2023)

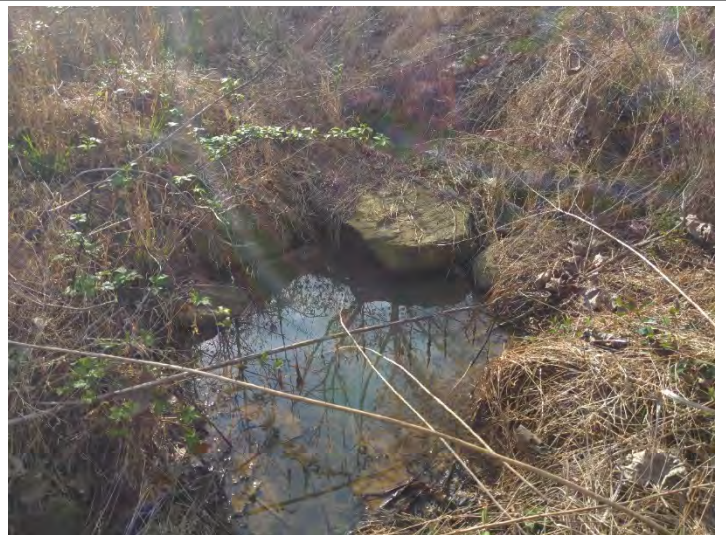
T4B R1 STA 451+40 – 451+70 – Piping Rock Sills (3/24/2023)

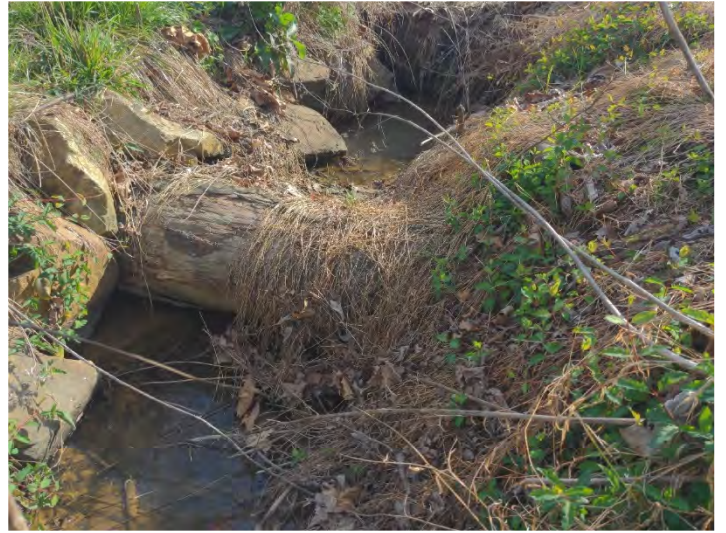
T4B R1 STA 453+00 – 453+50 – Piping Log and Rock Sills (3/24/2023)

453+00	453+50	50	Four piping log sills and two piping rock sills due to erosion around log sills.	Rebuild structures and remove boulder toe along banks.
T6 Reach 3	517+80	518+20	40	Four piping log sills due to erosion around log sill.	Remove log sills and replace with boulder sills.

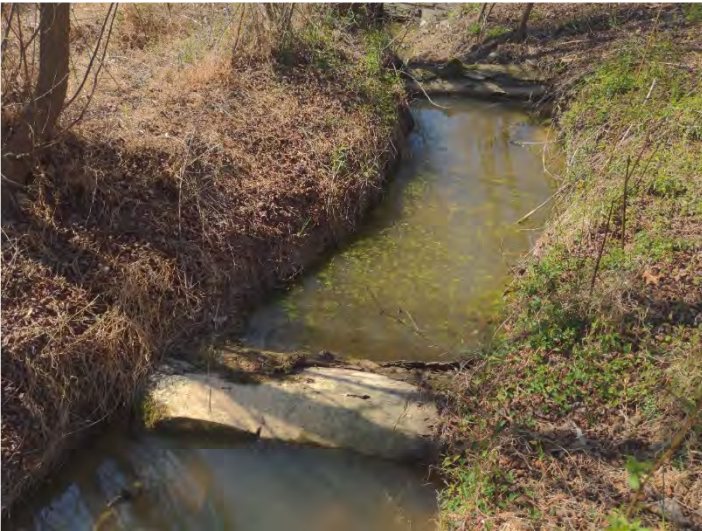
T4B R1 STA 453+00 – 453+50 – Piping Log and Rock Sills (3/24/2023)

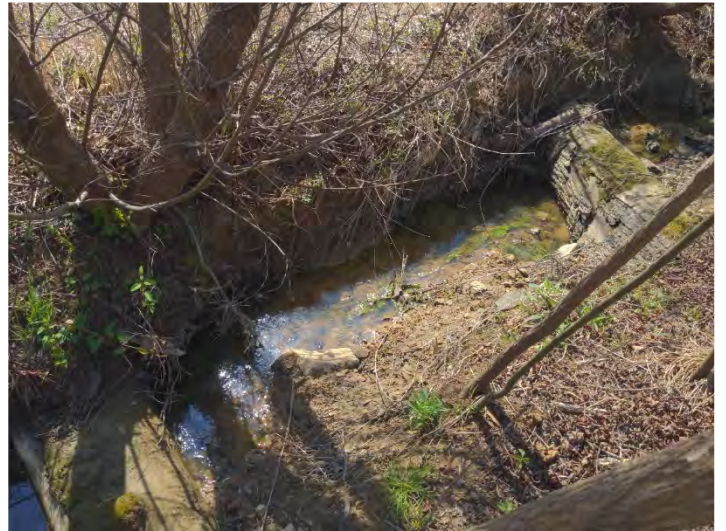
T6 R3 STA 517+80 – 518+20 – Piping Log Sills (3/24/2023)
