MY2 FINAL MONITORING REPORT
Buffalo Creek Tributaries Mitigation Project
Johnston County
Neuse River Basin
CU 03020201

DMS Project # 100042
DMS Contract # 7422
DMS RFP # 16-007279
USACE Action ID Number: SAW-2018-00425
DWR Project # 2018-0199 V2
Calendar Year of Data Collection: 2022

RE: WLS Responses to NCDEQ DMS Review Comments for Task 8 Submittal, Draft Monitoring Year 2 Report for the Buffalo Creek Tributaries Mitigation Project, DMS Full-Delivery Project ID #100042, Contract #7422, Neuse River Basin, Cataloging Unit 03020201, Johnston County, NC

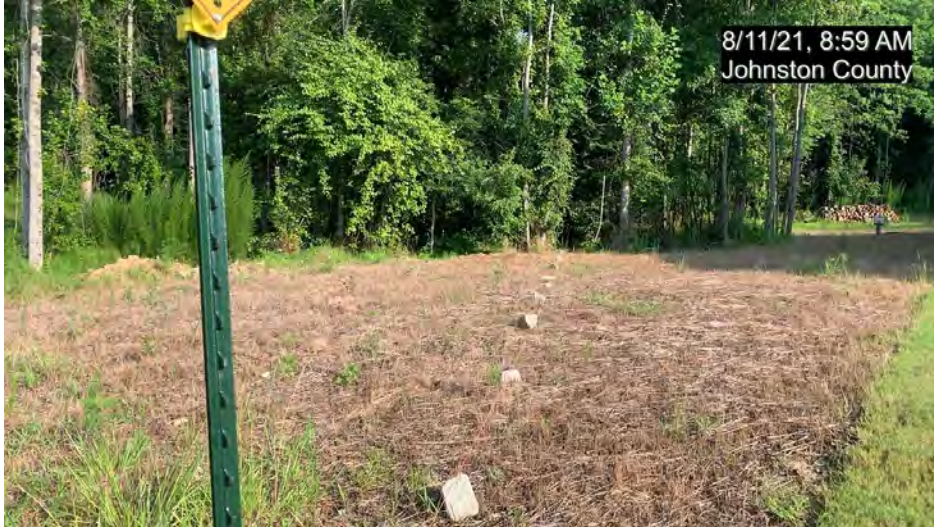
During MY1 there were two encroachments (~0.014 acres) observed near the southernmost culvert crossing on MS-R2. Both were recently sodded/planted grassy areas adjacent to new home construction. To prevent further encroachment, the homeowners were contacted, and the easement line was more clearly marked. Encroachment planting occurred on January 6th, 2022, using one-gallon trees (see planting list below). During MY2, no further encroachments have occurred in these areas. A new encroachment (~0.0005 acres) was noted on August 18th, 2022. The landowner was contacted, and the easement was more clearly marked to prevent future mowing (see photos in Appendix A).

Encroachment Area 1, MS-R2, Upstream of Culvert (MY-01)

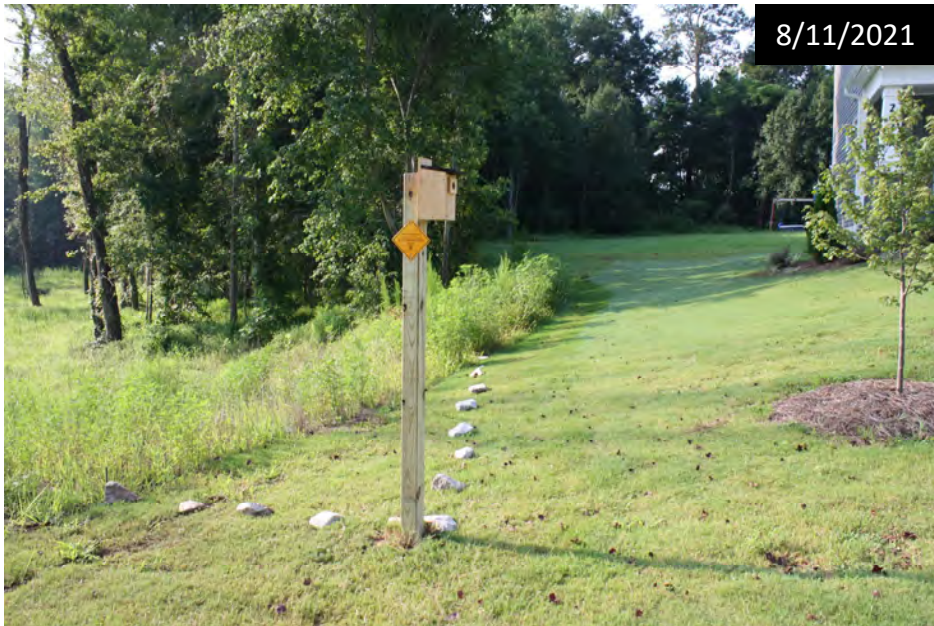
Encroachment Area 2, MS-R2, Downstream of Culvert (MY-02)

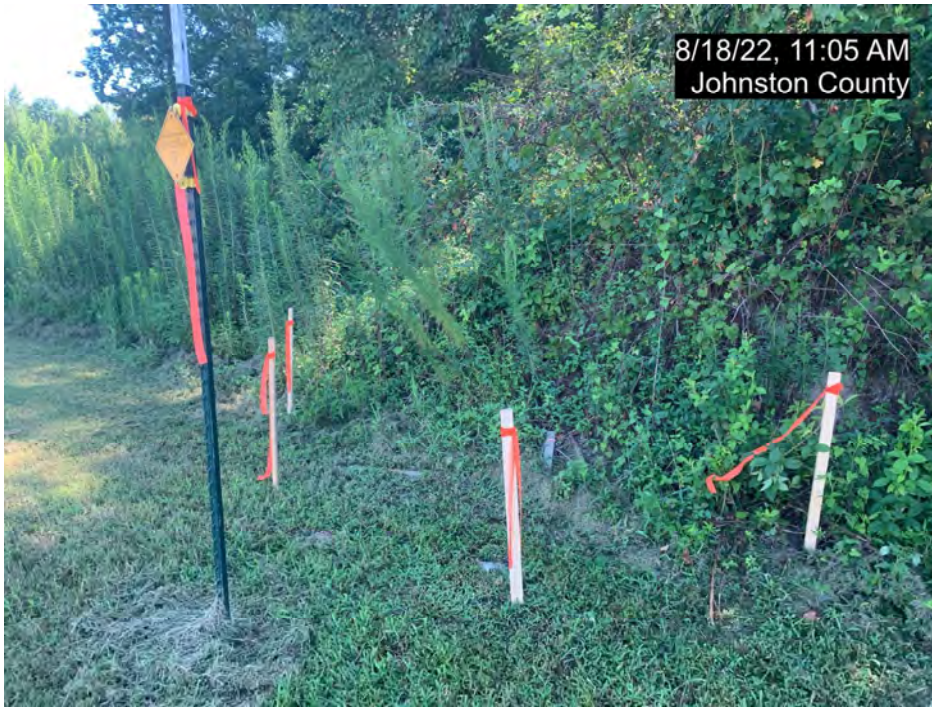
Encroachment Area 3, R6, East of BMP (MY-02)

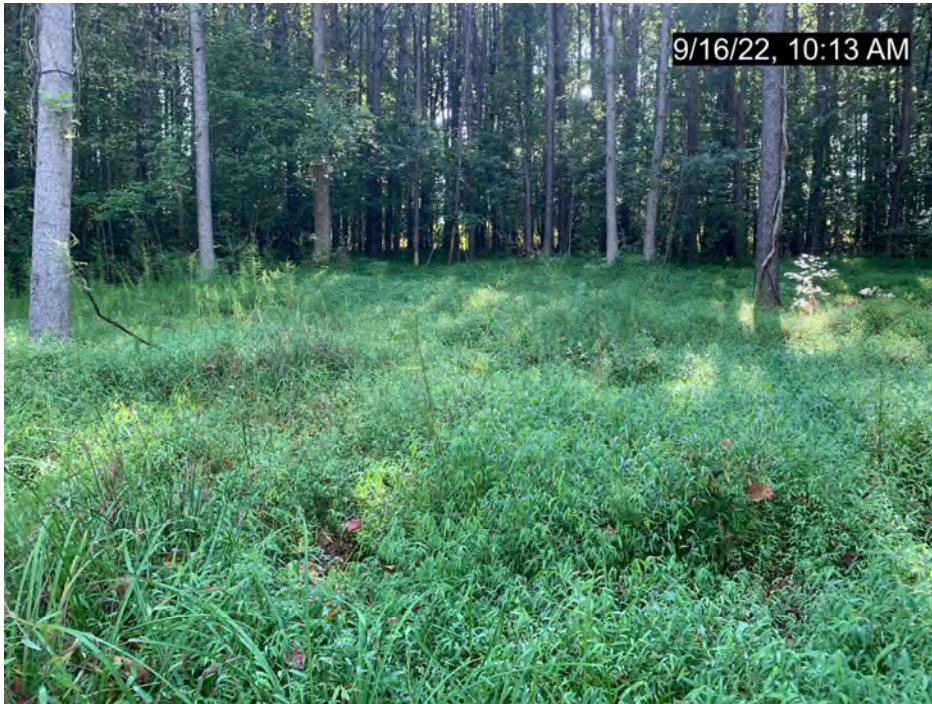
An area of concern was noted during a DMS site visit on July 2nd, 2021, of overland flow occurring along MS-R1 from an offsite BMP. This area is stable with dense herbaceous vegetation preventing soil erosion and there are no significant impacts to the floodplain or the stream (see photos in Appendix A). This area will continue to be monitored and any remedial actions will be documented in future reports.

MS-R1, STA 15+00, BMP Overflow, Right Floodplain (MY-02)
