# As-Built/Monitoring Year 1 Report

## LITTLE BUGABOO CREEK Wilkes County, North Carolina

June 2005

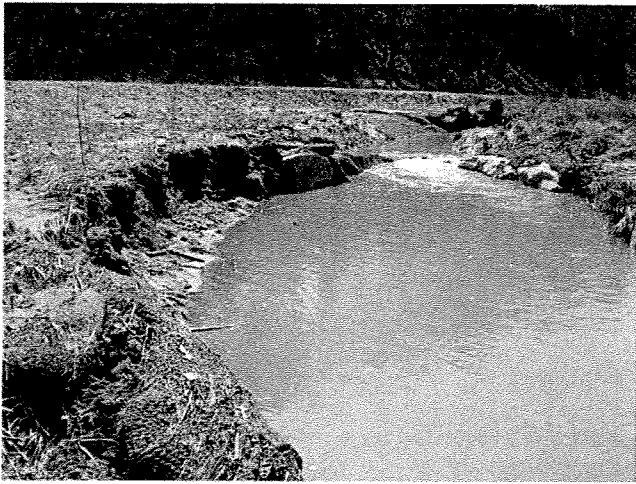
13. Station 46+25

<b>Exhibit Table IXa. Stream Problem Areas Little Bugaboo Creek</b> <b>Project Number and Name: SCO# 00-5327-01A (Little Bugaboo Creek)</b>			
Feature Issue	Station Numbers	Suspected Cause	Photo Number
Aggradation/Bar Formation			
Bank Scour	11+00	Back eddy in front of rootwads	1
	12+00	no vegetation	2
	13+50-14+50	no vegetation	3
	19+25	back eddy below cross-vane	4
	20+90-22+00	no vegetation, back eddy behind rootwads, and incoming flow from tributary	5
	24+50	no vegetation	6
	25+00	overland flow/small drainageway	7
	25+50	cross-vane, no vegetation	8
	29+00	no vegetation, overland flow	9
	33+30	eroding drainageway, overland flow	10
	36+00	no vegetation	11
	36+50	cross vane, no vegetation	12
	46+25	back eddy from cross-vane	13
	51+00	overland flow/cross vane	14
Engineered structures		see also bank scour at rock structures

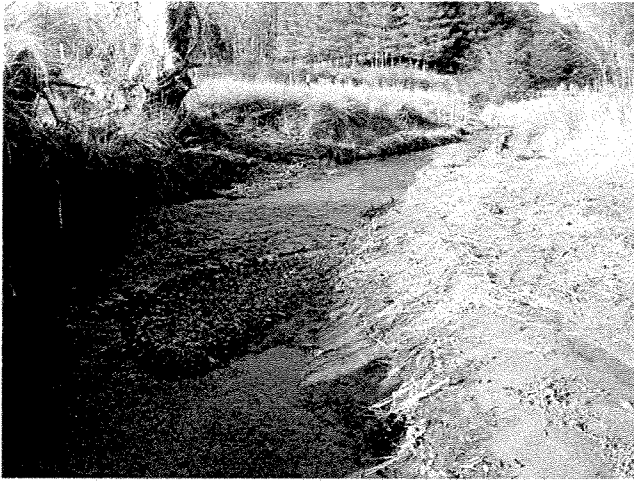
15. Station 14+00

<b>Exhibit Table IXb. Stream Problem Areas UT Little Bugaboo Creek</b>			
<b>Project Number and Name: SCO# 00-5327-01A (Little Bugaboo Creek)</b>			
<b>Feature Issue</b>	<b>Station Numbers</b>	<b>Suspected Cause</b>	<b>Photo Number</b>
Aggradation/Bar Formation	14+00	Transverse Bar, narrowing channel	1
Bank Scour	15+25	Overland flow and eddies around rootwads	2
	17+80	Erosion below cross-vane, angle of vane	3
	23+80	Erosion upstream of vane, tight bend	4
Engineered structures		see also bank scour at rock structures

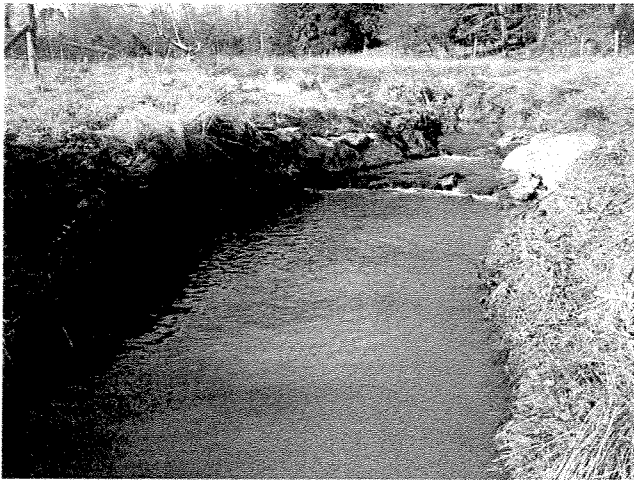
17. Station 17+80

<b>Exhibit Table VIIb. Vegetative Problem Areas UT to Little Bugaboo Creek</b>			
Project Number and Name: SCO# 00-5327-01A (UT Little Bugaboo Creek)			
Feature/Issue	Station #/Range	Probable Cause	Photo #
<b>Bare Bank</b>	15+25	Overland flow and eddies around rootwads	2
	17+80	Erosion below cross-vane, angle of vane	3
	23+80	Erosion upstream of vane, tight bend	4
<b>Bare Bench</b>			
<b>Bare Floodplain</b>			
<b>Invasive/Exotic Populations</b>
