Bugaboo Stream Restoration 2005 Year One Monitoring Report

NCEEP Project Number 56

Prepared by: EcoLogic Associates, P.C.
4321-A S. Elm-Eugene St.
Greensboro, NC 27406

Submitted: September, 2006

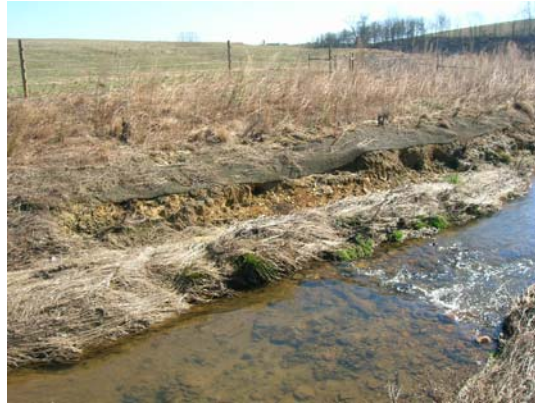
P658

Table IXb. Stream Problem Areas				
EEP Project Number: 00056				
Segment Reach: UT to Little Bugaboo Creek				
Feature Issue	Station	Suspected Cause	Photo	Severity
bank erosion	0+85	scour	p656	yellow
bank erosion	5+35	mass wasting	p659	yellow
bank erosion	5+40	scour	p658	yellow
structure degradation	5+95	high flow	p660	yellow
structure degradation	6+10	stability	p662	yellow
bank erosion	6+50	scour	p663	red
bank erosion	7+15	scour	p665	red
structure degradation	7+25	high flow	p666	red
bank erosion	7+55	mass wasting	p668	yellow
bank erosion	8+00	scour	p669	yellow
bank erosion	8+25	scour	p671	red
structure degradation	9+35	high flow	p672	red
bank erosion	11+00	scour	p674	yellow
bank erosion	11+75	mass wasting	p675	yellow
structure degradation	12+40	high flow	p677	red
bank erosion	12+60	scour	p678	yellow
bank erosion	14+50	mass wasting	p680	yellow
bank erosion	15+10	scour	p682	yellow
bank erosion	16+00	mass wasting	p683	yellow

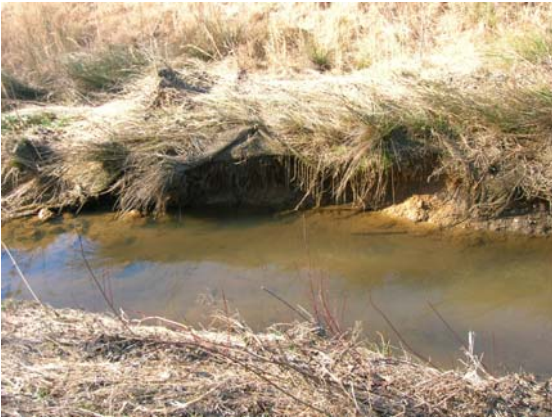
P684

bank erosion	16+40	scour	p684-6	yellow
structure degradation	16+60	high flow	p688	red
structure degradation	17+50	scour	p689	red
bank erosion	18+15	scour	p690	yellow
bank erosion	18+75	scour	p692	yellow

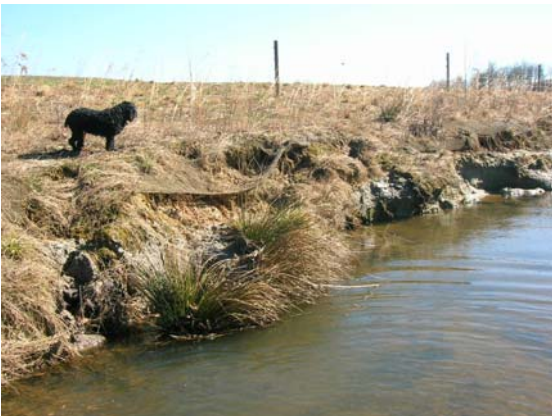
P700

Table IXa. Stream Problem Areas				
EEP Project Number: 00056				
Segment Reach: Little Bugaboo Creek				
Feature Issue	Station	Suspected Cause	Photo	Severity
bank erosion	0+50	scour	p697	yellow
bank erosion	1+75	scour	p699-700	yellow
bank erosion	3+25	mass wasting	p701	red
bank erosion	4+20	scour	p702	red
structure degradation	4+90	mass wasting	p704	red
bank erosion	7+95	scour	p705	yellow
structure degradation	8+40	high flow	p707	yellow
bank erosion	9+00	mass wasting	p708	yellow
structure degradation	9+50	stability	p709	red
bank erosion	11+10	scour	p710	red
channel	11+35	stability	p711	red
bank erosion	14+25	scour	p712	red
structure degradation	16+00	scour	p713	red
bank erosion	16+25	stability	p714	red
structure degradation	17+05	mass wasting	p715	red
bank erosion	21+60	overland flow	p716	yellow
bank erosion	21+90	scour	p717	yellow
bank erosion	23+25	mass wasting	p719	yellow
bank erosion	24+90	scour	p721	red
structure degradation	25+25	stability	p722	yellow

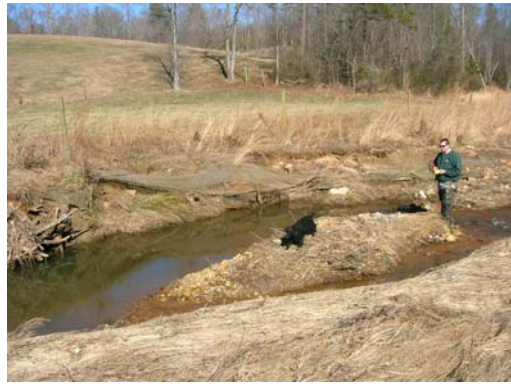
P724

channel	26+15	stability	p724	red
bank erosion	26+30	mass wasting	p724	red
bank erosion	27+00	scour	p725	red
structure degradation	27+50	high flow	p726	red
bank erosion	29+60	scour	p727	yellow
bank erosion	31+40	scour	p730	yellow
bank erosion	32+60	scour	p731	yellow
bank erosion	35+00	scour	p732	yellow
bank erosion	37+40	mass wasting	p735	yellow
bank erosion	37+95	mass wasting	p736	red
bank erosion	41+60	mass wasting	p737	red
structure degradation	41+80	stability	p738	red
bank erosion	41+95	scour	p739	yellow
bank erosion	42+25	mass wasting	p740	yellow
structure degradation	42+60	stability	p742	red
