**Little Bugaboo Creek Stream Restoration
2006 Monitoring Report
Monitoring Year Two**

Ecosystem Enhancement Program Project Number 00056

Submitted: January 19, 2007

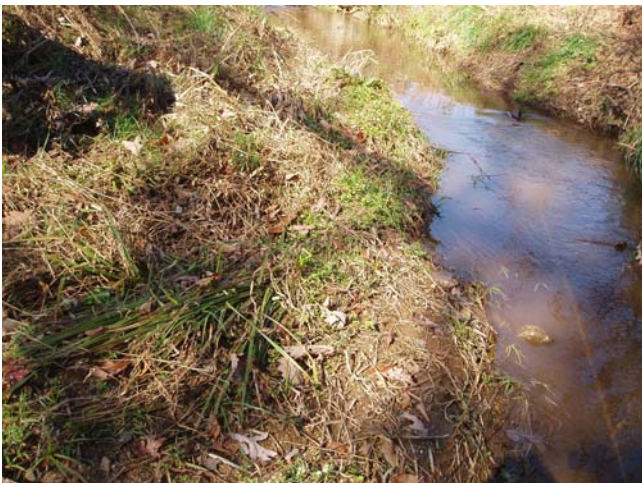
UTPA9 facing upstream

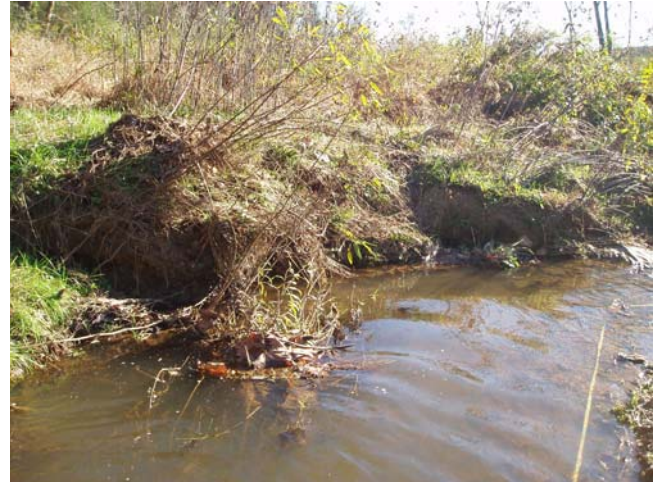
UTPA14 facing downstream

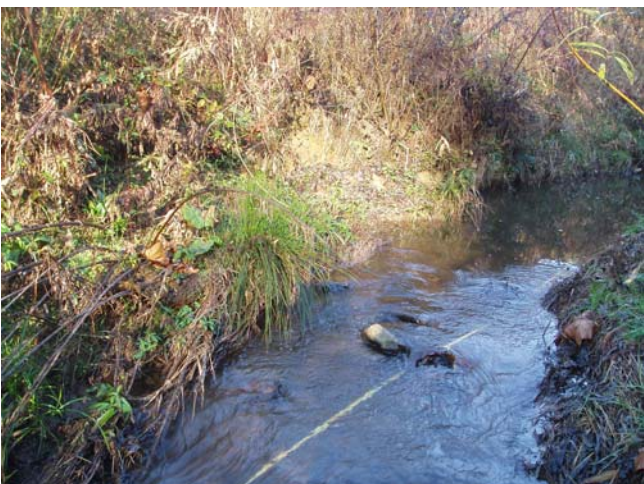
UTPA23 facing upstream

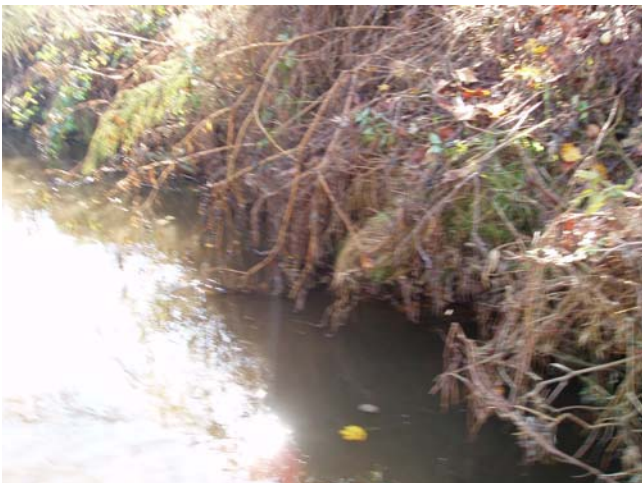
PA1 facing right bank

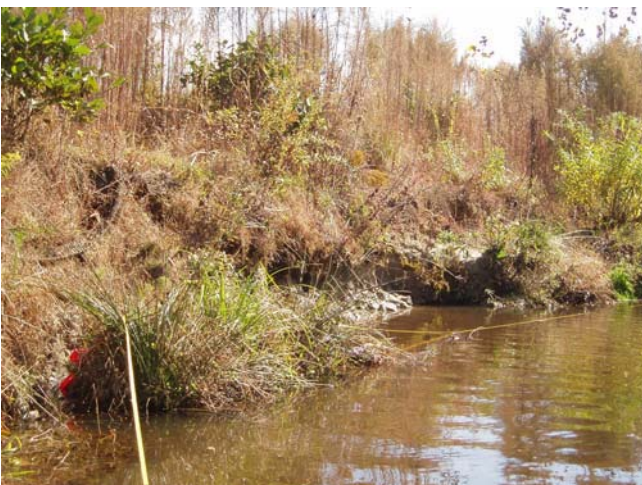
PA3 facing downstream, left bank

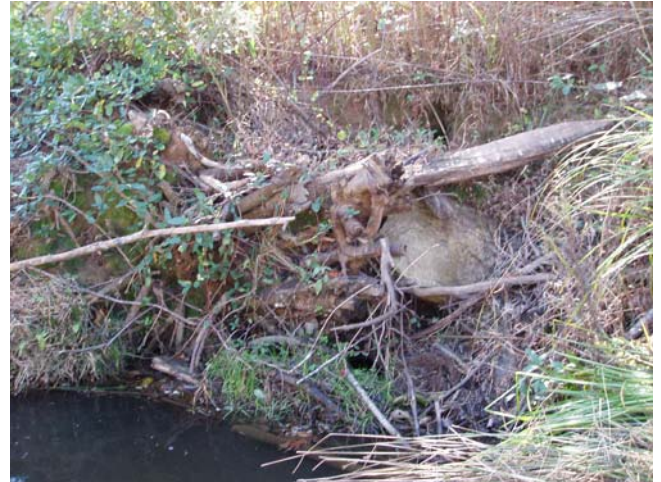
PA6 facing left bank

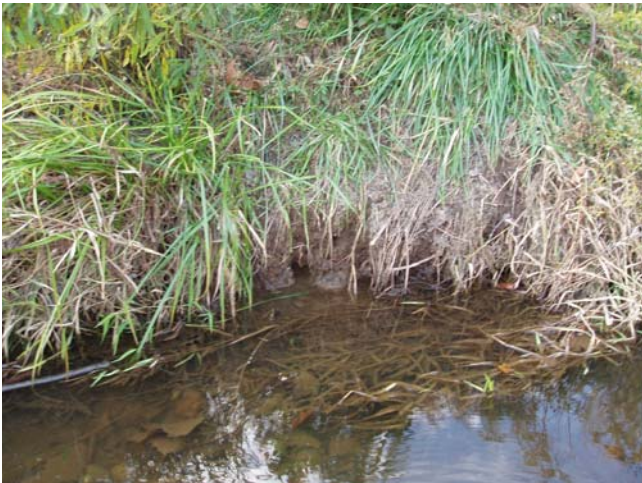
PA7 facing right bank

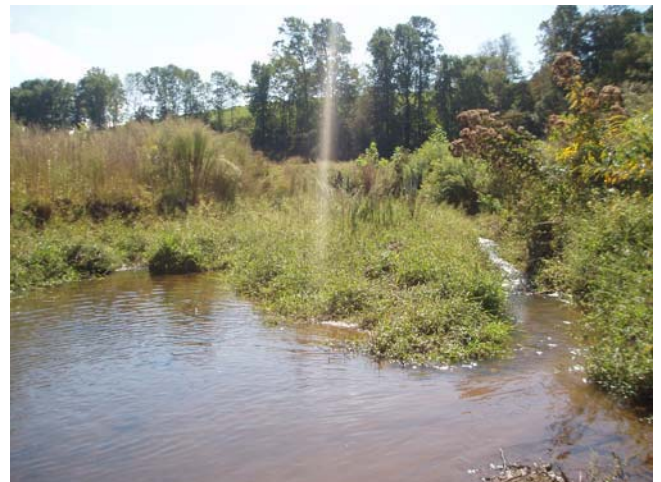
PA10 facing upstream

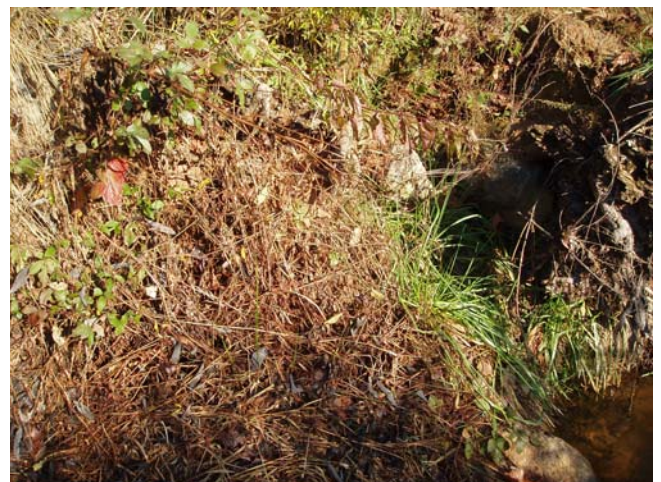
PA16 facing left bank

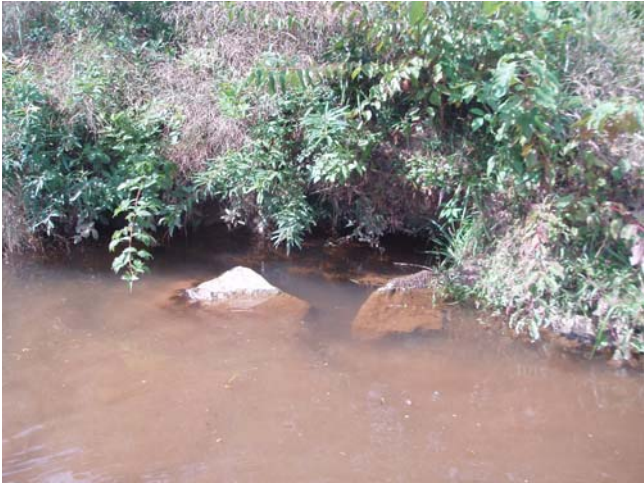
PA17 facing left bank

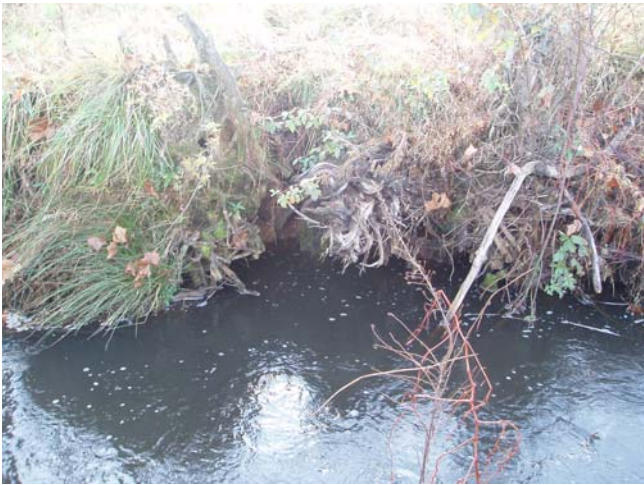
PA19 facing right bank

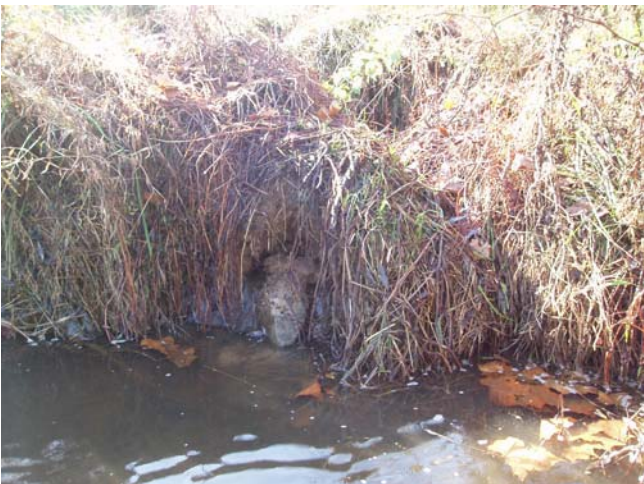
PA21 facing right bank

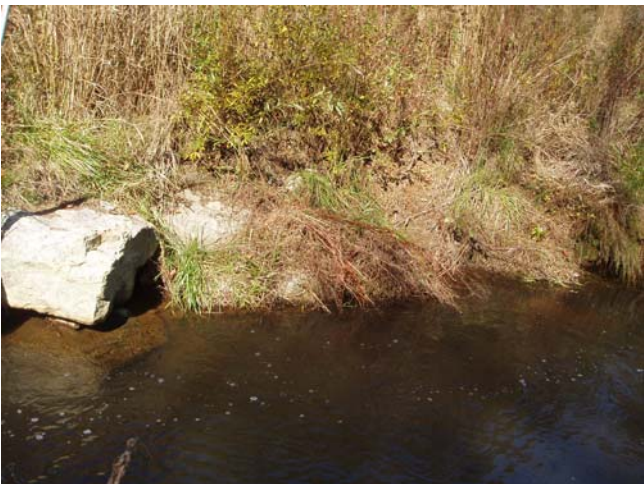
PA27 facing left bank

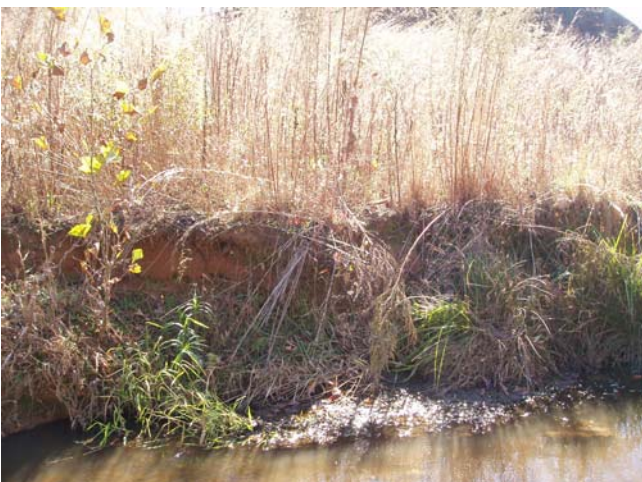
PA33 facing right bank

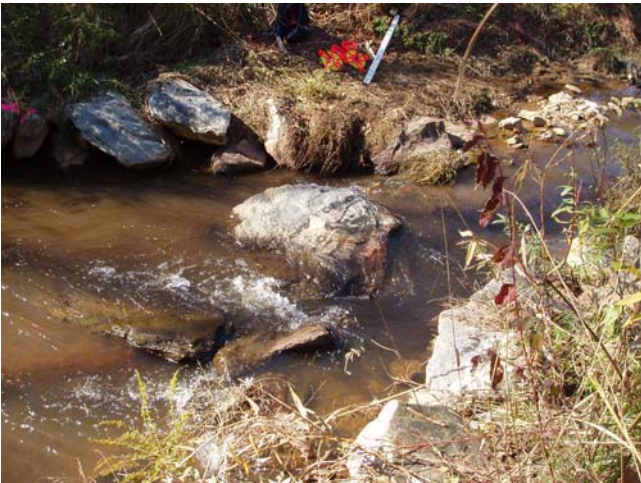
PA37 facing upstream at junction with UT

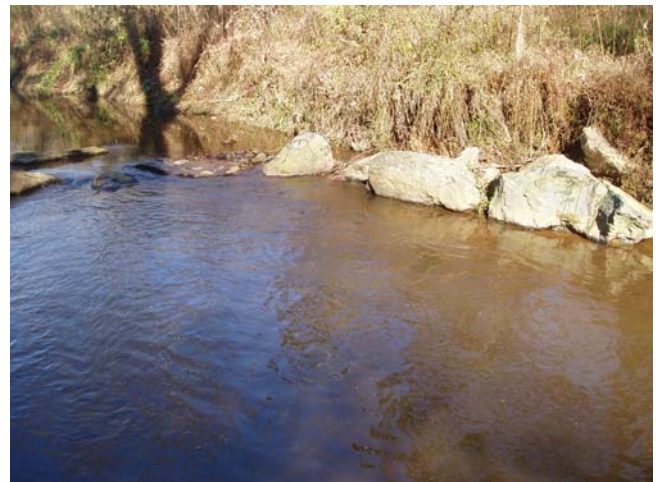
PA29	Bank erosion/scour	28+20	Improper design and/or construction	PA29
PA30	Bank erosion/scour	31+10	Improper design and/or construction	PA30
PA31	Bank erosion/scour	35+00	Improper design and/or construction	PA31
PA32	Bank erosion/scour	35+10	Improper design and/or construction	PA32
PA33	Bank erosion/scour	37+30	Improper design and/or construction	PA33
PA34	Bank erosion/scour	39+90	Structure placement	PA34
PA35	Bank erosion/scour	41+00	Improper design and/or construction	PA35
PA36	Bank erosion/scour	41+30	Improper design and/or construction	PA36
PA37	Structure degradation	41+60	Improper design and/or construction	PA37
PA38	Bank erosion/scour	42+00	Improper design and/or construction	PA38
PA39	Bank erosion/scour	42+30	Improper design and/or construction	PA39
PA40	Structure degradation	42+76	Improper design and/or construction	PA40

PA40 facing upstream
