**Little Bugaboo Creek Stream Restoration  
2007 Final Monitoring Report  
Monitoring Year Three**

**Ecosystem Enhancement Program Project Number 00056**

Submitted: February 26, 2008

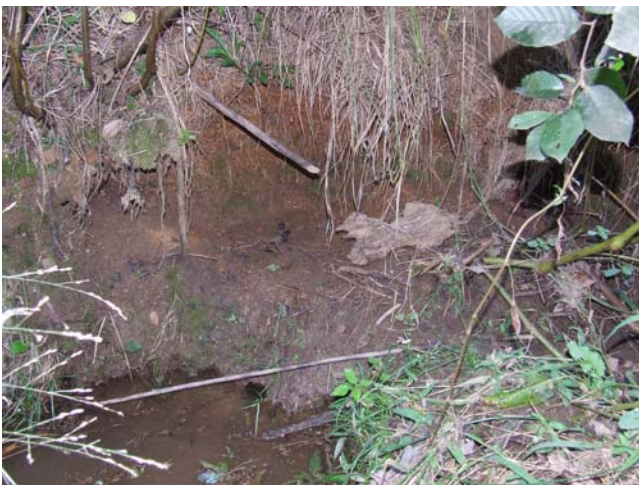
UTPA7 facing left bank

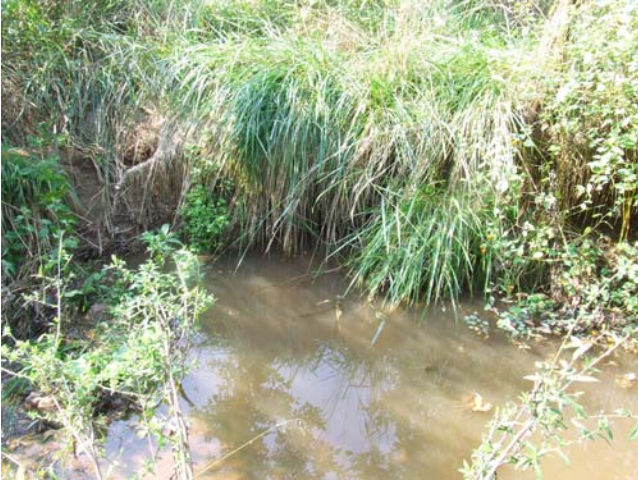
UTPA9 facing right bank

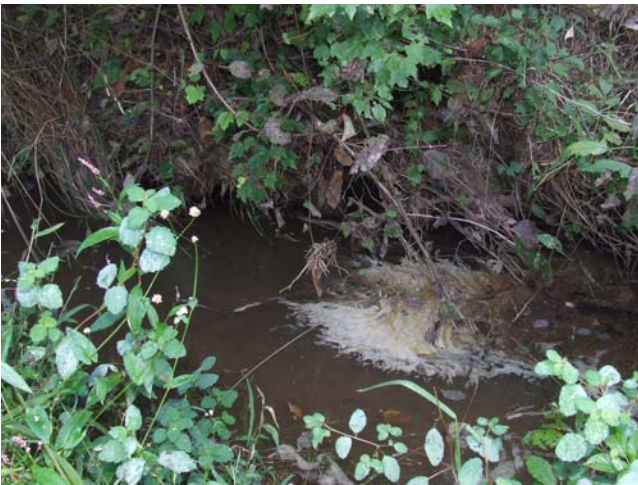
UTPA11 facing left bank

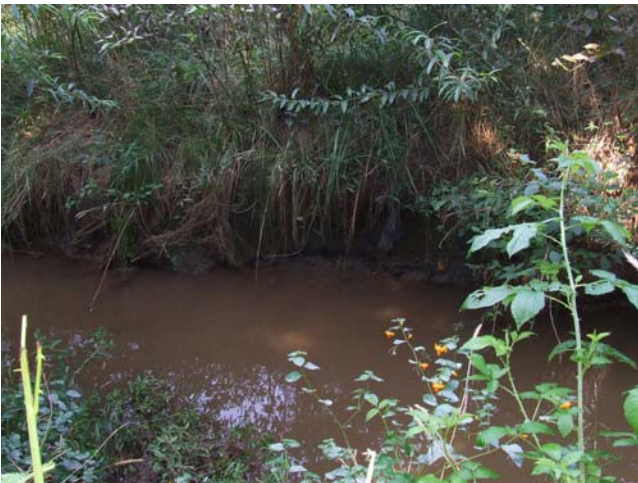
Stream Problem Areas – Unnamed Tributary			
Little Bugaboo Creek			
Feature #	Feature/Issue	Station	Probable Cause
UTPA1	Beaver dam	0+60	Beaver
UTPA2	Structure failure	1+00	Improper design and/or construction
UTPA3	Beaver dam	2+80	Beaver
UTPA4	Bank erosion/scour	5+35	Improper design and/or construction
UTPA5	Structure degradation	5+95	Improper design and/or construction
UTPA6	Structure degradation	6+10	Improper design and/or construction
UTPA7	Bank erosion/scour	6+50	Improper design and/or construction
UTPA8	Bank erosion/scour	7+15	Improper design and/or construction
UTPA9	Structure degradation	7+25	Improper design and/or construction
UTPA10	Structure failure	7+40	Improper design and/or construction
UTPA11	Bank erosion/scour	7+55	Improper design and/or construction
UTPA12	Bank erosion/scour	8+00	Improper design and/or construction
UTPA13	Beaver dam	7+60	Beaver
UTPA14	Bank erosion/scour	8+25	Improper design and/or construction

UTPA14 facing right bank

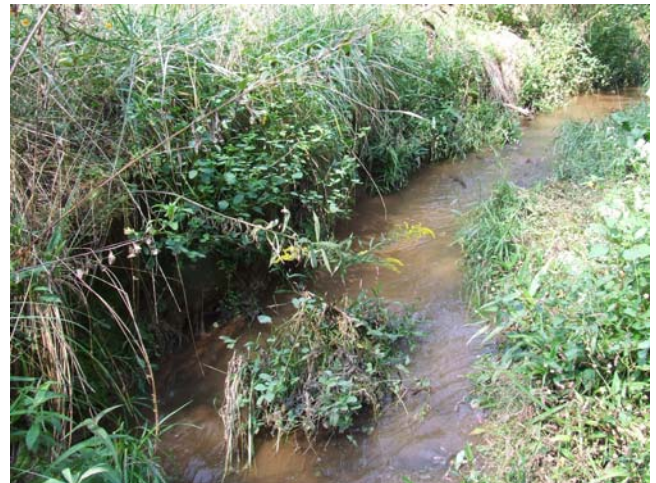
UTPA15	Beaver dam	9+00	Beaver
UTPA16	Bank erosion/scour	11+75	Improper design and/or construction
UTPA17	Bank erosion/scour	12+40	Improper design and/or construction
UTPA18	Bank erosion/scour	12+60	Improper design and/or construction
UTPA19	Channel widening	13+40	Scour
UTPA20	Structure degradation	14+50	Improper design and/or construction
UTPA21	Bank erosion/scour	15+10	Improper design and/or construction
UTPA22	Bank erosion/scour	18+15	Improper design and/or construction
UTPA23	Debris jam	18+50	Debris jam
UTPA24	Bank erosion/scour	19+20	Improper design and/or construction

UTPA16 facing downstream

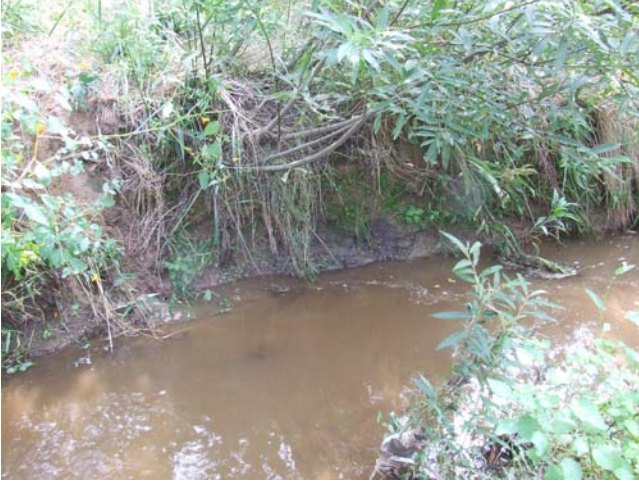
UTPA17 facing right bank

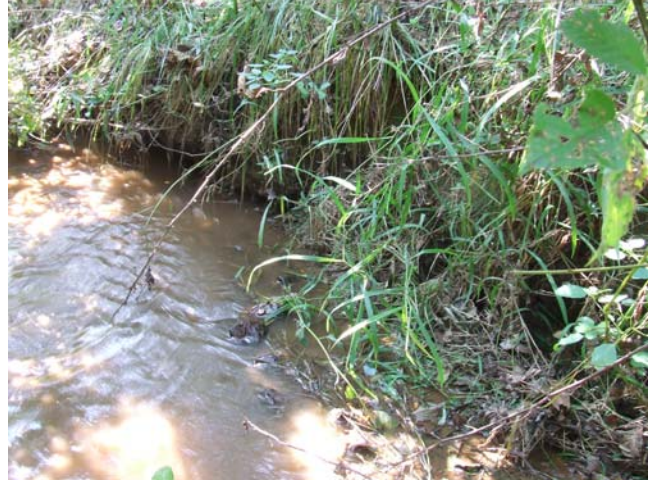
UTPA18 facing downstream

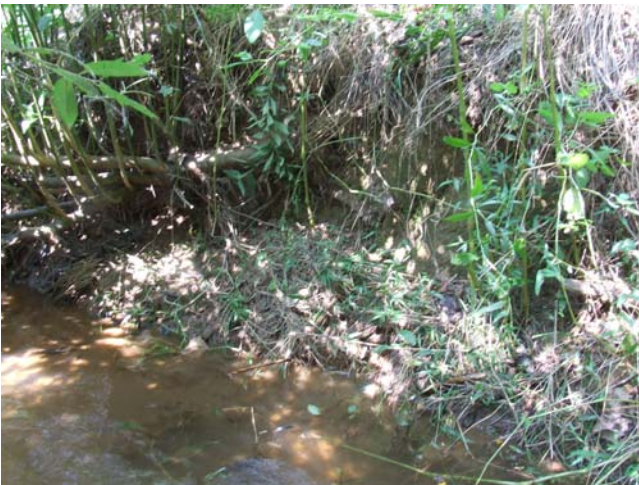
UTPA19 facing right bank

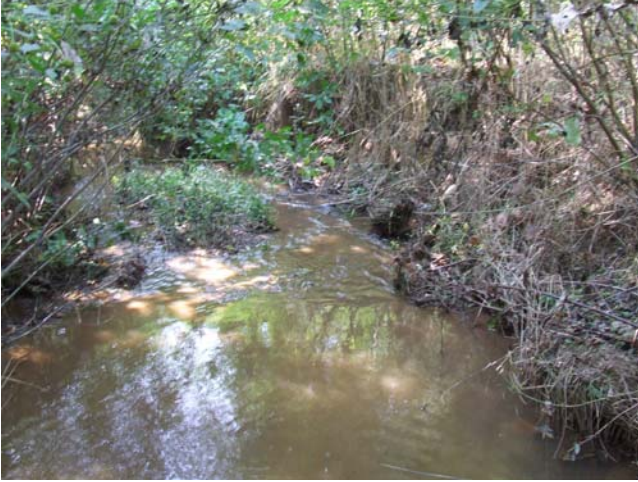
UTPA23 facing downstream

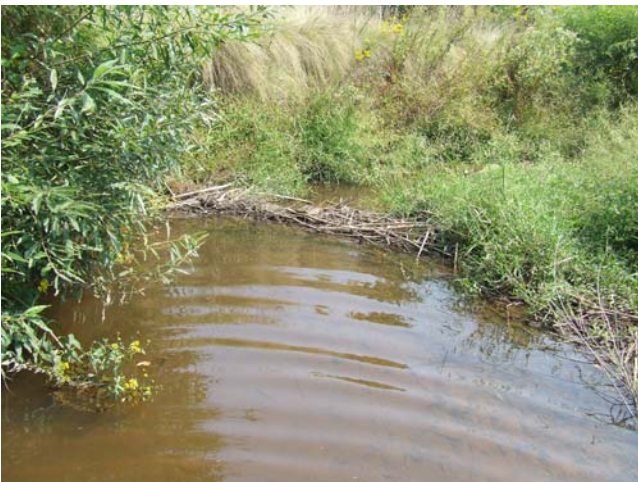
Stream Problem Areas – Little Bugaboo Creek			
Little Bugaboo Creek			
Feature #	Feature/Issue	Station #/Range	Probable Cause
PA1	Bank erosion	3+10	Root wad failure
PA2	Bank erosion/scour	3+70	Improper design and/or construction
PA3	Beaver dam	4+20	Beaver
PA4	Structure degradation	6+80	Scour behind rootwad
PA5	Beaver dam	7+40	Beaver
PA6	Bank erosion/scour	7+50	Improper design and/or construction
PA7	Structure degradation	8+45	Improper design and/or construction
PA8	Structure failure	9+20	Erosion behind arm
PA9	Beaver dam	11+00	Beaver
PA10	Channel failure	10+60 to	Improper design and/or construction
PA11	Bank erosion/scour	14+00	Improper design and/or construction
PA12	Structure degradation	15+10	Scour behind rootwad
PA13	Bar formation	16+15	Aggradation
PA14	Bank erosion/scour	16+50	Improper design and/or construction
PA15	Structure degradation	17+80	Mass wasting
PA16	Structure failure	19+90	Bank erosion
PA17	Bank erosion/scour	21+10	Improper design and/or construction

PA3 facing downstream

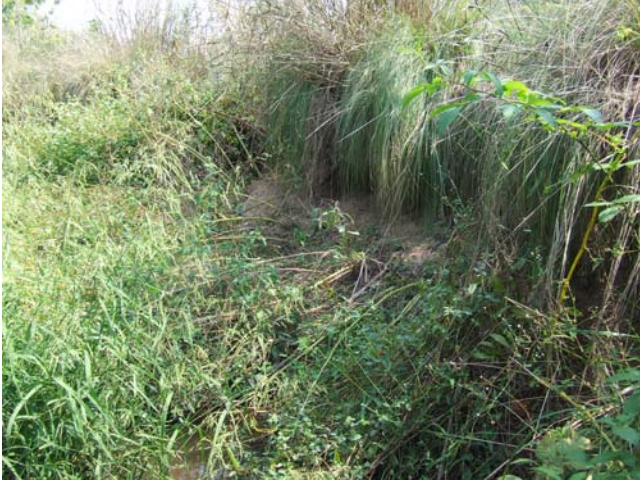
PA11 facing downstream

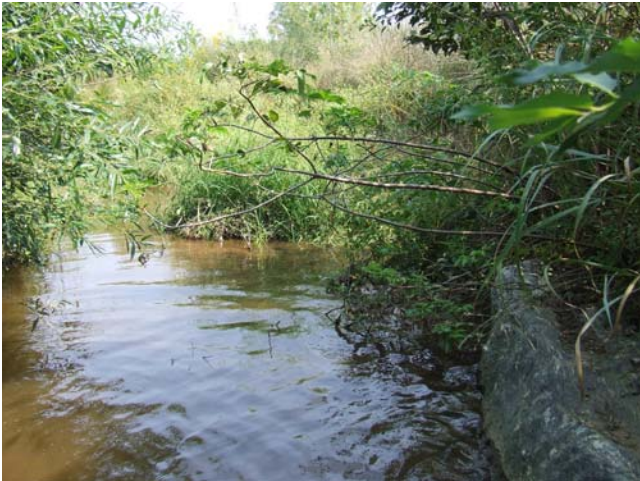
<b>Exhibit Table B1b. Stream Problem Areas – Little Bugaboo Creek</b>				
<b>Little Bugaboo Creek</b>				
<b>EEP Project Number 00056</b>				
<b>Feature #</b>	<b>Feature/Issue</b>	<b>Station # /Range</b>	<b>Probable Cause</b>	<b>Photo #</b>
PA1	Bank erosion	3+10	Root wad failure	PA1
PA2	Bank erosion/scour	3+70	Improper design and/or construction	PA2
PA3	Beaver dam	4+20	Beaver	PA3
PA4	Structure degradation	6+80	Scour behind rootwad	PA4
PA5	Beaver dam	7+40	Beaver	PA5
PA6	Bank erosion/scour	7+50	Improper design and/or construction	PA6
PA7	Structure degradation	8+45	Improper design and/or construction	PA7
PA8	Structure failure	9+20	Erosion behind arm	PA8
PA9	Beaver dam	11+00	Beaver	PA9
PA10	Channel failure	10+60 to 11+00	Improper design and/or construction	PA10
PA11	Bank erosion/scour	14+00	Improper design and/or construction	PA11
PA12	Structure degradation	15+10	Scour behind rootwad	PA12
PA13	Bar formation	16+15	Aggradation	PA13

PA13 facing downstream

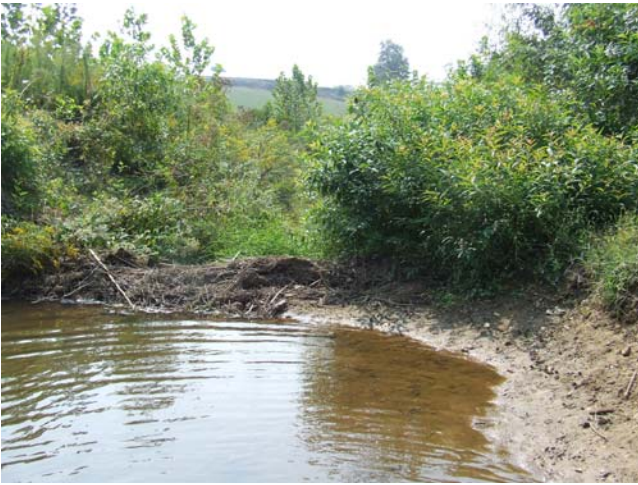
PA23 facing downstream

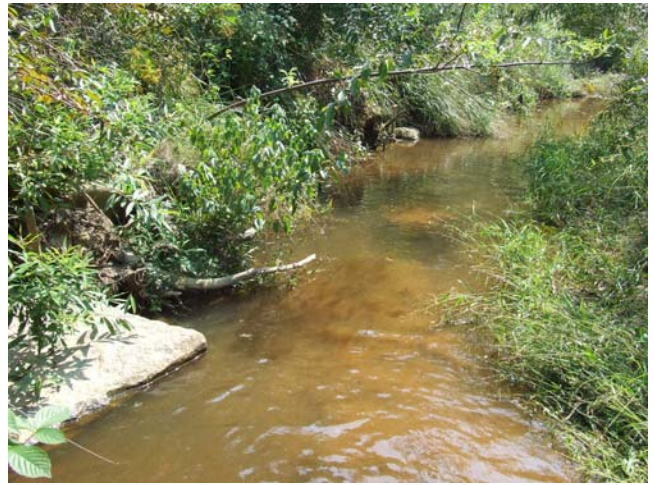
PA30	Bank erosion/scour	41+00	Improper design and/or construction	PA30
PA31	Beaver dam	41+20	Beaver	PA31
PA32	Bank erosion/scour	41+30	Improper design and/or construction	PA32
PA33	Structure degradation	41+60	Improper design and/or construction	PA33
PA34	Structure degradation	42+76	Improper design and/or construction	PA34

PA30 facing downstream

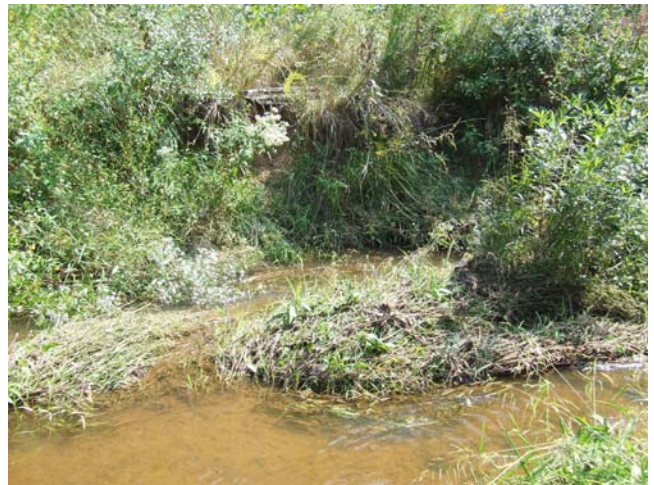
PA32 facing junction with UT

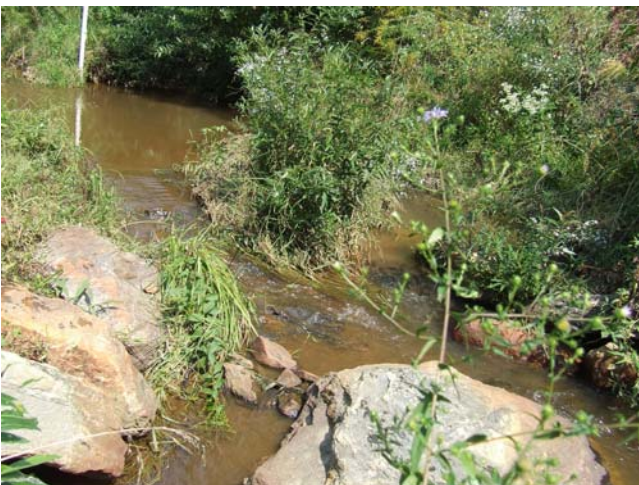
PA33 facing upstream at junction with UT
