**Little Bugaboo Creek Stream Restoration
2008 Final Monitoring Report
Monitoring Year Four**

Ecosystem Enhancement Program Project Number 00056

Submitted: February 17, 2009

URS Corporation – North Carolina
1600 Perimeter Park Drive, Suite 400
Morrisville, NC 27560

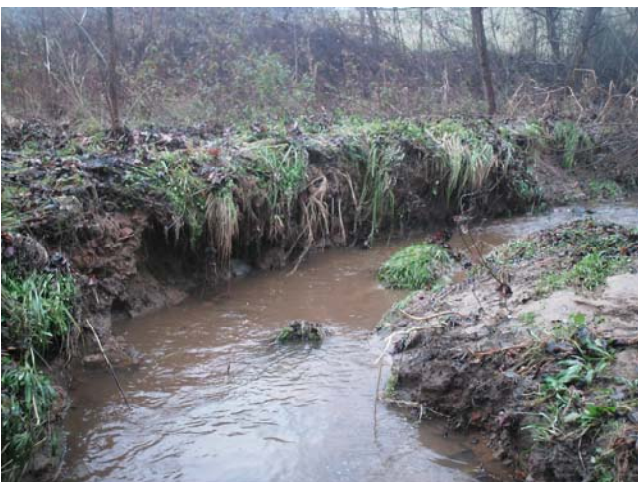
UTPA17 facing downstream

Little Bugaboo Creek EEP Project Number 00056				
Feature #	Feature/Issue	Station # / Range	Probable Cause	Photo #
PA7	Structure degradation	8+45	Thalweg flowing through vane arm, not center of structure	PA7
PA21	Bank erosion	25+10	Scour	PA21
PA30	Bank erosion	41+00 to 41+10	Scour	PA30
PA32	Bank erosion	41+30	Scour	PA32
PA33	Structure degradation	41+60	Boulders shifted	PA33
PA34	Structure degradation	42+76	Bank scour behind vane arm	PA34
PA36	Aggradation	10+40 to 10+70	Bank erosion and scour	PA36
PA37	Bank erosion	22+80 to 23+10	Scour	PA37
PA40	Bank erosion	7+20 to 7+40	Scour	PA40
PA41	Bank erosion	14+00 to 14+30	Scour	PA41
PA42	Beaver dam	14+35	Beaver	PA42
Unnamed Tributary EEP Project Number 00056				
UTPA2	Bank erosion	1+60 to 2+00	Scour	UTPA2
UTPA4	Bank erosion	5+35	Scour	UTPA4
UTPA12	Bank erosion	8+00	Scour	UTPA12
UTPA16	Bank erosion	11+75	Scour	UTPA16
UTPA17	Bank erosion	12+40	Scour	UTPA17
UTPA21	Bank erosion	15+10	Scour	UTPA21

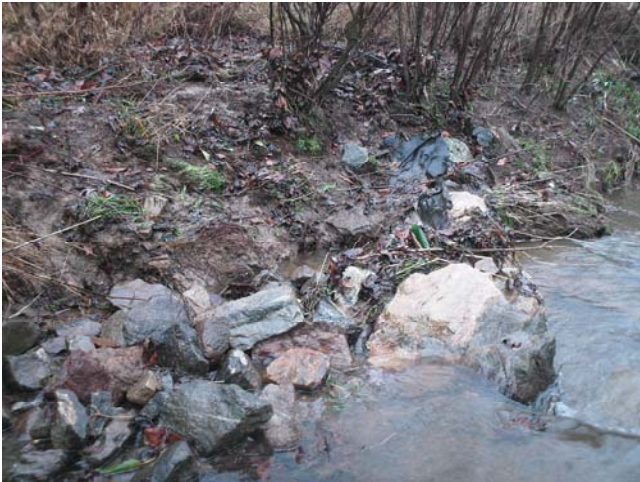
UTPA22 facing downstream

UTPA22	Structure degradation	6+80	Scour behind vane arm	UTPA22
