MONITORING YEAR 2 ANNUAL REPORT

BUG HEADWATERS MITIGATION SITE

Wilkes County, NC
Yadkin River Basin
HUC 03040101

DMS Project No. 100084
DMS RFP No. 16-007406 / Date of Issue: December 17,
2017
NCDEQ Contract No. 7617
USACE Action ID No. 2018-01788
DWR Project No. 2018-1273

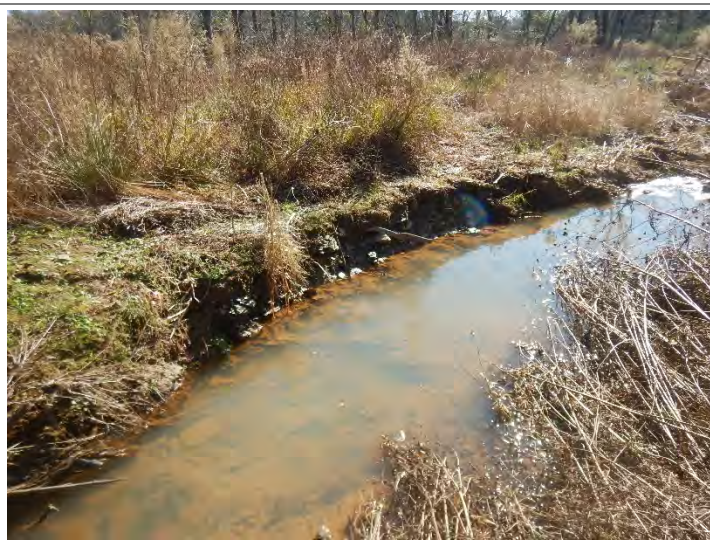
Before – Localized Toe Erosion (11/17/2022)

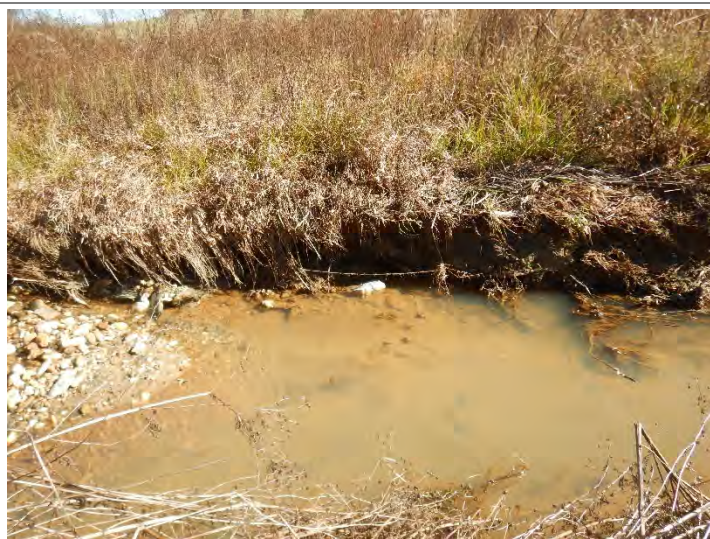
Before – Localized Toe Erosion (11/17/2022)

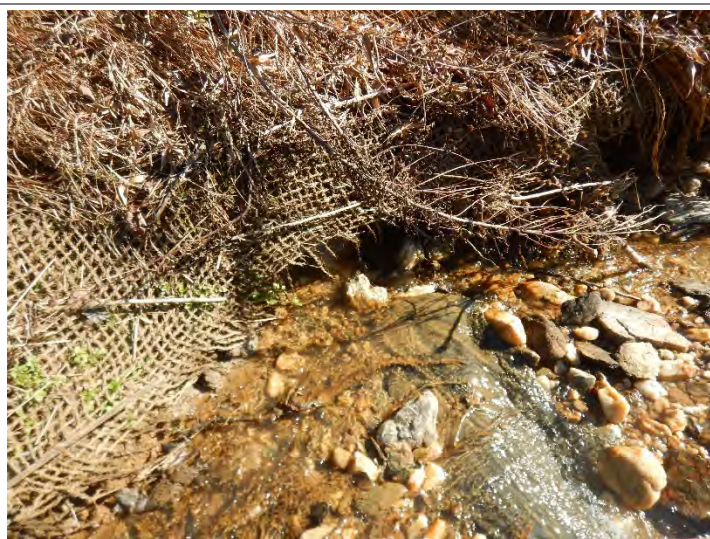
Before – Eroded Log Sill at STA 139+59 (11/17/2022)
