MY2 (2023) FINAL MONITORING REPORT

Bull Chute Stream and Riparian Wetland Mitigation Site

Randolph County, NC
Yadkin River Basin
Cataloging Unit 03040103

DMS Project ID No. 100137
Full Delivery Contract No. 7878-01
RFP #16-007878 (Issued: 5/6/2019)
USACE Action ID No. SAW-2020-00049
DWR Project No. 20200021

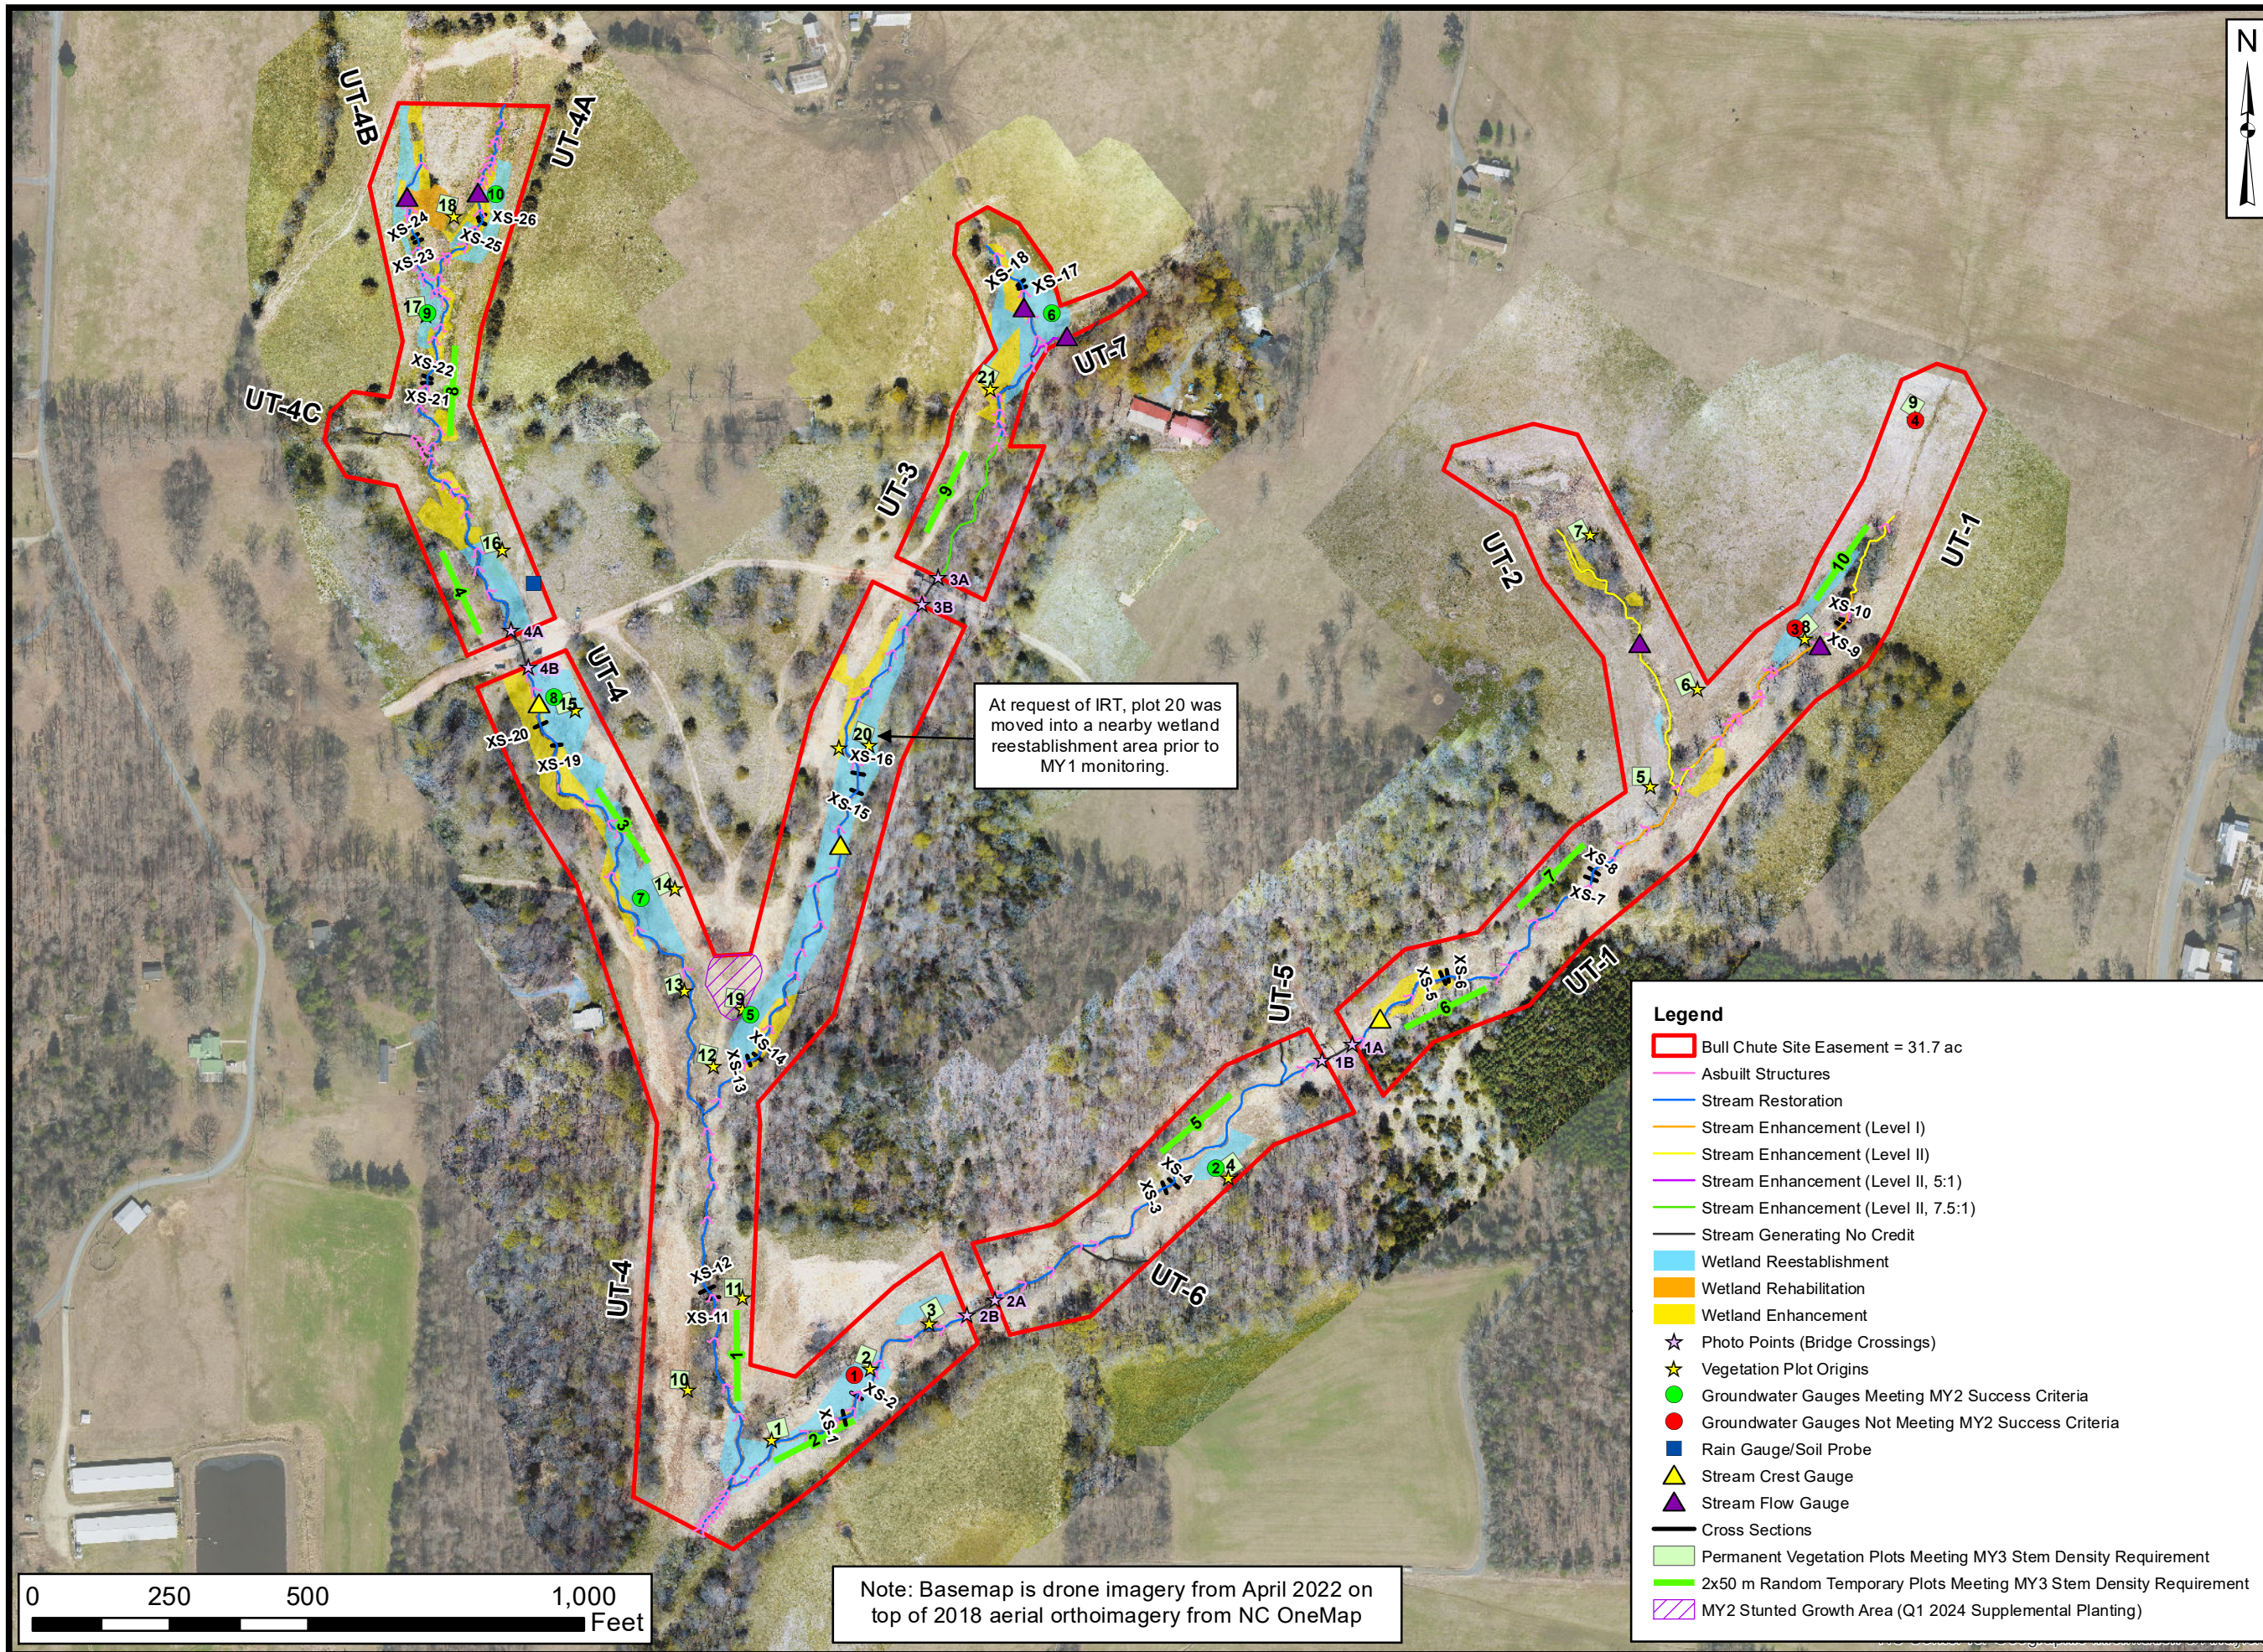
**CURRENT
CONDITIONS
PLAN VIEW**

- 11) CCPV – Recommend including the low stem density area near VP19 on the CCPV and updated Table 5 to reflect this area.
Re: The CCPV has been updated to show the low stem density area near VP19 and Table 5 has been updated to reflect this area.

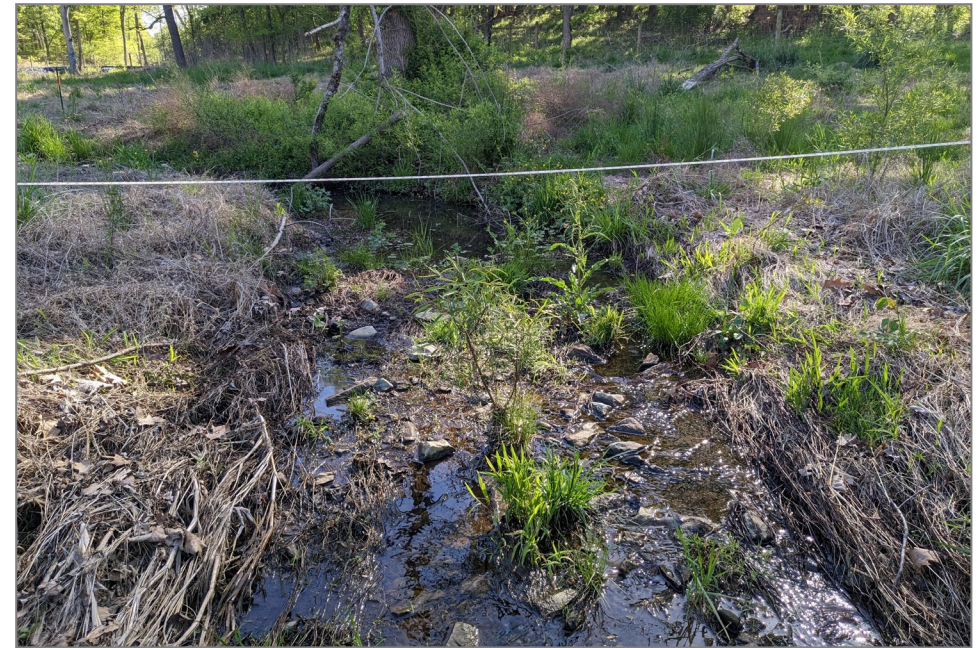
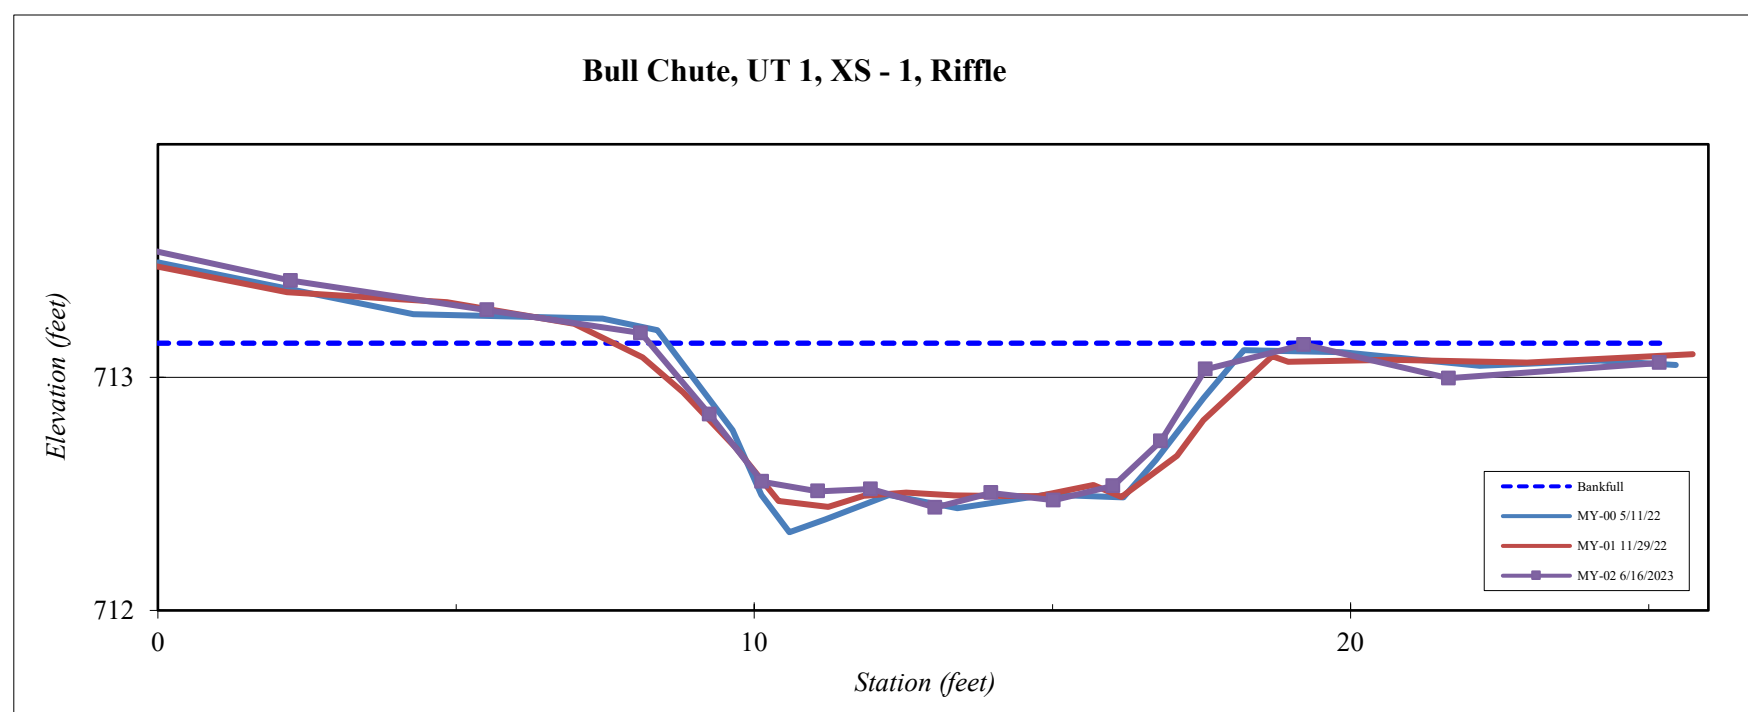
Site	Bull Chute Site
Watershed:	Yadkin River Basin, 03040103
XS ID	UT1, XS -1
Feature	Riffle
Date:	6/16/2023
Field Crew:	Perkinson, Smith, Flemming, Lance

SUMMARY DATA	
Bankfull Elevation:	713.57
Bank Height Ratio:	0.99
Thalweg Elevation:	712.78
LTOB Elevation:	713.57
LTOB Max Depth:	0.79
LTOB Cross Sectional Area:	5.7

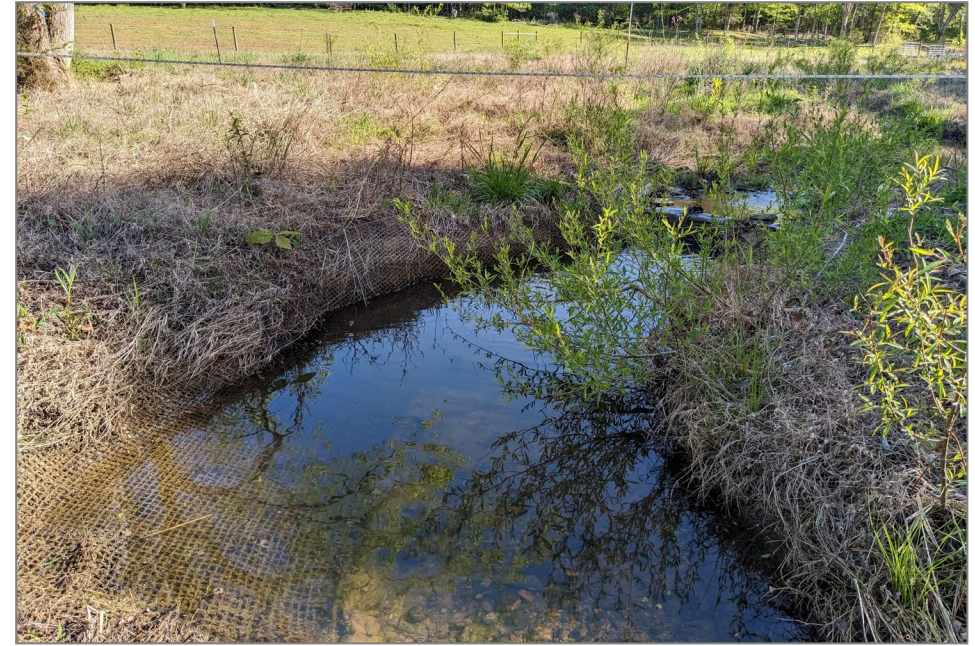
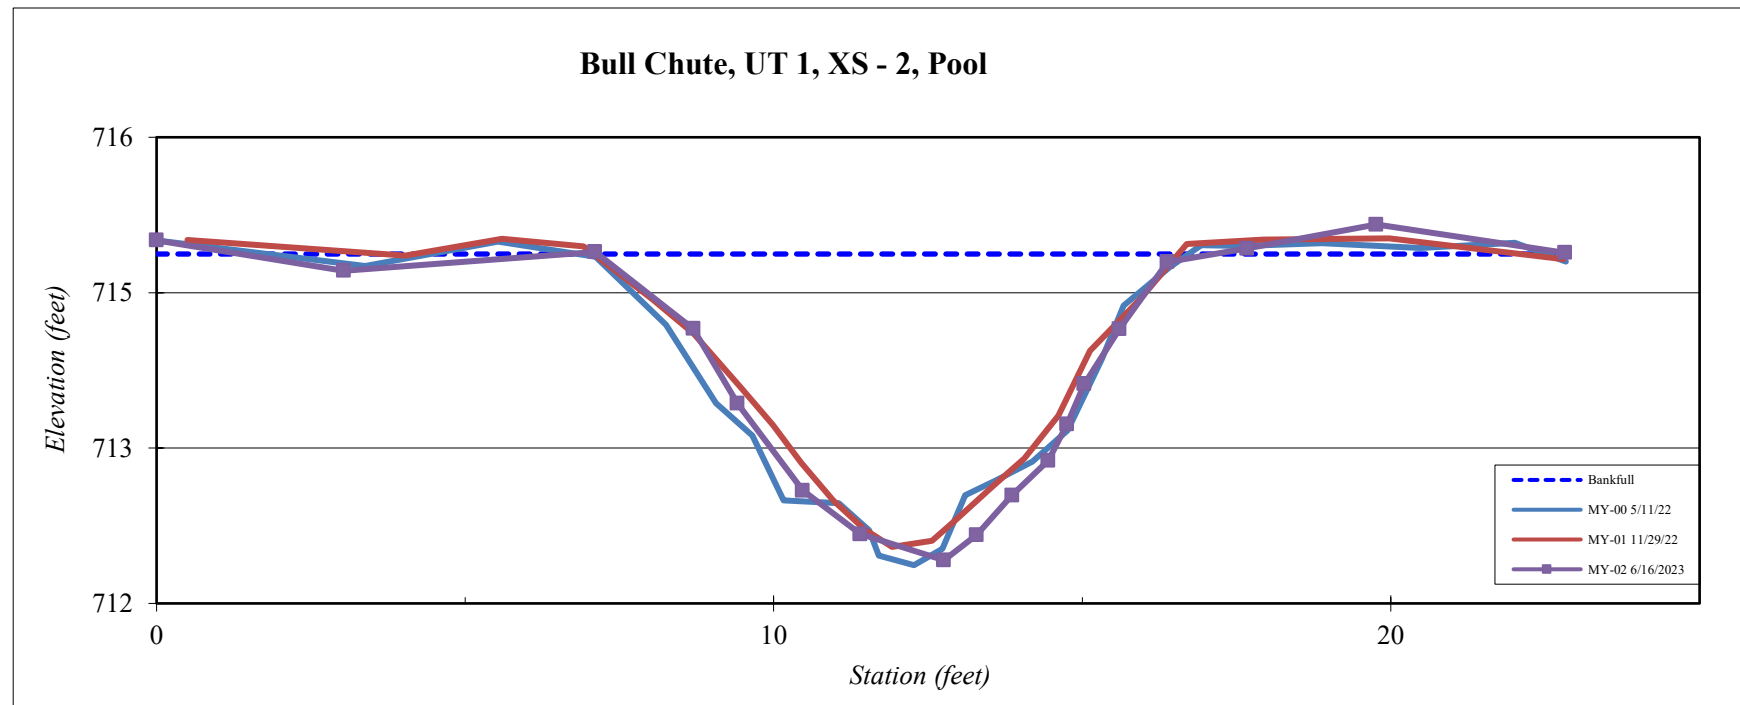
Site	Bull Chute Site
Watershed:	Yadkin River Basin, 03040103
XS ID	UT1, XS -2
Feature	Pool
Date:	6/16/2023
Field Crew:	Perkinson, Smith, Flemming, Lance

SUMMARY DATA	
Bankfull Elevation:	714.82
Bank Height Ratio:	0.97
Thalweg Elevation:	712.59
LTOB Elevation:	714.76
LTOB Max Depth:	2.17
LTOB Cross Sectional Area:	11.2

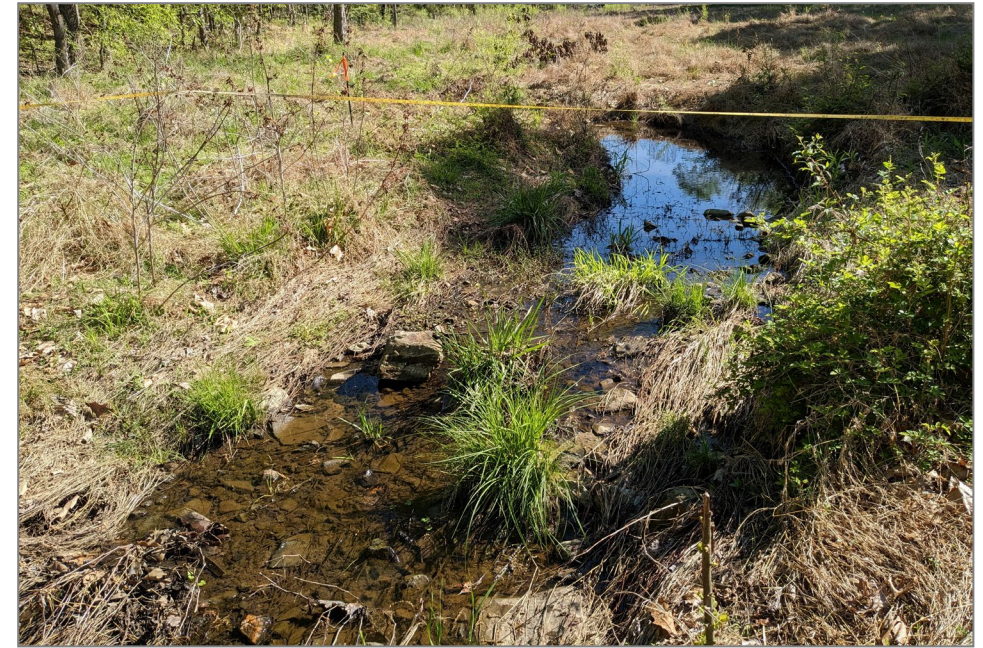
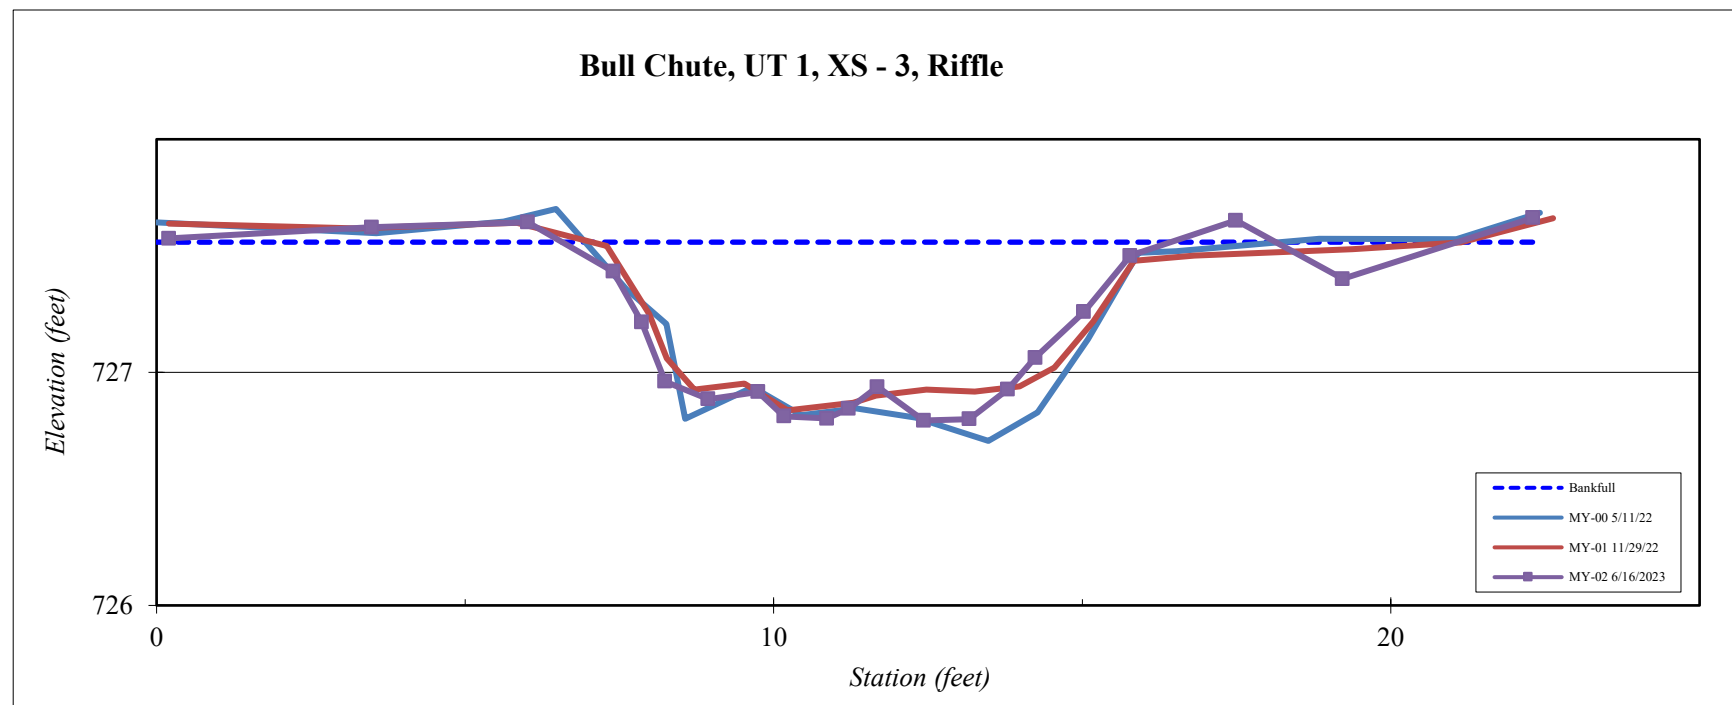
Site	Bull Chute Site
Watershed:	Yadkin River Basin, 03040103
XS ID	UT1, XS -3
Feature	Riffle
Date:	6/16/2023
Field Crew:	Perkinson, Smith, Flemming, Lance

SUMMARY DATA	
Bankfull Elevation:	727.61
Bank Height Ratio:	0.92
Thalweg Elevation:	726.74
LTOB Elevation:	727.54
LTOB Max Depth:	0.80
LTOB Cross Sectional Area:	5.0

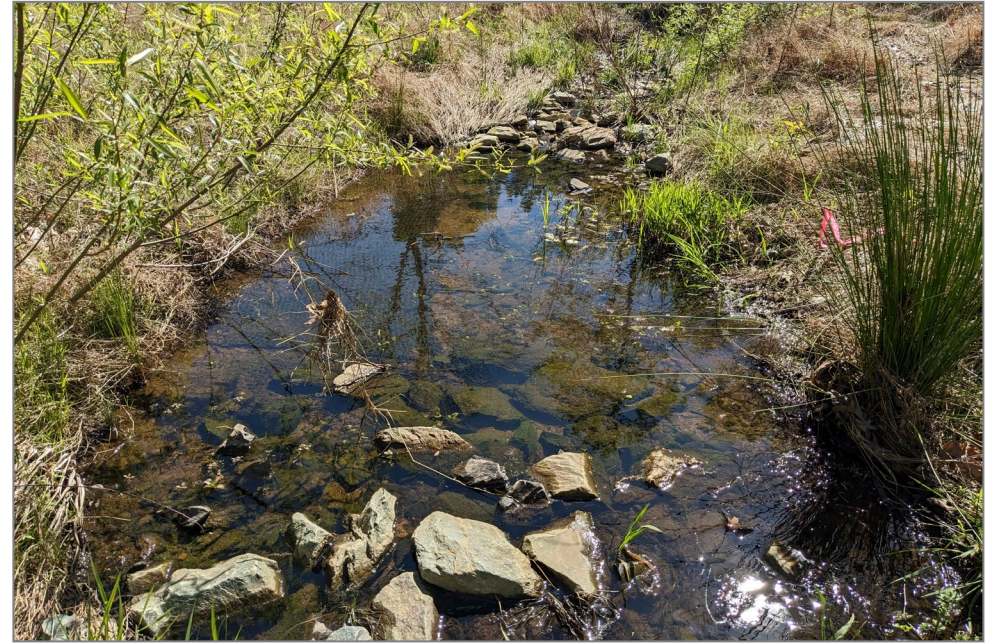
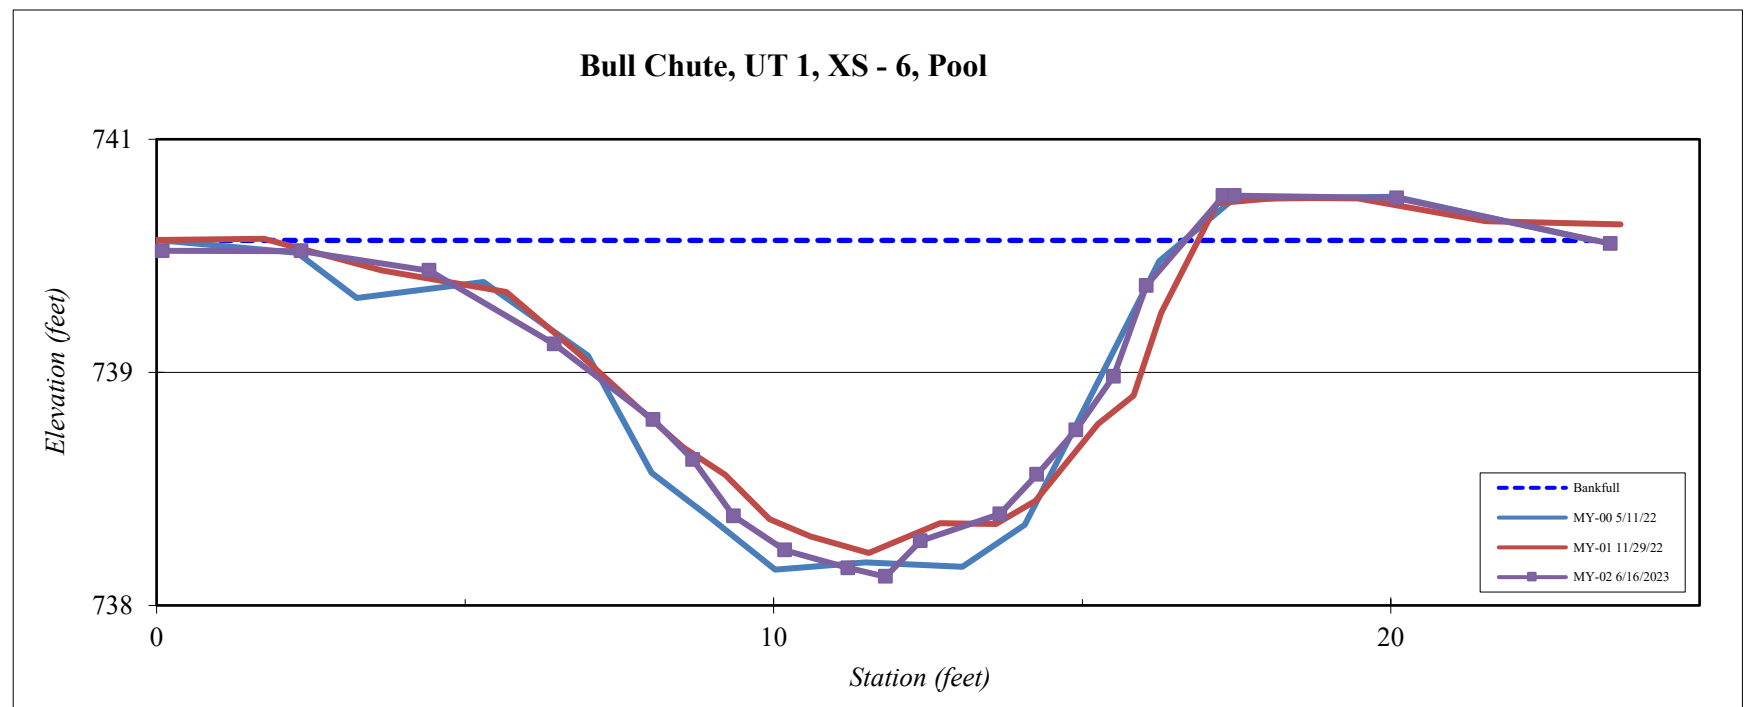
Site	Bull Chute Site
Watershed:	Yadkin River Basin, 03040103
XS ID	UT1, XS -6
Feature	Pool
Date:	6/16/2023
Field Crew:	Perkinson, Smith, Flemming, Lance

SUMMARY DATA	
Bankfull Elevation:	740.05
Bank Height Ratio:	0.97
Thalweg Elevation:	738.42
LTOB Elevation:	740.00
LTOB Max Depth:	1.58
LTOB Cross Sectional Area:	11.2

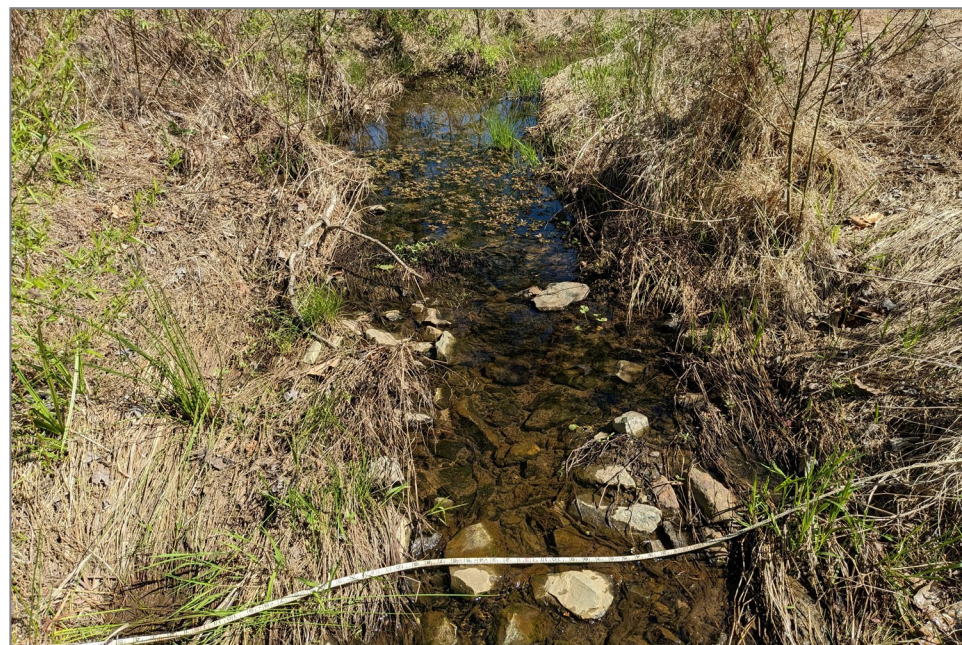
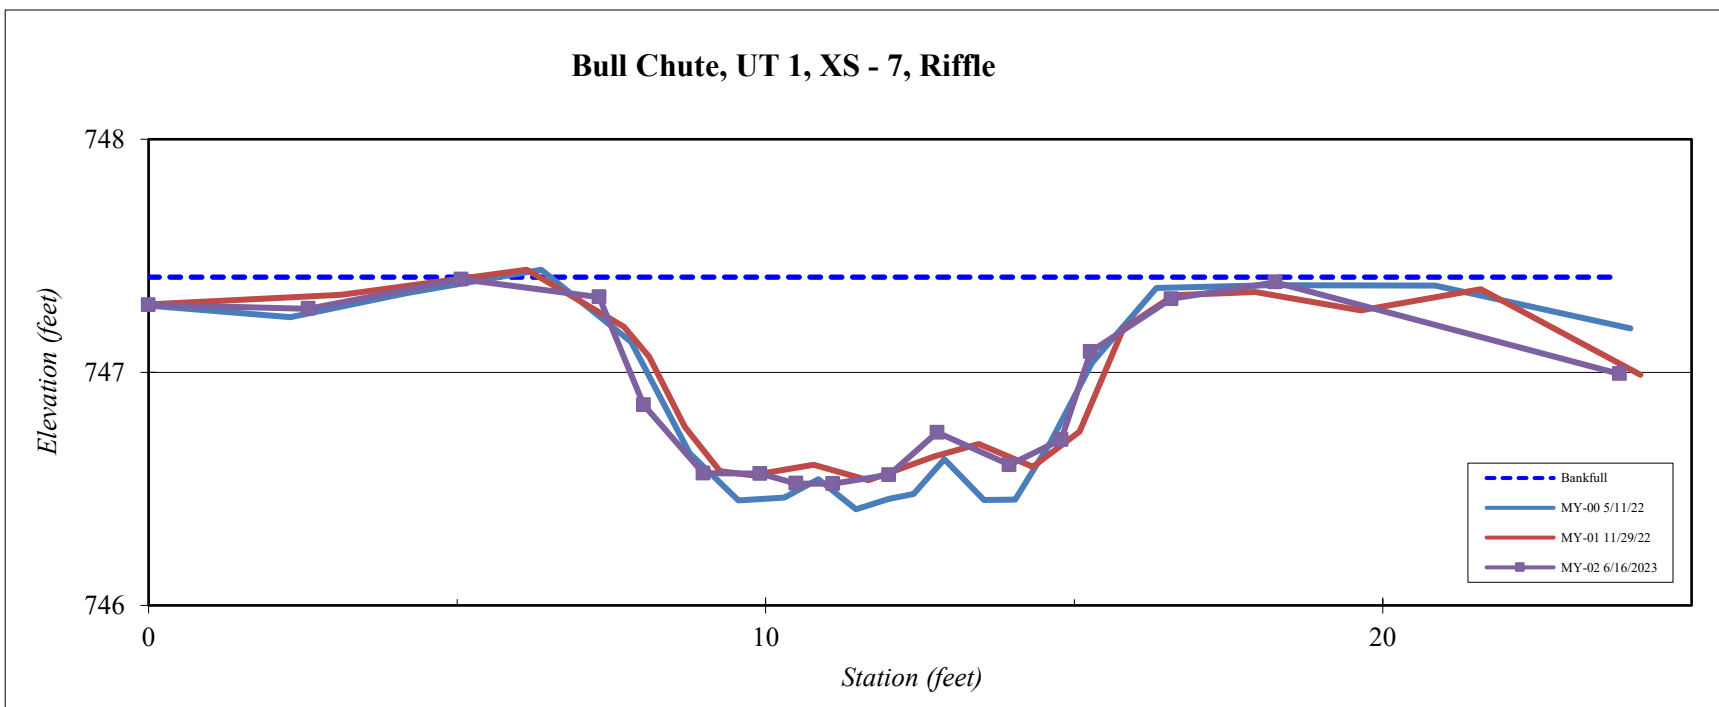
Site	Bull Chute Site
Watershed:	Yadkin River Basin, 03040103
XS ID	UT1, XS -7
Feature	Riffle
Date:	6/16/2023
Field Crew:	Perkinson, Smith, Flemming, Lance

SUMMARY DATA	
Bankfull Elevation:	747.79
Bank Height Ratio:	0.90
Thalweg Elevation:	746.79
LTOB Elevation:	747.68
LTOB Max Depth:	0.90
LTOB Cross Sectional Area:	5.9

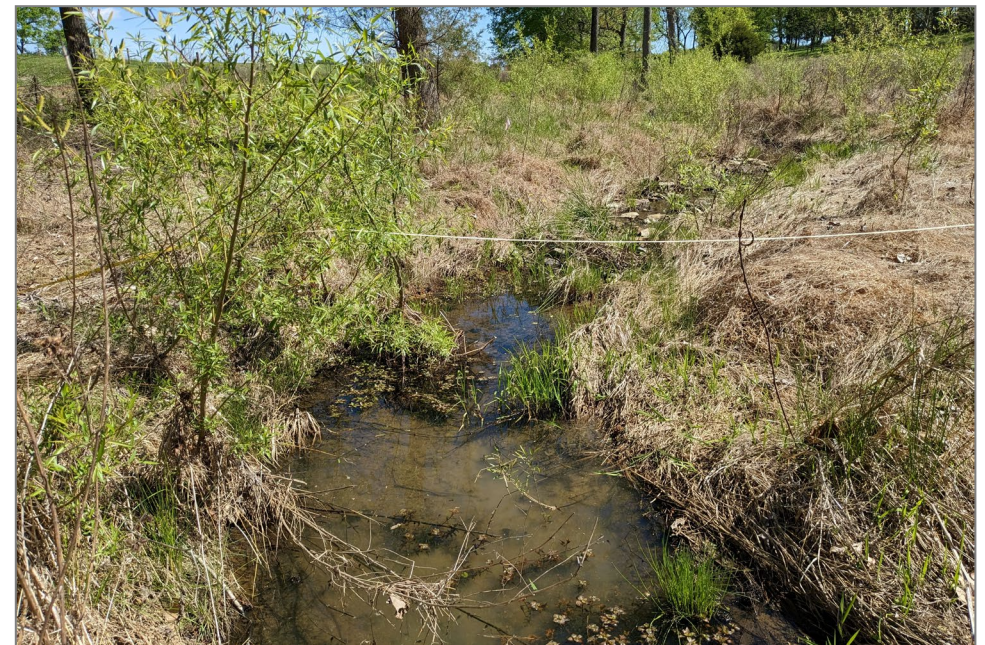
Site	Bull Chute Site
Watershed:	Yadkin River Basin, 03040103
XS ID	UT1, XS -8
Feature	Pool
Date:	6/16/2023
Field Crew:	Perkinson, Smith, Flemming, Lance

SUMMARY DATA	
Bankfull Elevation:	747.99
Bank Height Ratio:	0.98
Thalweg Elevation:	746.39
LTOB Elevation:	747.96
LTOB Max Depth:	1.58
LTOB Cross Sectional Area:	10.0

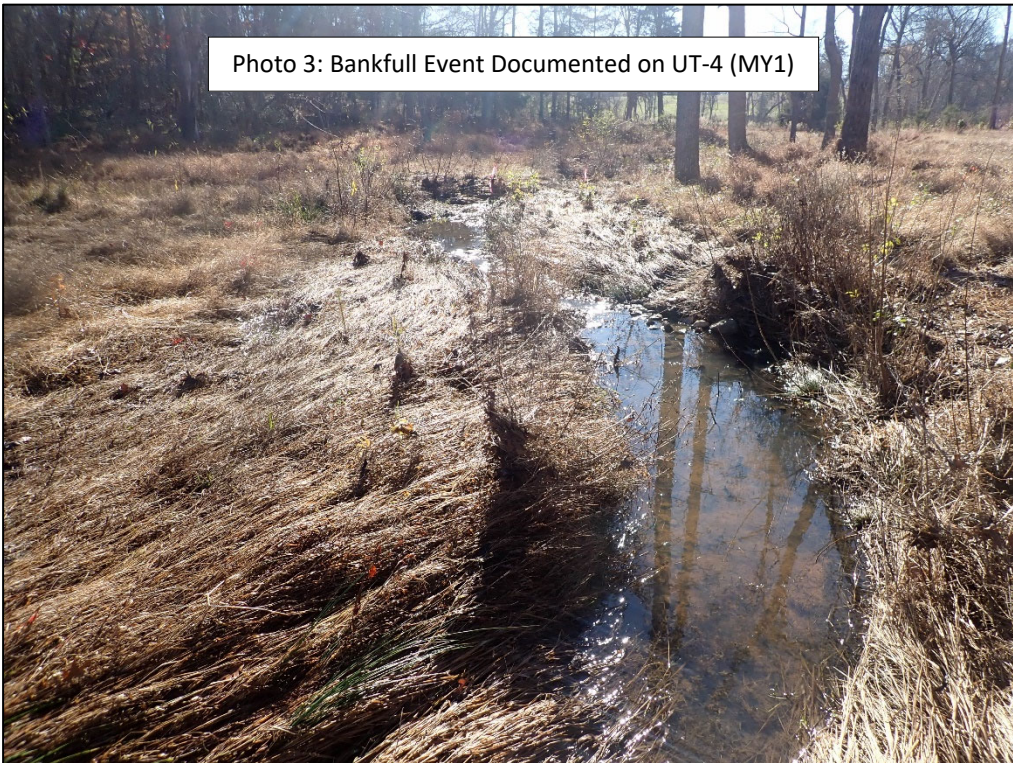
Photo 3: Bankfull Event Documented on UT-4 (MY1)
