# **MY4 FINAL MONITORING REPORT**

# **Burnetts Chapel Mitigation Site-Phase II**

DMS Project No. 100045 DMS Contract No. 7430 DMS RFP No. 16-007242 DWR Project Number 2011-0841

Data Collection Period: September 2022 Submission Date: November 2022

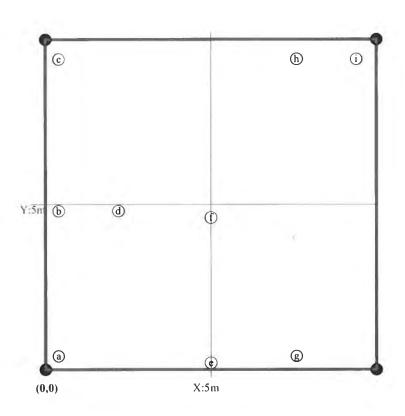
Plot	(continued):	10045-01-VP6			2021 Da	P-	3					EAR'S DATA
ID	Species	map source char	Y (m)	ddh (mm)	Height (cm)	DBH (cm)		ddh (mm)	Height (cm)	DBH (cm)	Re- sprout	Vigor* Damage* Notes

79	Platanus occidentalis	(g)	R	7.6	0.4	168.0	1,0	240	2						
81	Quercus phellos	<b>(b)</b>	R	0.4	4.8	47.0		58							
82	Quercus phellos	(d)	R	22	4 8	38.0		25		$\times$					
83	Liriodendron tulipifera	<b>①</b>	R	5.0	4.7	194.0	1.0	55		X		deer	broke inha		
86	Liriodendron tulipifera	©	R	0.4	9.5	61.0		59							
89	Platanus occidentalis	h	R	7.6	9.5	190.0	1.0	225	2		V		A STATE OF THE STA		
90	Platanus occidentalis	(i)	R	9.4	9.5	220.0	1.0	350	3		4
