# MONITORING YEAR 3 ANNUAL REPORT

## BYRDS CREEK MITIGATION SITE

Person County, NC  
NCDEQ Contract 003987  
DMS Project Number 95020

Data Collection Period: March 2016-August 2016  
Draft Submission Date: September 26, 2016  
Final Submission Date: October 19, 2016

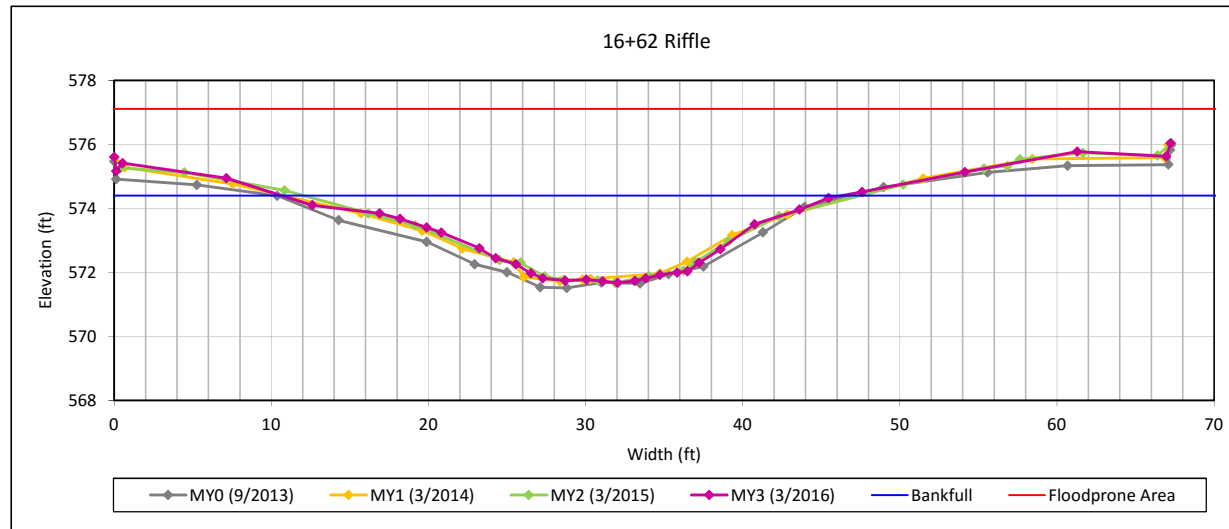
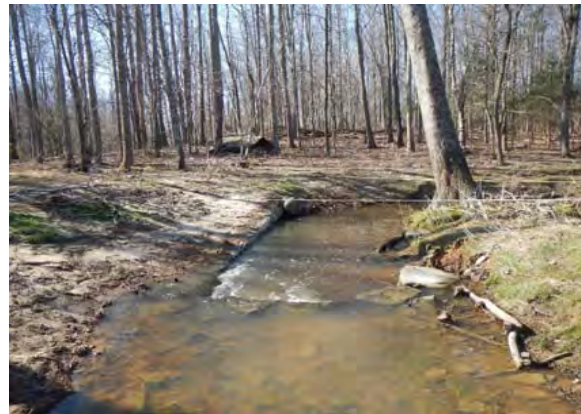
#### Cross Section 1-Byrds Creek Reach 2

50.6	x-section area (ft.sq.)
35.6	width (ft)
1.4	mean depth (ft)
2.7	max depth (ft)
36.2	wetted perimeter (ft)
1.4	hyd radi (ft)
25.0	width-depth ratio
150.0	W flood prone area (ft)
4.2	entrenchment ratio
1.0	low bank height ratio

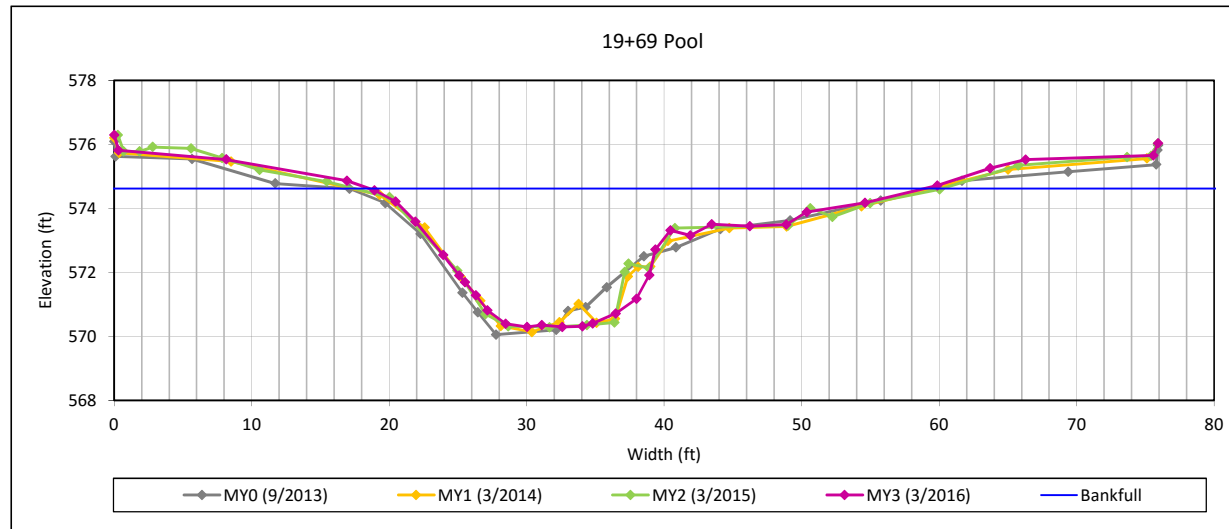
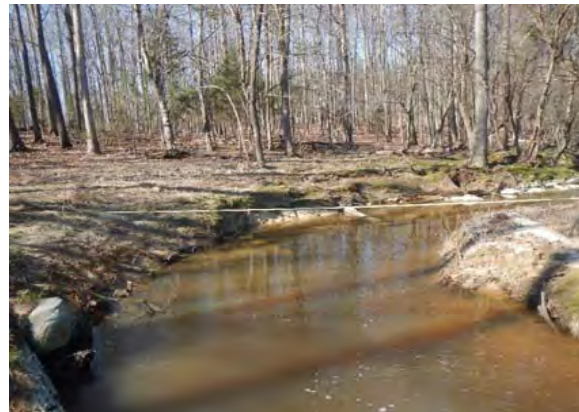
#### Cross Section 2-Byrds Creek Reach 2

79.3	x-section area (ft.sq.)
40.3	width (ft)
2.0	mean depth (ft)
4.3	max depth (ft)
42.3	wetted perimeter (ft)
1.9	hyd radi (ft)
20.5	width-depth ratio

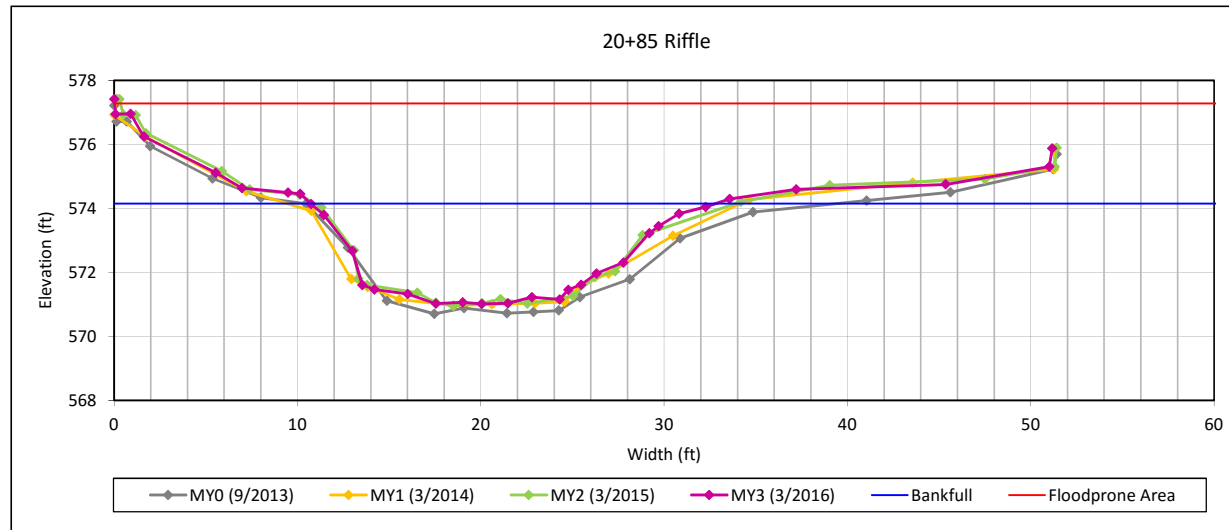
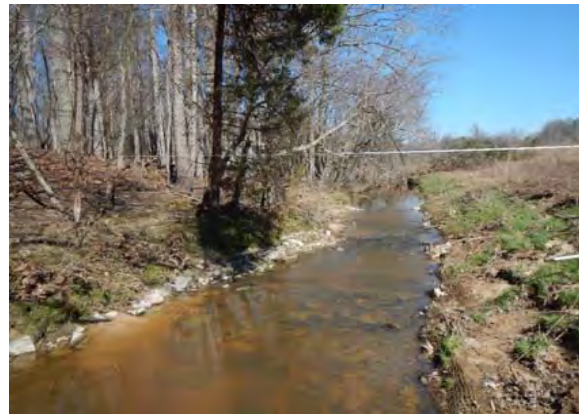
#### Cross Section 3-Byrds Creek Reach 2

45.9	x-section area (ft.sq.)
22.1	width (ft)
2.1	mean depth (ft)
3.1	max depth (ft)
23.9	wetted perimeter (ft)
1.9	hyd radi (ft)
10.6	width-depth ratio
150.0	W flood prone area (ft)
6.8	entrenchment ratio
1.0	low bank height ratio

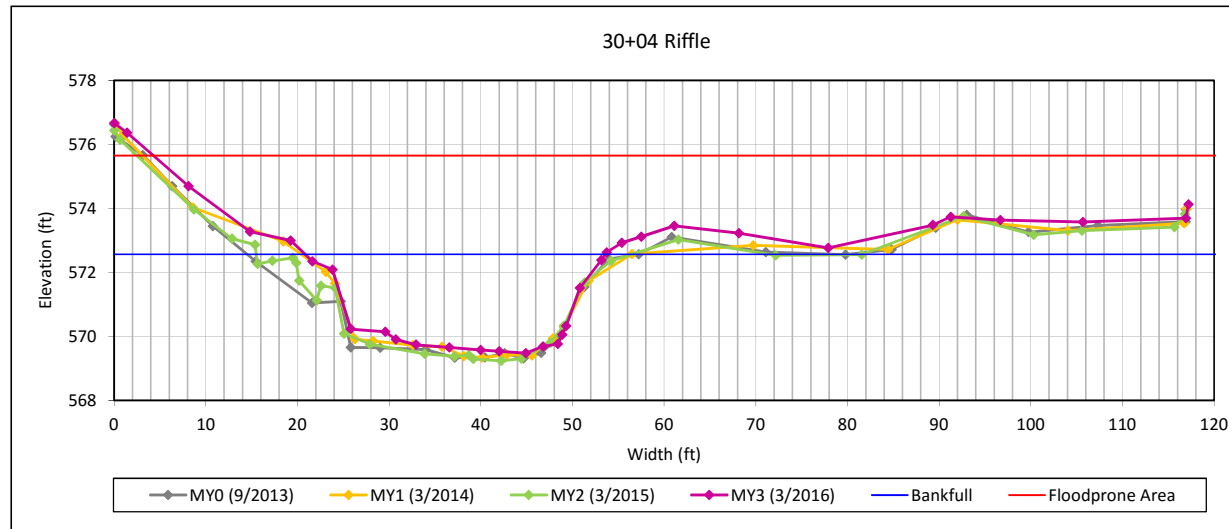
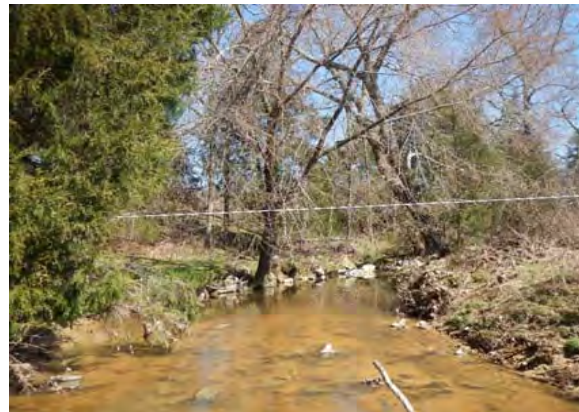
#### Cross Section 4-Byrds Creek Reach 2

73.4	x-section area (ft.sq.)
32.8	width (ft)
2.2	mean depth (ft)
3.1	max depth (ft)
34.3	wetted perimeter (ft)
2.1	hyd radi (ft)
14.6	width-depth ratio
150.0	W flood prone area (ft)
4.6	entrenchment ratio
1.0	low bank height ratio

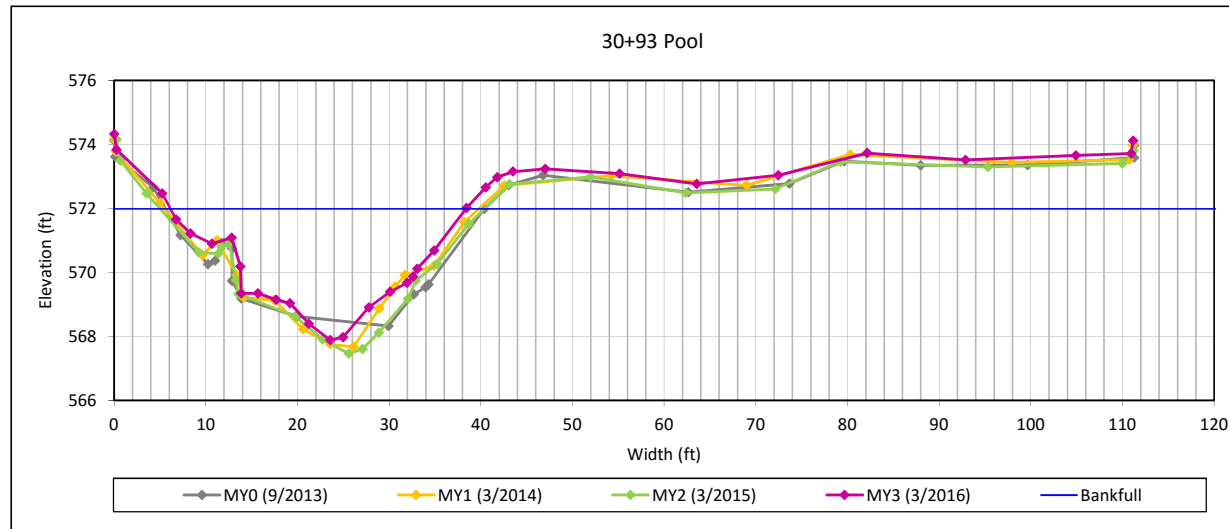
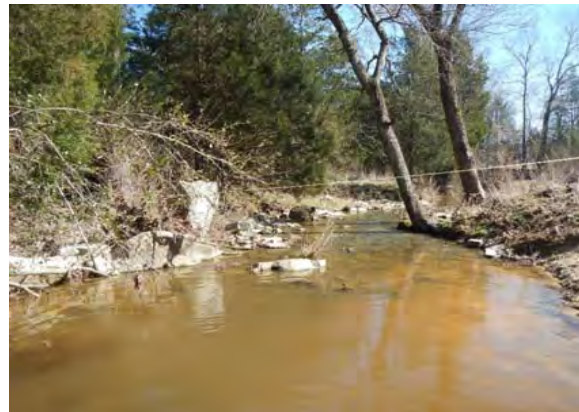
#### Cross Section 5-Byrds Creek Reach 2

71.4	x-section area (ft.sq.)
32.2	width (ft)
2.2	mean depth (ft)
4.1	max depth (ft)
34.3	wetted perimeter (ft)
2.1	hyd radi (ft)
14.5	width-depth ratio

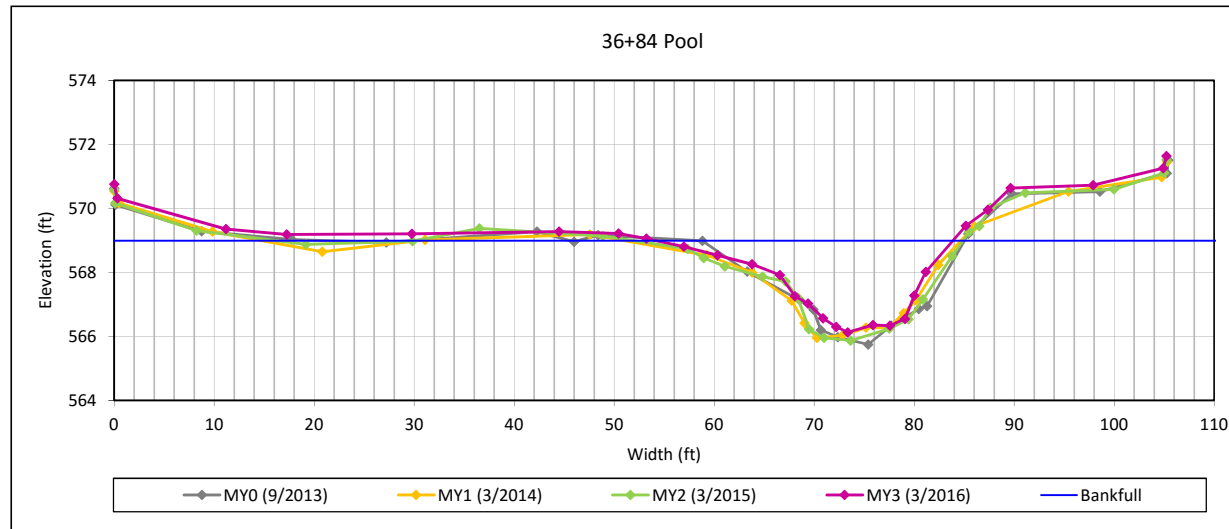
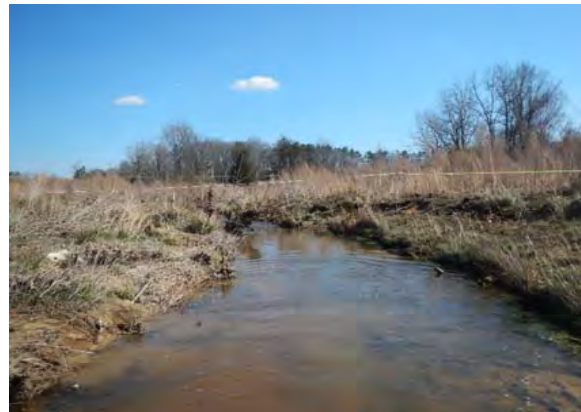
### Cross Section 6-Byrds Creek Reach 3

40.3	x-section area (ft.sq.)
29.6	width (ft)
1.4	mean depth (ft)
2.9	max depth (ft)
30.6	wetted perimeter (ft)
1.3	hyd radi (ft)
21.7	width-depth ratio

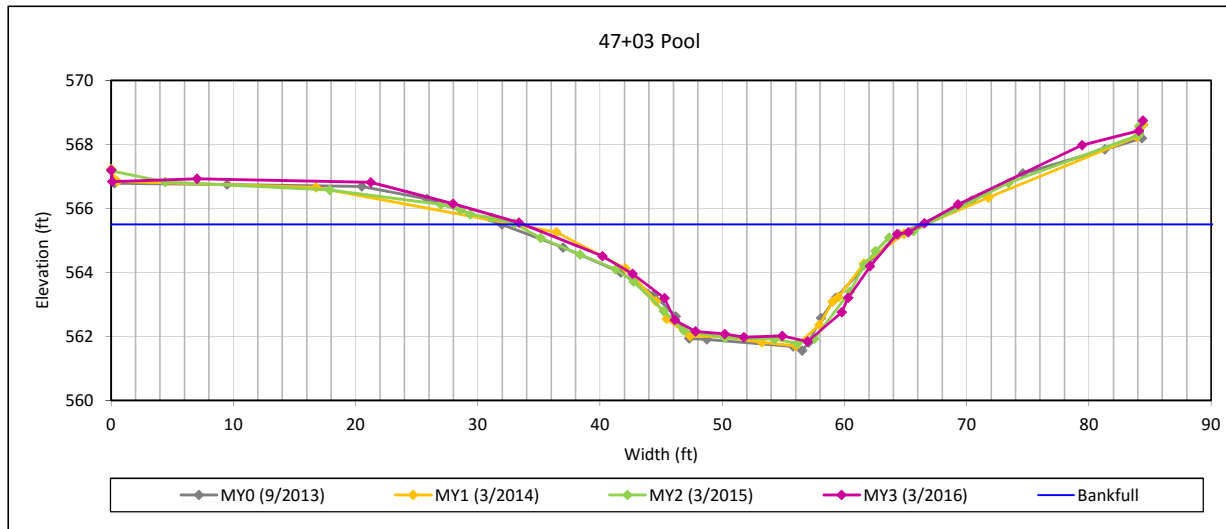
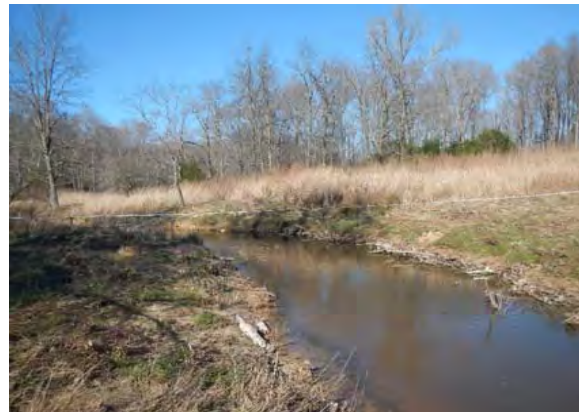
#### Cross Section 9- Byrds Creek Reach 3

66.5	x-section area (ft.sq.)
32.6	width (ft)
2.0	mean depth (ft)
3.7	max depth (ft)
34.0	wetted perimeter (ft)
2.0	hyd radi (ft)
16.0	width-depth ratio

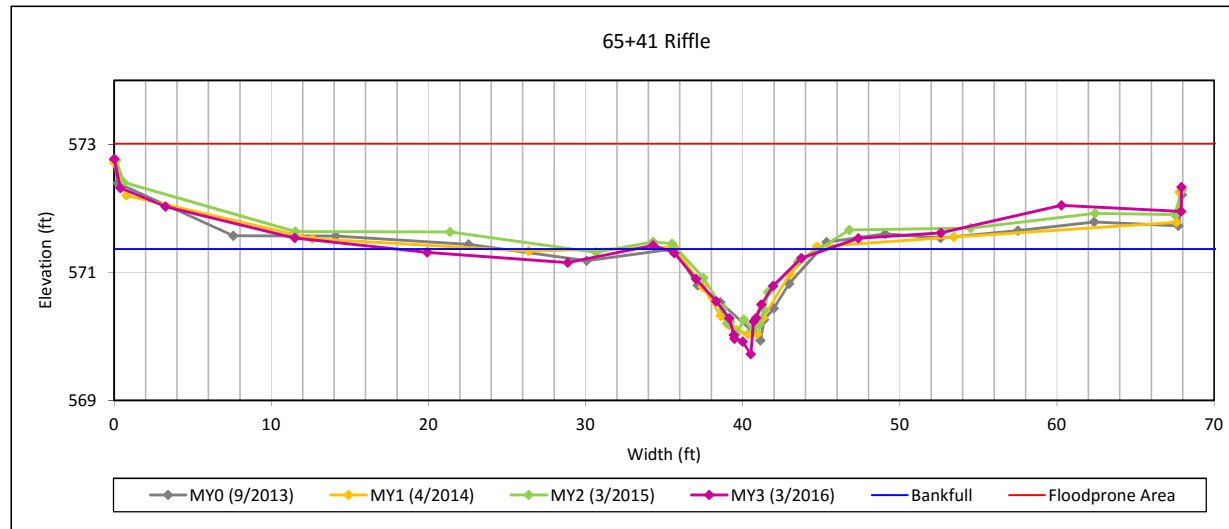
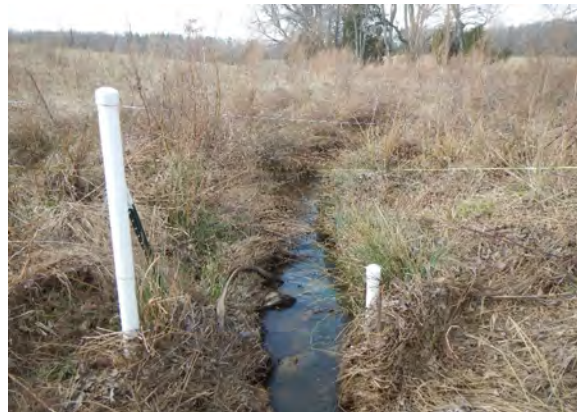
#### Cross Section 10-South Branch Reach 1

6.0	x-section area (ft.sq.)
9.8	width (ft)
0.6	mean depth (ft)
1.6	max depth (ft)
10.6	wetted perimeter (ft)
0.6	hyd radi (ft)
15.9	width-depth ratio
100.0	W flood prone area (ft)
10.2	entrenchment ratio
1.0	low bank height ratio

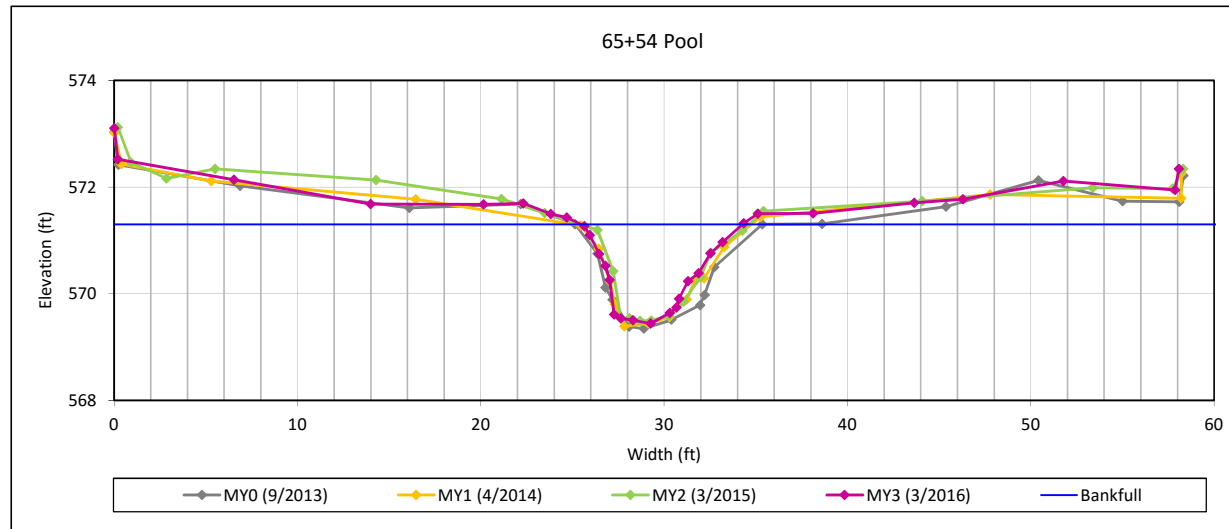
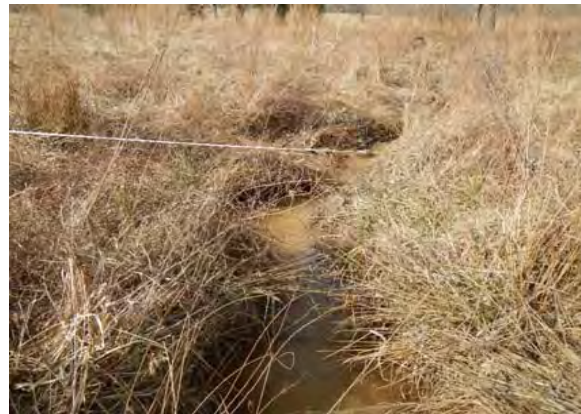
#### Cross Section 11- South Branch Reach 1

9.3	x-section area (ft.sq.)
8.8	width (ft)
1.1	mean depth (ft)
1.9	max depth (ft)
10.0	wetted perimeter (ft)
0.9	hyd radi (ft)
8.3	width-depth ratio

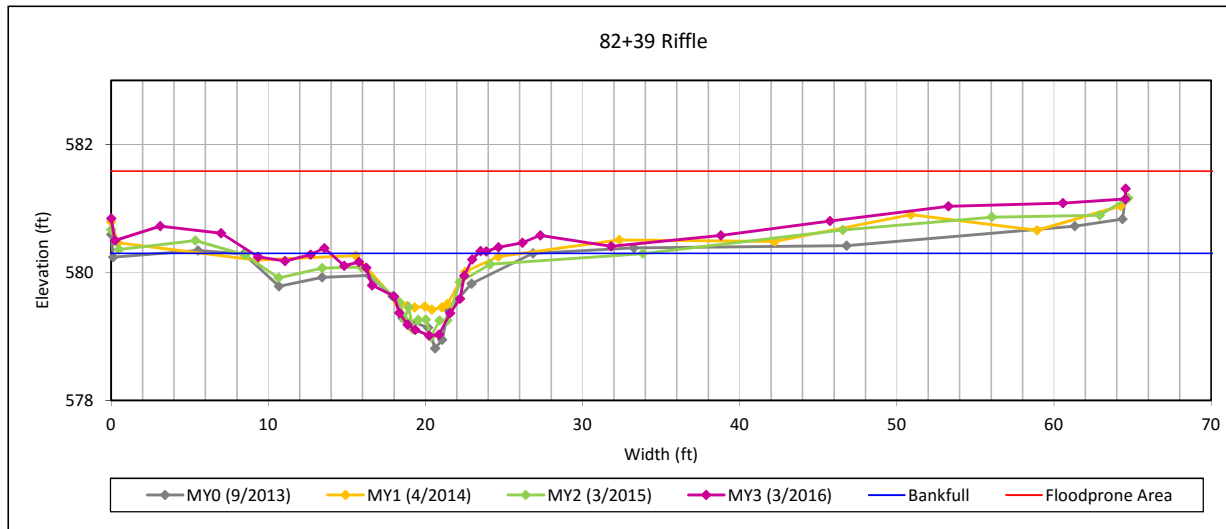
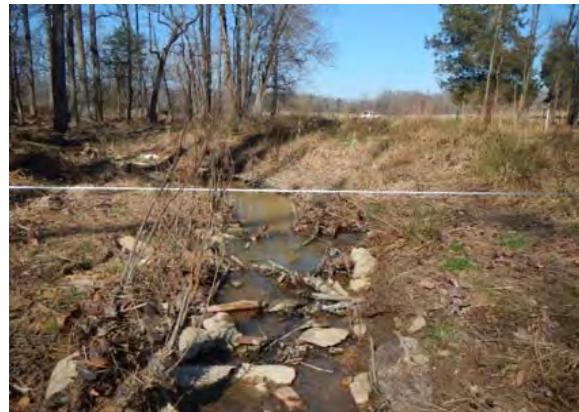
#### Cross Section 12 - Southeast Reach 1

6.0	x-section area (ft.sq.)
8.5	width (ft)
0.7	mean depth (ft)
1.3	max depth (ft)
9.1	wetted perimeter (ft)
0.7	hyd radi (ft)
12.0	width-depth ratio
75.0	W flood prone area (ft)
8.8	entrenchment ratio
1.0	low bank height ratio

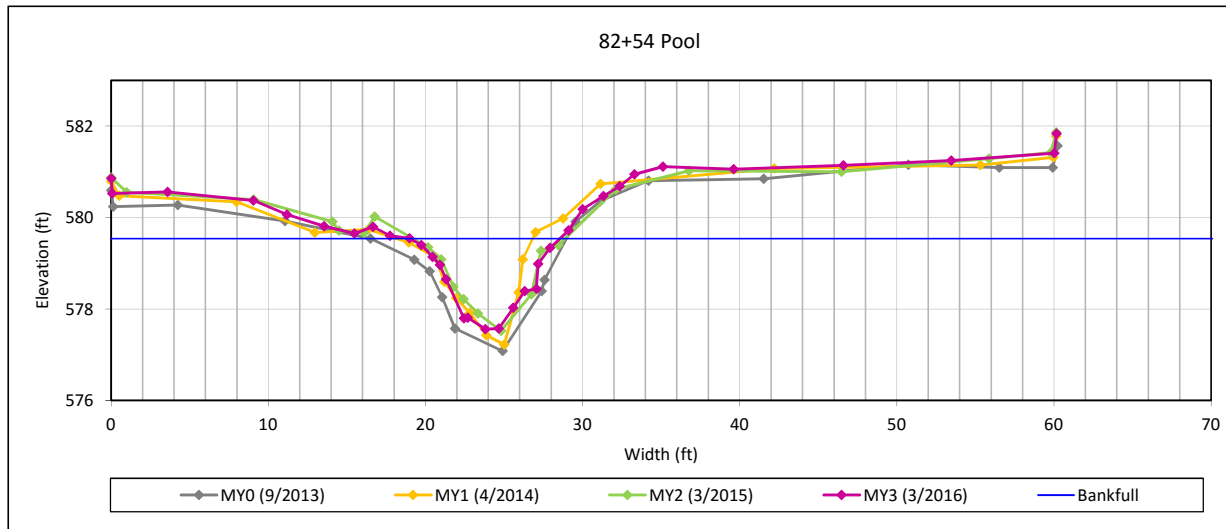
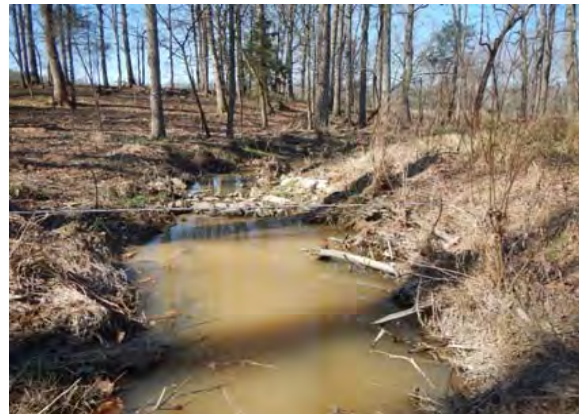
#### Cross Section 13 - Southeast Reach 1

10.3	x-section area (ft.sq.)
9.5	width (ft)
1.1	mean depth (ft)
2.0	max depth (ft)
10.8	wetted perimeter (ft)
1.0	hyd radi (ft)
8.8	width-depth ratio

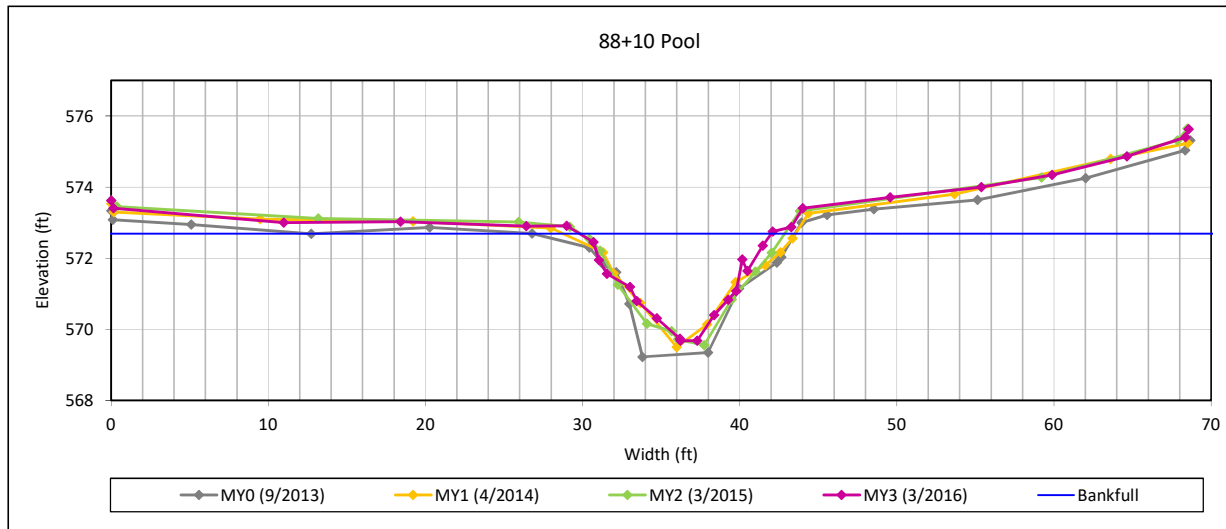
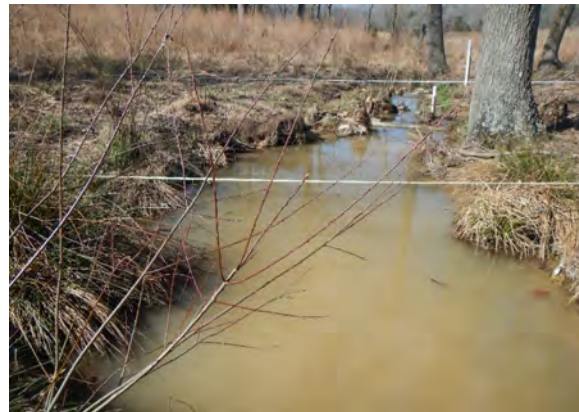
#### Cross Section 14 - Southeast Reach 2

20.5	x-section area (ft.sq.)
12.2	width (ft)
1.7	mean depth (ft)
3.0	max depth (ft)
14.5	wetted perimeter (ft)
1.4	hyd radi (ft)
7.2	width-depth ratio

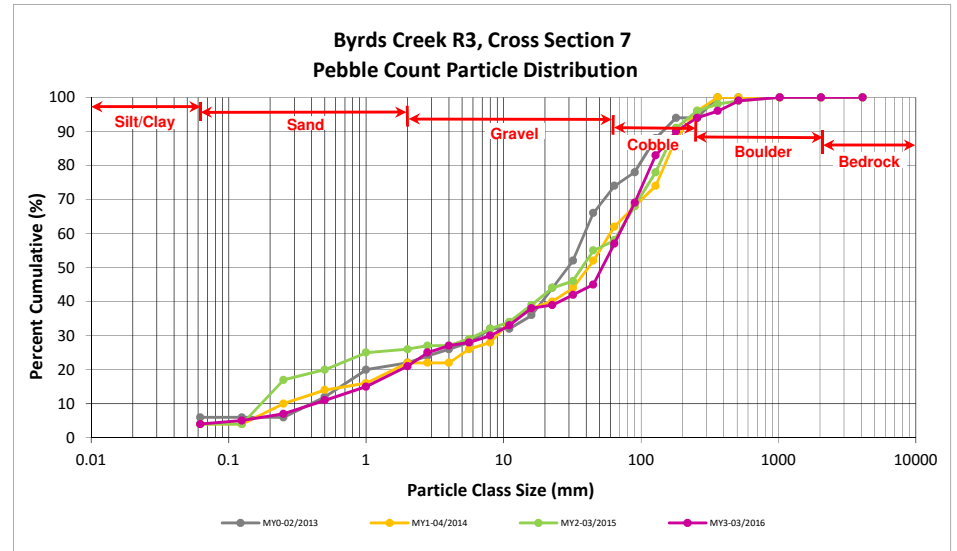
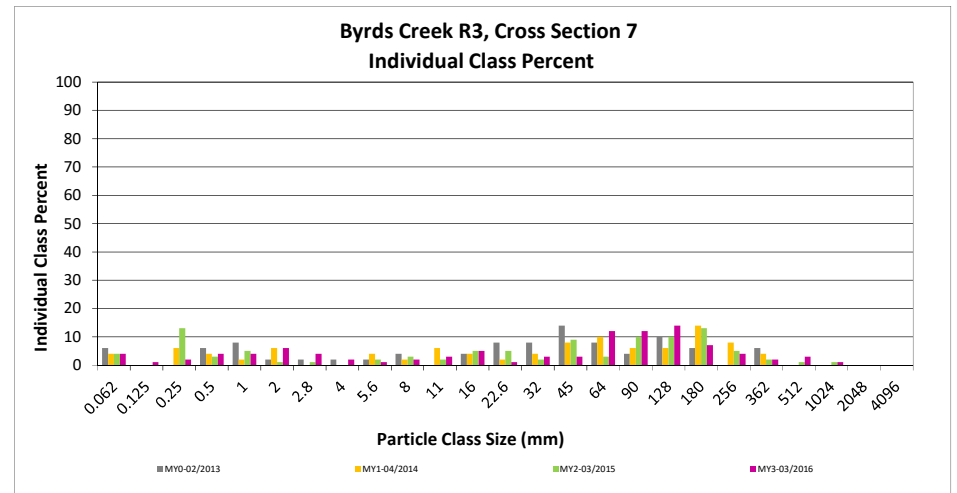
Cross Section 7	
Channel materials (mm)	
D <sub>16</sub> =	1.12
D <sub>35</sub> =	12.78
D <sub>50</sub> =	52.1
D <sub>84</sub> =	134.4
D <sub>95</sub> =	304.4
D <sub>100</sub> =	1024.0

Bank scour was observed along portions of Byrds Creek Reach 3 below the culvert crossing at the end of MY-1 and MY-2. These areas were repaired at the beginning of MY-3 following the cross-sectional survey. Cross sections seven and eight show some minor bank scour that has occurred on Byrds Creek Reach 3. Scour in the cross sections has stabilized between MY-2 and MY-3. The cross-sectional areas and bankfull widths on cross sections seven and eight still fall within the appropriate Rosgen stream type parameters. These areas will be monitored for any active scour during subsequent monitoring years.

During March of MY-3, existing areas of localized instability were repaired along Byrds Creek between stations 35+00 and 48+00. Banks were reconstructed with geolifts and live whips to minimize the effects of bank stress during high flow events. Additionally, permanent seed, live stakes and herbaceous plugs

were installed following the repair activities. These areas appear to be stable with strong support from vegetation. Wildlands will continue to monitor these areas and take corrective action as needed.
