**CANDIFF CREEK RESTORATION PROJECT**  
**ANNUAL MONITORING REPORT FOR 2012 (YEAR 1)**

**EEP Project Number: 92767**

**January 2013**  
**FINAL**

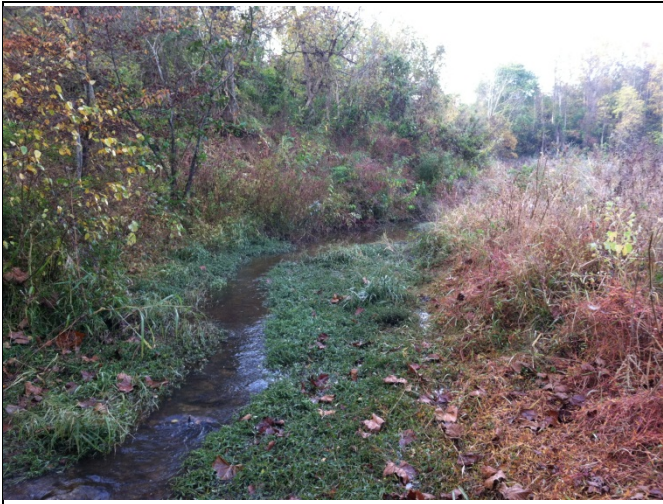
PP1 STA 61+60, Constructed Riffle

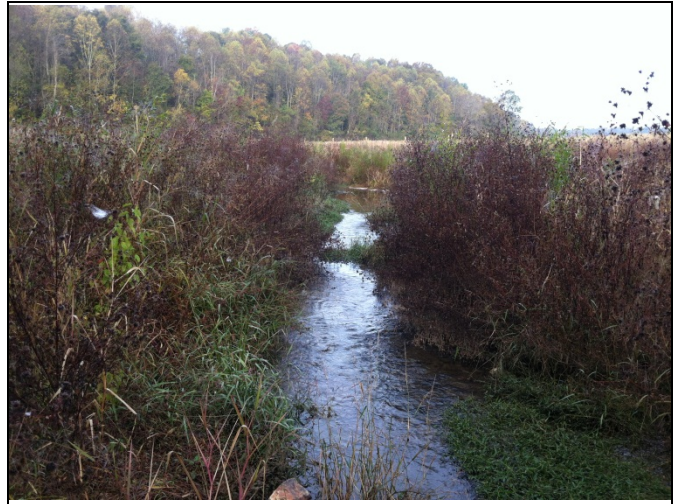
PP 2 61+25, Constructed Riffle

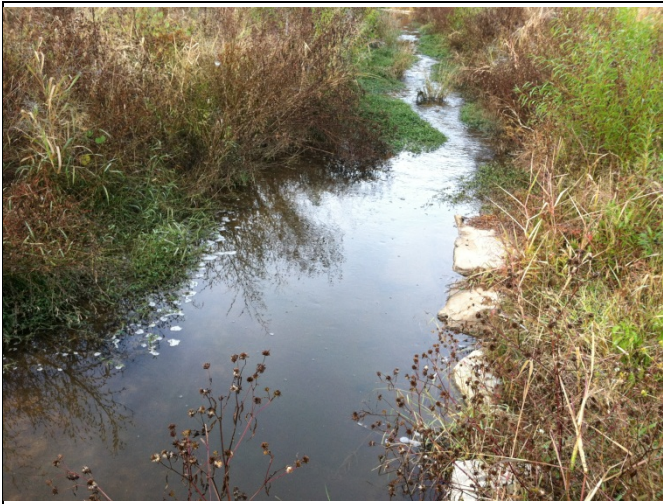
PP 3 STA 60+25, Rock J-Hook

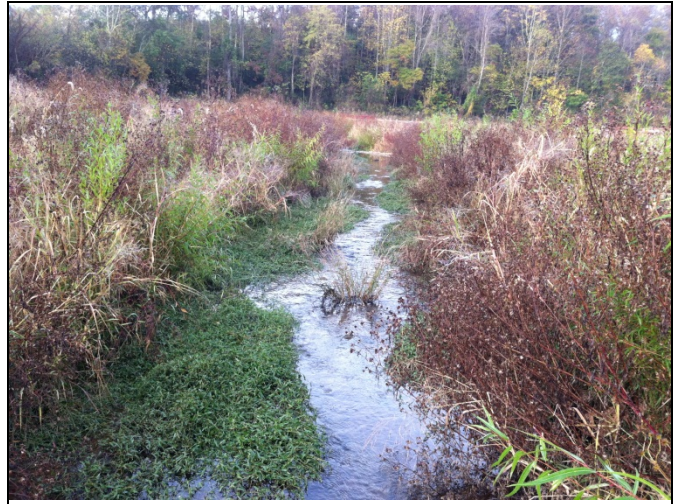
PP 4 STA 60+10, Constructed Riffle

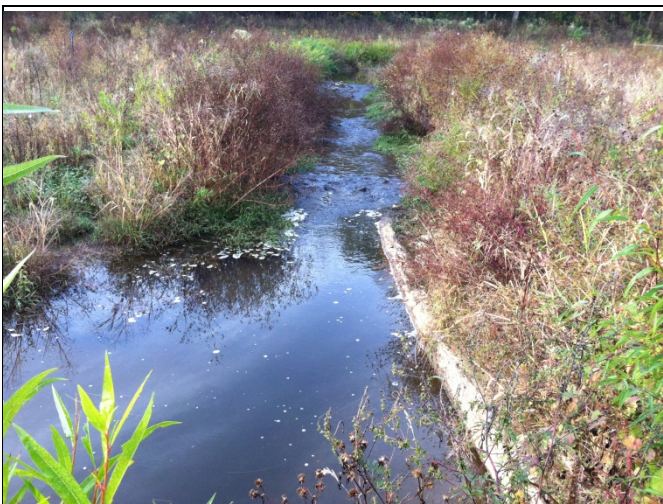
PP 5 STA 59+10, Log J-Hook

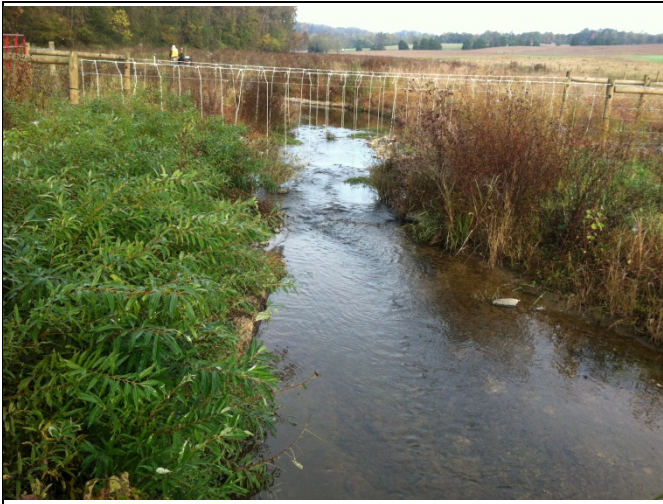
PP 7 STA 57+65, Log J-Hook

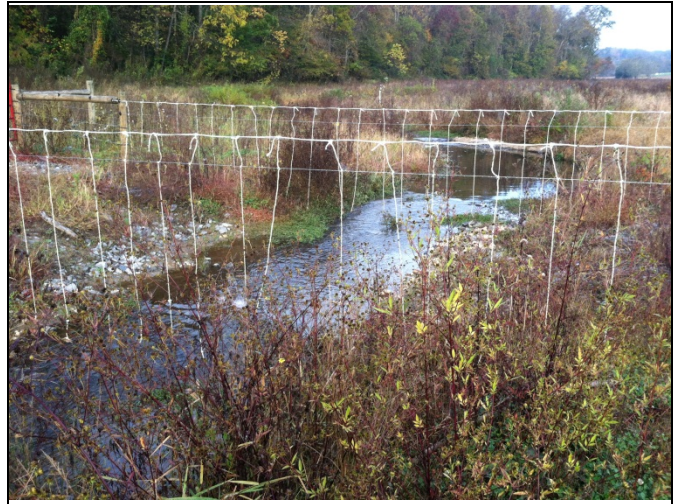
PP 8 STA 57+50, Stream Crossing

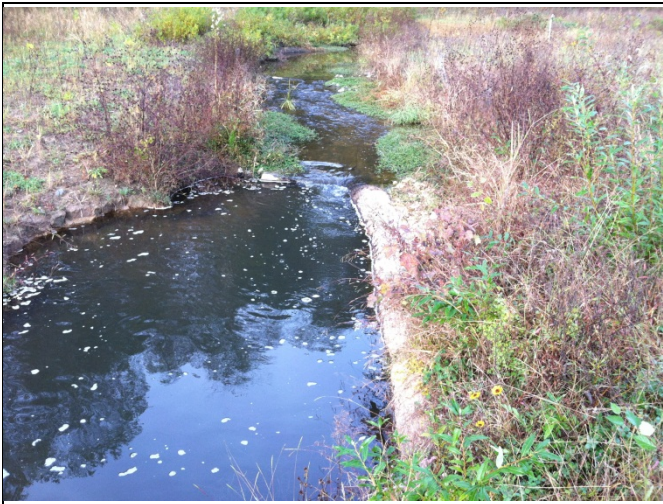
PP 9 STA 56+70, Log J-Hook

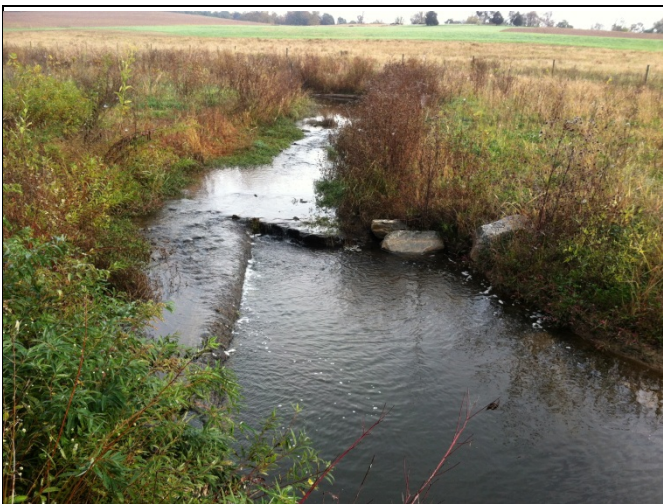
PP 11 STA 55+40, Log J-Hook

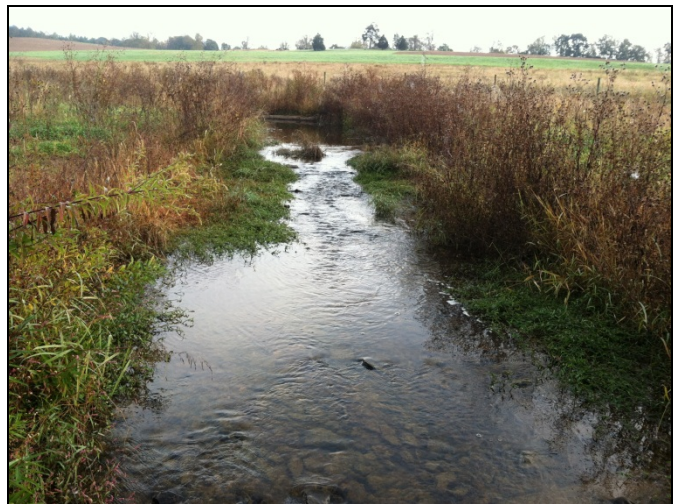
PP 12 STA 55+15, Constructed Riffle

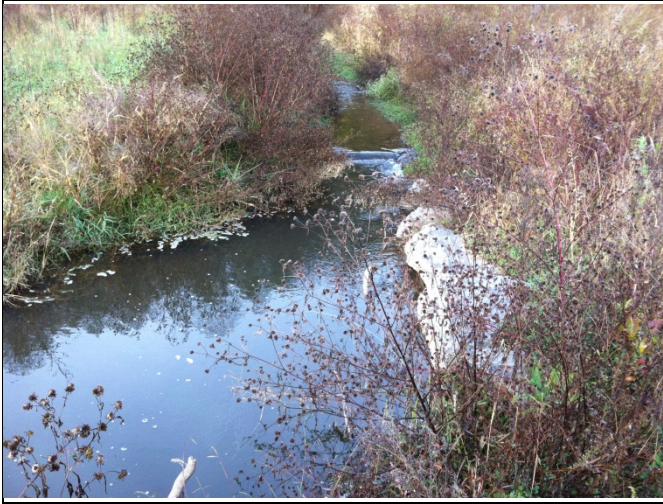
PP 13 STA 53+95, Rock J-Hook

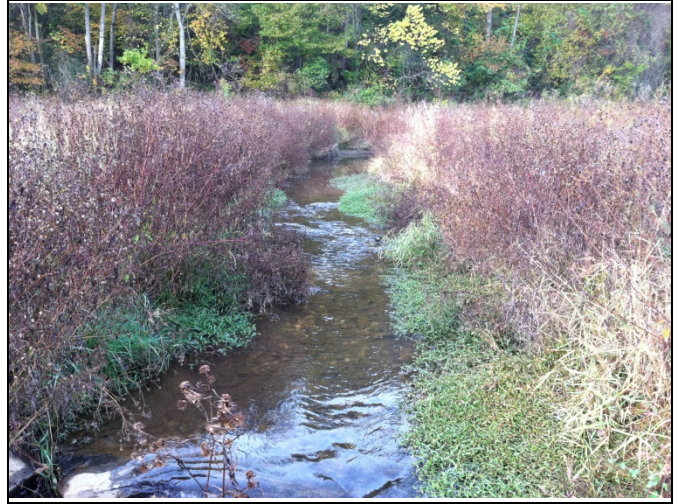
PP 14 STA 53+75, Constructed Riffle

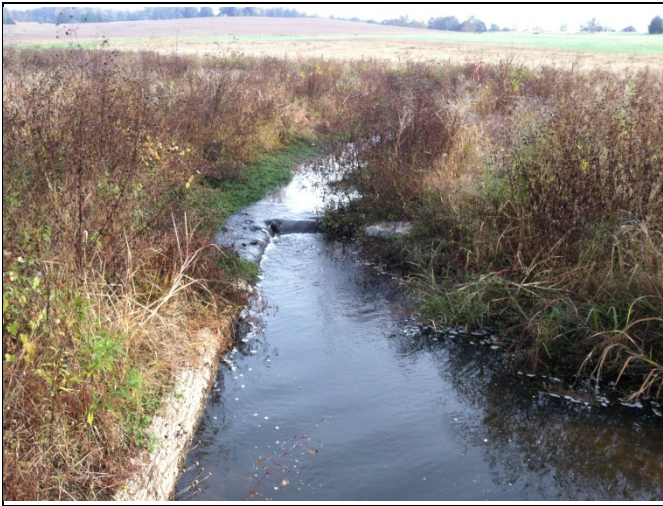
PP 15 STA 52+35, Log J-Hook

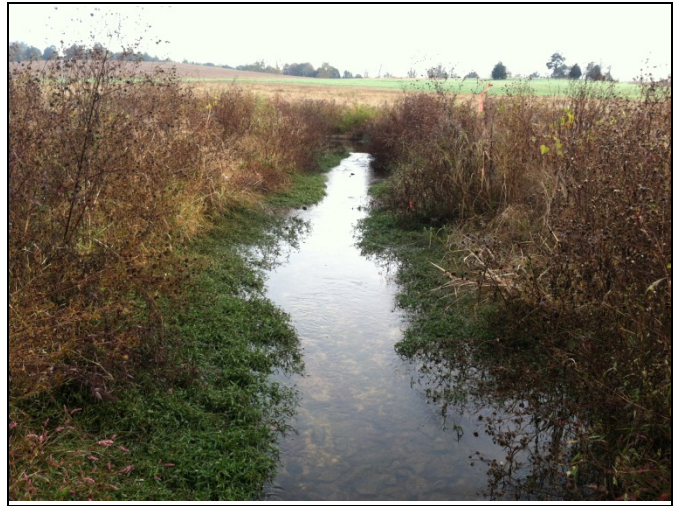
PP 16 STA 52+05, Constructed Riffle

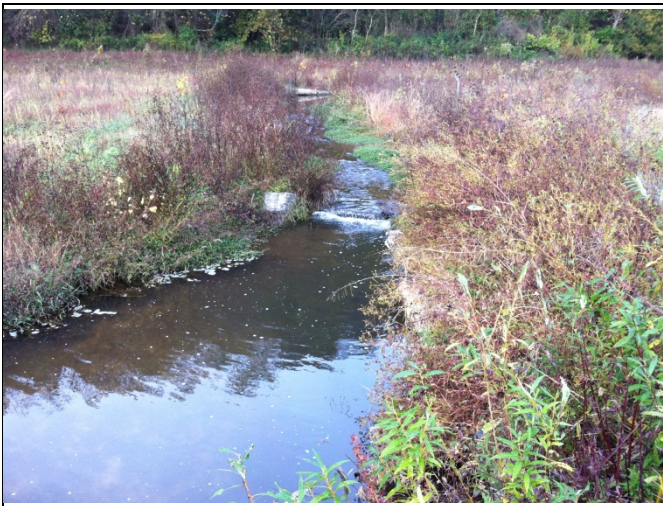
PP 17 STA 50+75, Log J-Hook

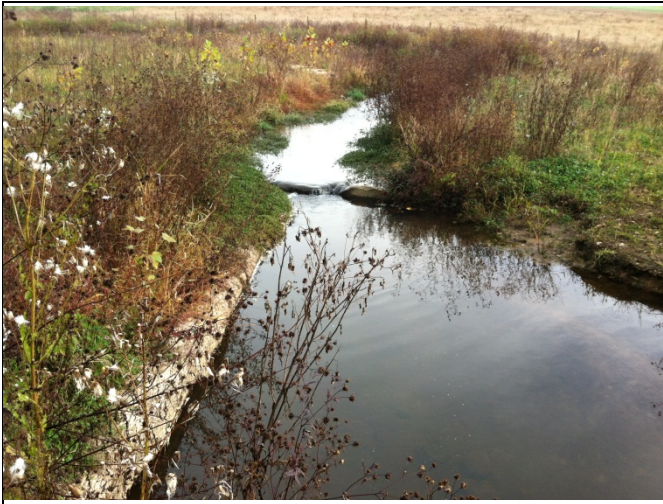
PP 19 STA 49+15, Log J-Hook

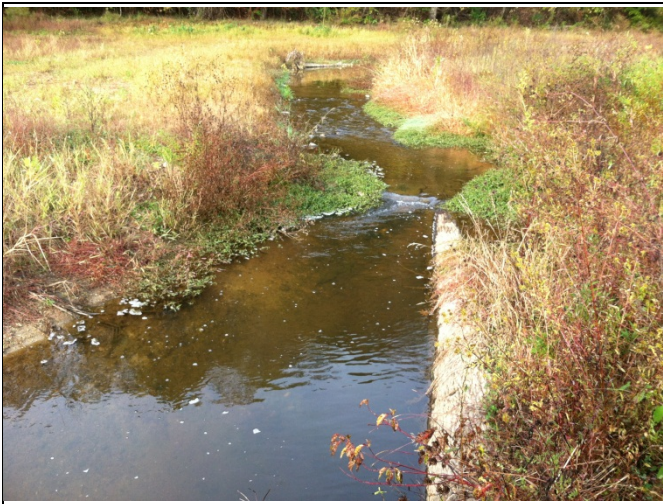
PP 21 STA 47+50, Log J-Hook

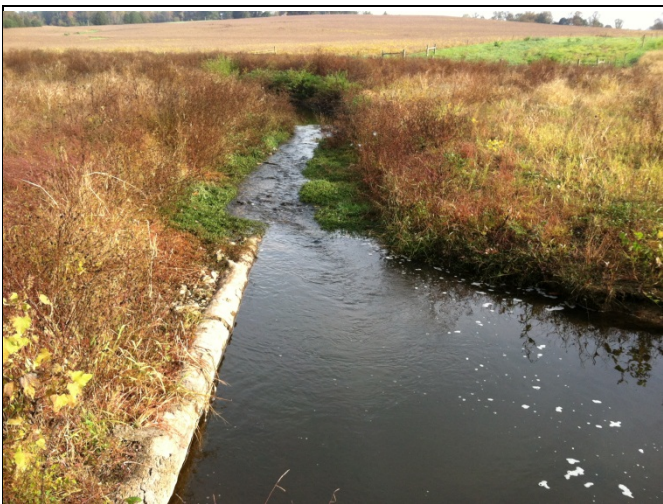
PP 23 STA 46+15, Log J-Hook
