CANDIFF CREEK RESTORATION PROJECT
ANNUAL MONITORING REPORT FOR 2013 (YEAR 2)

EEP Project Number: 92767

February 2014
FINAL

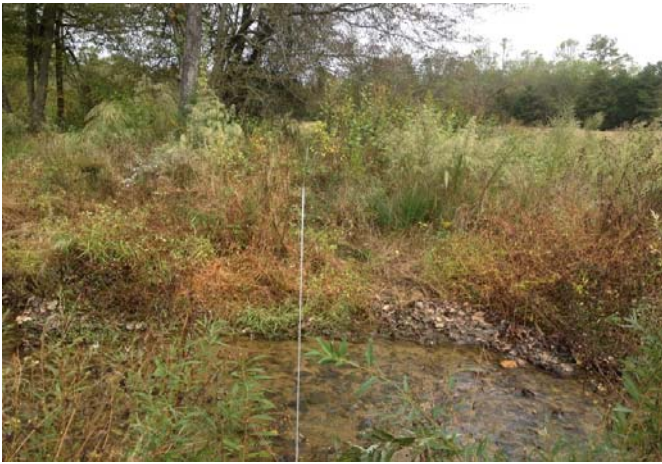
Looking at the Left Bank

Feature	Stream Type	BKF Area	BKF Width	BKF Depth	Max BKF Depth	W/D	BH Ratio	ER	BKF Elev	TOB Elev
Riffle	C	24.6	19.92	1.24	1.83	16.12	1.1	3.9	817.07	817.31

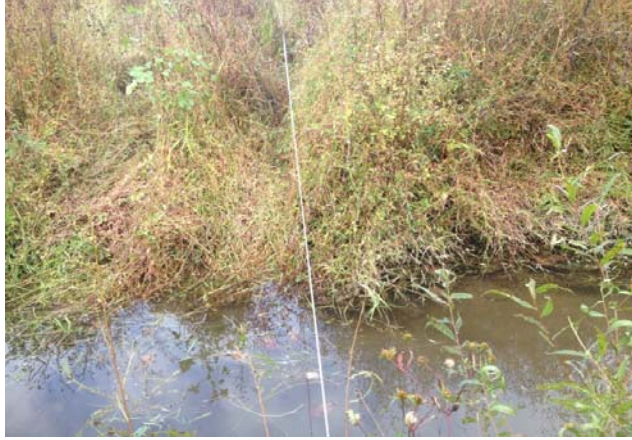
Looking at the Left Bank

Feature	Stream Type	BKF Area	BKF Width	BKF Depth	Max BKF Depth	W/D	BH Ratio	ER	BKF Elev	TOB Elev
Pool		35.1	19.24	1.82	3.99	10.55	1	8	816.08	816

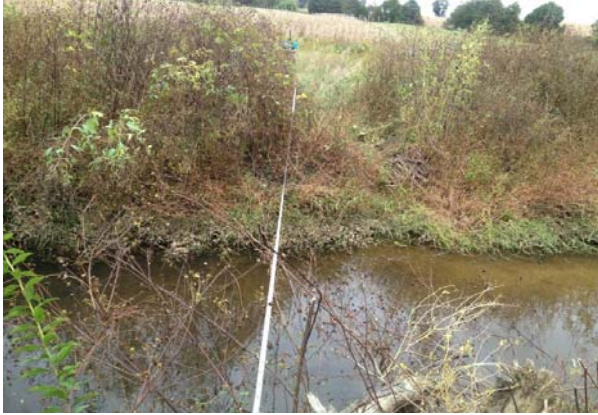
Looking at the Left Bank

Feature	Stream Type	BKF Area	BKF Width	BKF Depth	Max BKF Depth	W/D	BH Ratio	ER	BKF Elev	TOB Elev
Pool		54.2	17.96	3.02	4.27	5.95	1.1	6.9	813.37	813.68

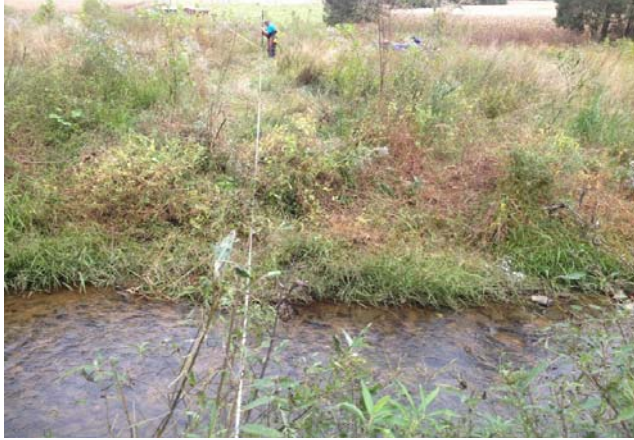
Looking at the Left Bank

Feature	Stream Type	BKF Area	BKF Width	BKF Depth	Max BKF Depth	W/D	BH Ratio	ER	BKF Elev	TOB Elev
Riffle	C	31.1	19.33	1.61	2.3	12.03	1	6.2	810.63	810.64

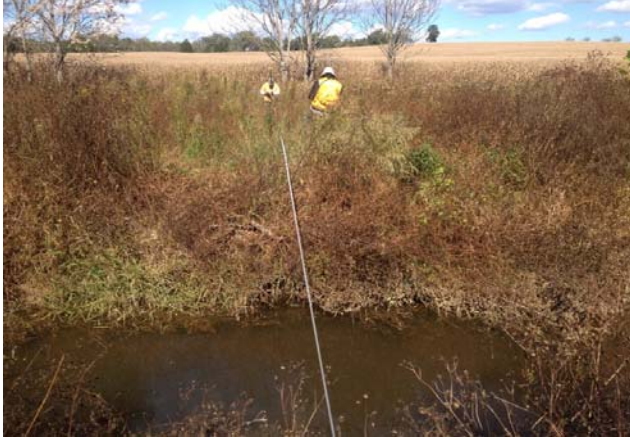
Looking at the Left Bank

Feature	Stream Type	BKF Area	BKF Width	BKF Depth	Max BKF Depth	W/D	BH Ratio	ER	BKF Elev	TOB Elev
Pool		58.6	34.93	1.68	4.37	20.81	0.9	3.4	808.2	807.61

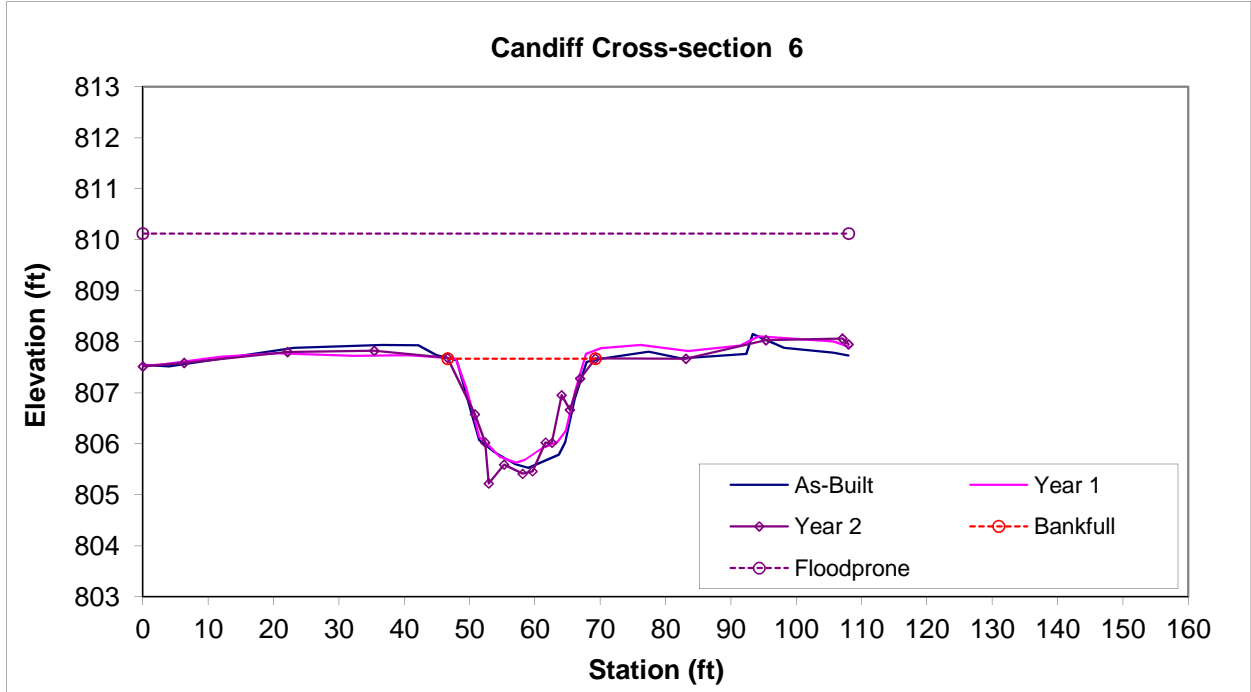
Permanent Cross-section 7
 (Year 2 Data - Collected October 2013)

Feature	Stream Type	BKF Area	BKF Width	BKF Depth	Max BKF Depth	W/D	BH Ratio	ER	BKF Elev	TOB Elev
Riffle	C	30.2	22.56	1.34	2.45	16.86	1	4.8	807.67	807.68

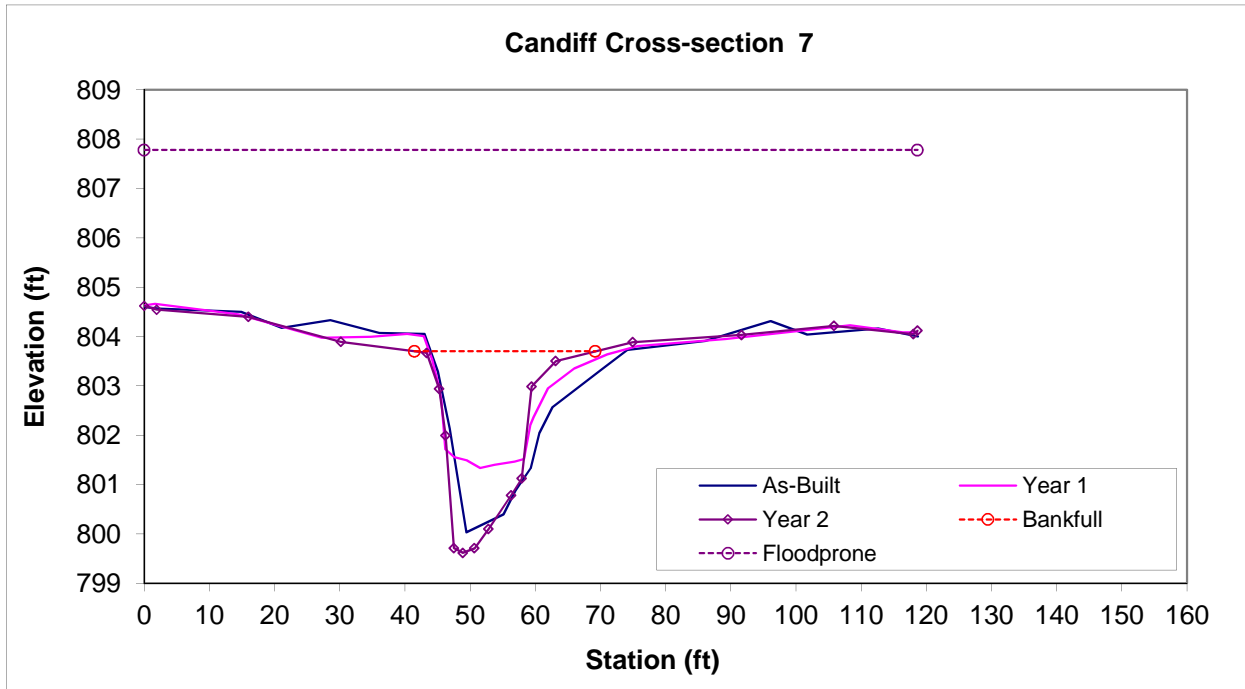
Permanent Cross-section 8
 (Year 2 Data - Collected October 2013)

Feature	Stream Type	BKF Area	BKF Width	BKF Depth	Max BKF Depth	W/D	BH Ratio	ER	BKF Elev	TOB Elev
Pool		47.2	27.78	1.7	4.08	16.36	1	4.3	803.7	803.5

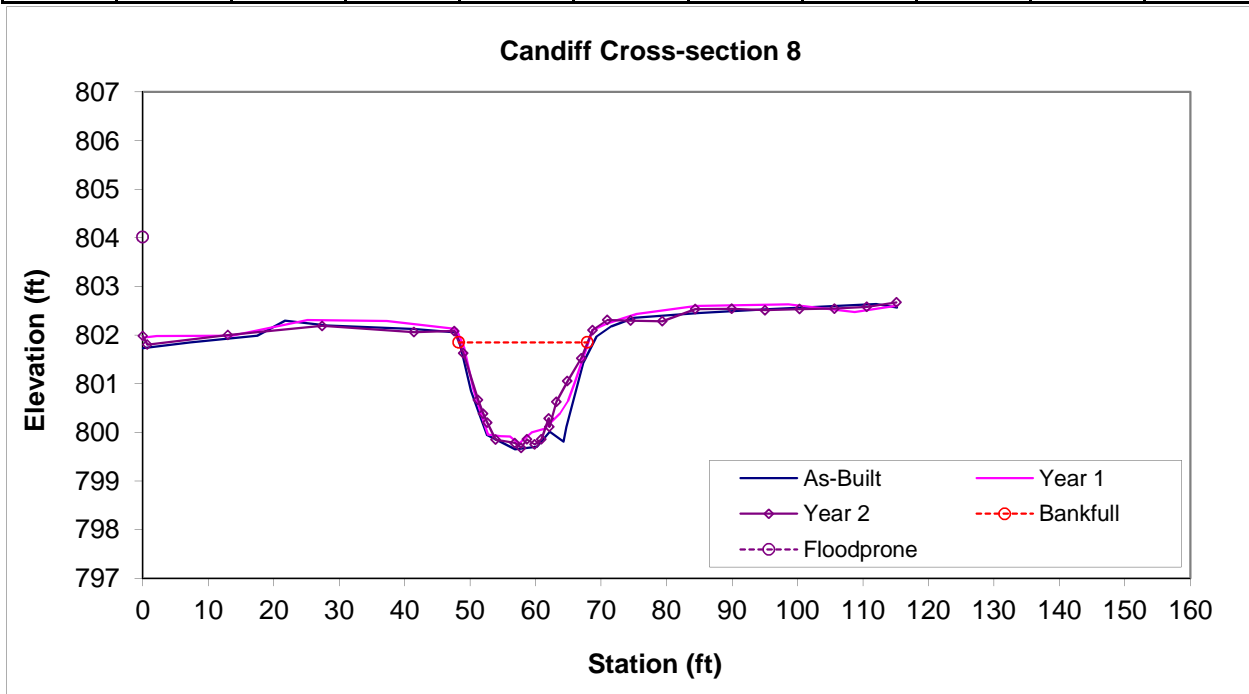
Permanent Cross-section 9
(Year 2 Data - Collected October 2013)

Feature	Stream Type	BKF Area	BKF Width	BKF Depth	Max BKF Depth	W/D	BH Ratio	ER	BKF Elev	TOB Elev
Riffle	C	27.1	19.66	1.38	2.17	14.23	1.1	5.9	801.85	802.08

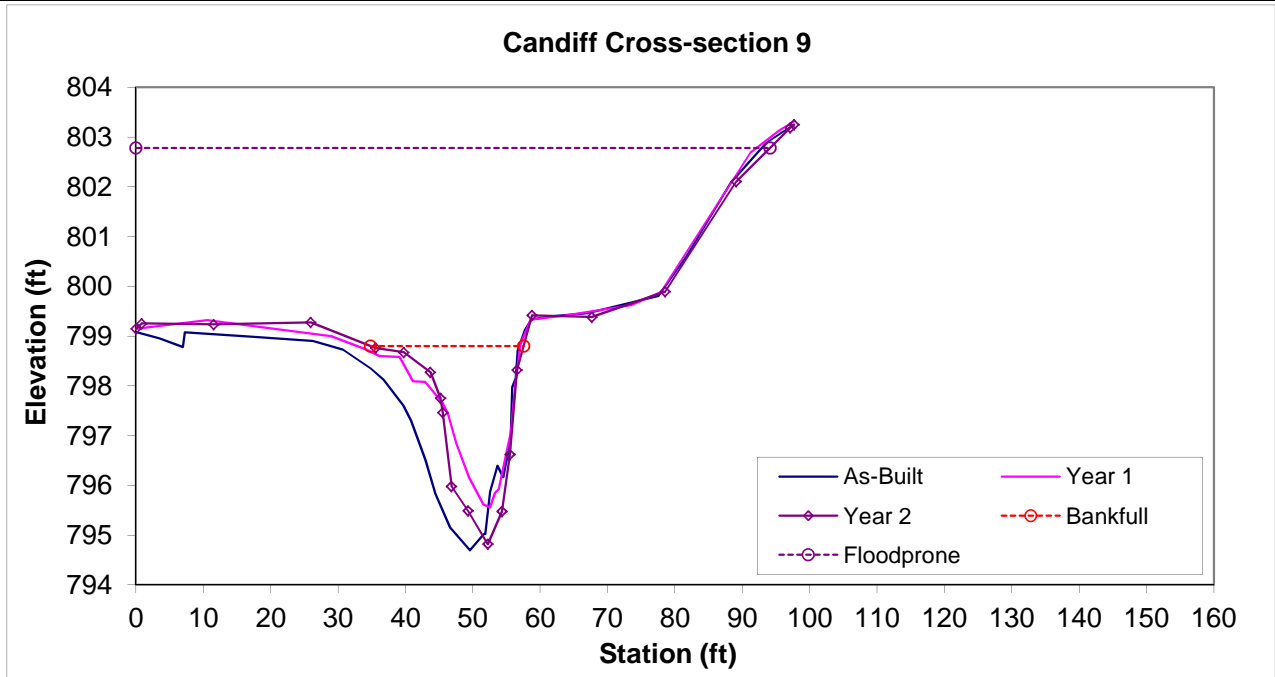
Permanent Cross-section 10
(Year 2 Data - Collected October 2013)

Feature	Stream Type	BKF Area	BKF Width	BKF Depth	Max BKF Depth	W/D	BH Ratio	ER	BKF Elev	TOB Elev
Pool		36.8	22.72	1.62	3.98	14.05	1	4.1	798.8	798.67
