CANDIFF CREEK RESTORATION PROJECT
ANNUAL MONITORING REPORT FOR 2014 (YEAR 3)

EEP Project Number: 92767

Prepared by: Michael Baker International

January 2015
FINAL

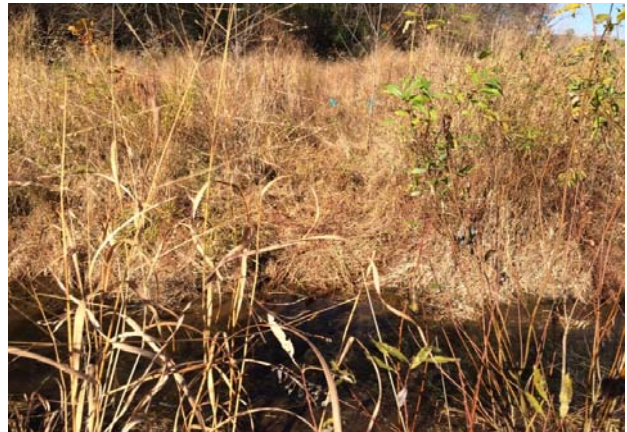
Permanent Cross-section 8

Looking at the Right Bank

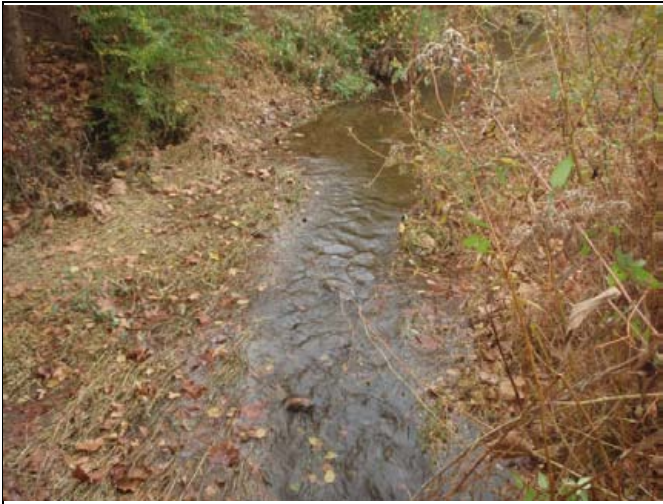
PP1 STA 61+60, Constructed Riffle

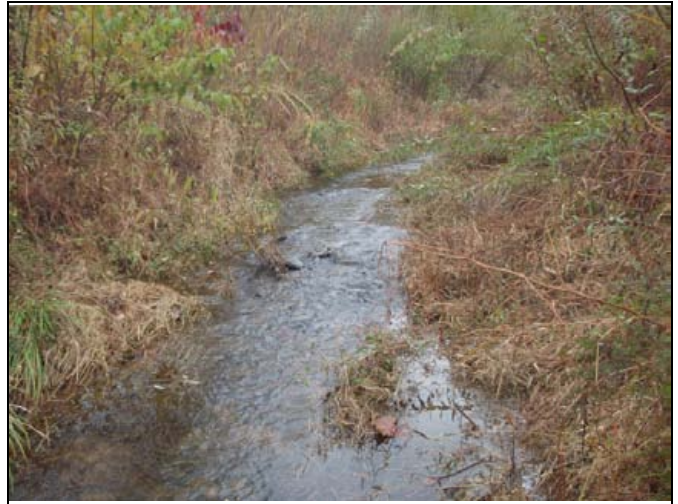
PP 2 61+25, Constructed Riffle

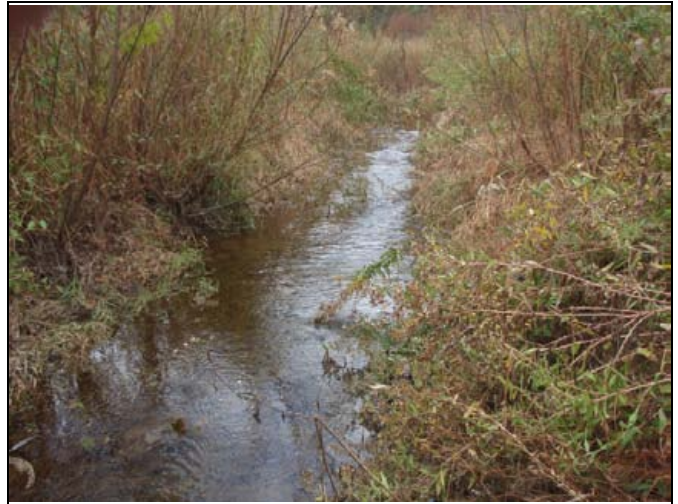
PP 4 STA 60+10, Constructed Riffle

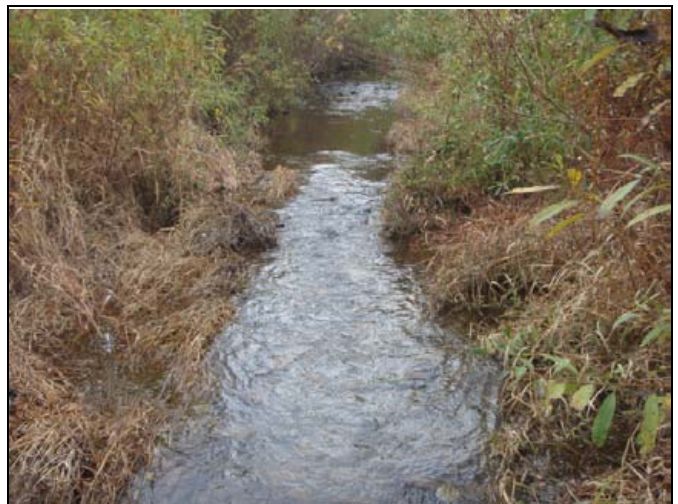
PP 6 STA 58+85, Constructed Riffle

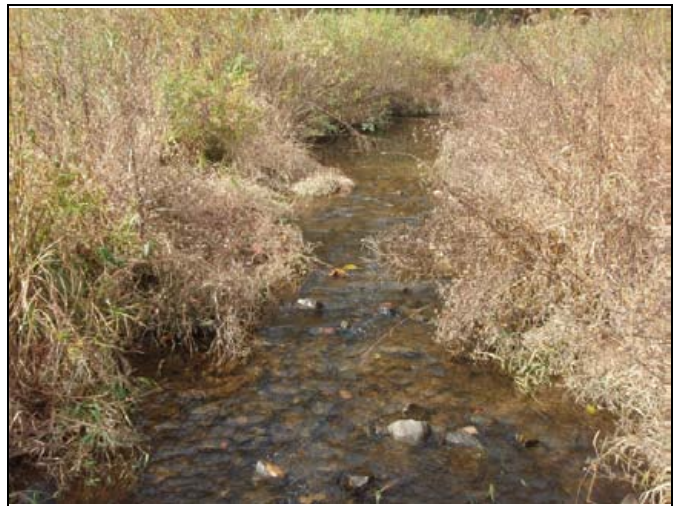
PP 10 STA 56+50, Constructed Riffle

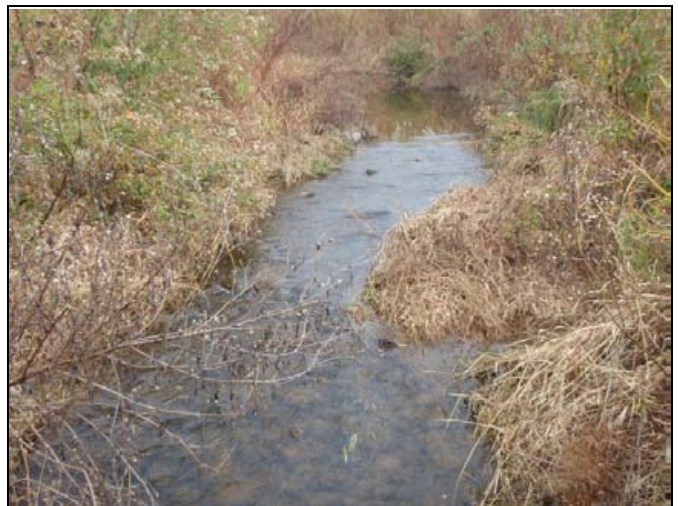
PP 12 STA 55+15, Constructed Riffle

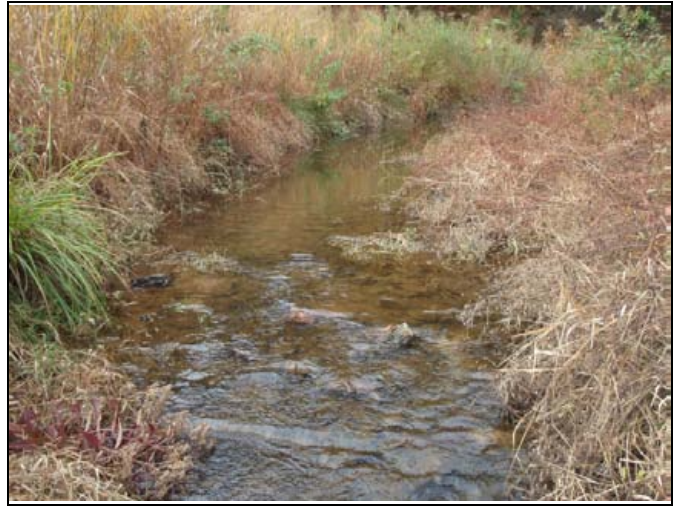
PP 14 STA 53+75, Constructed Riffle

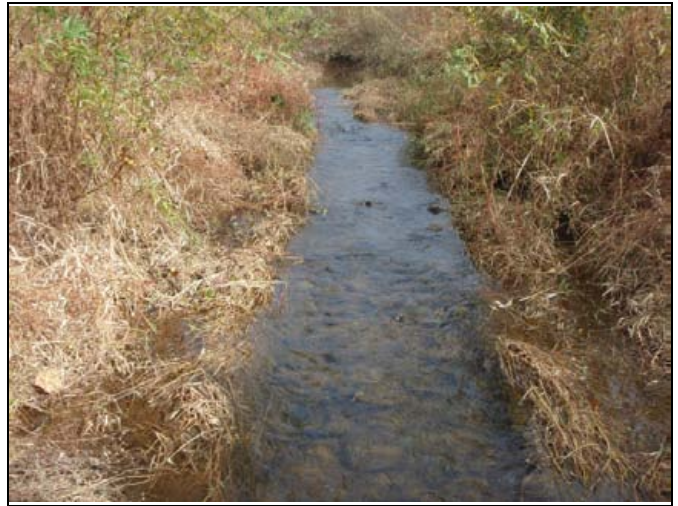
PP 16 STA 52+05, Constructed Riffle

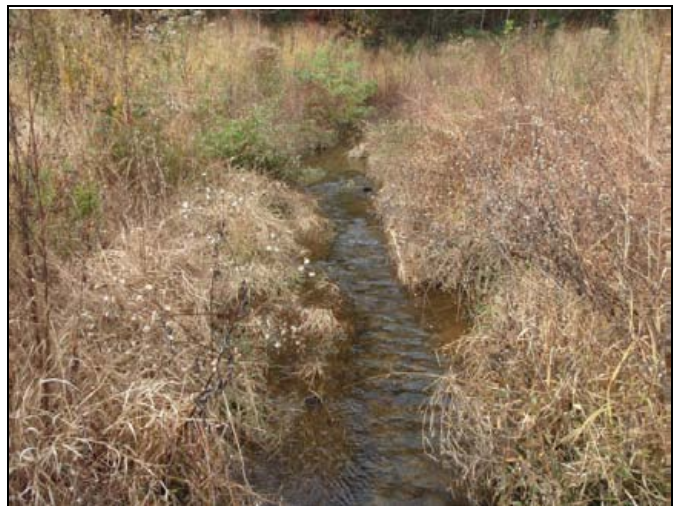
PP 18 STA 50+40, Constructed Riffle

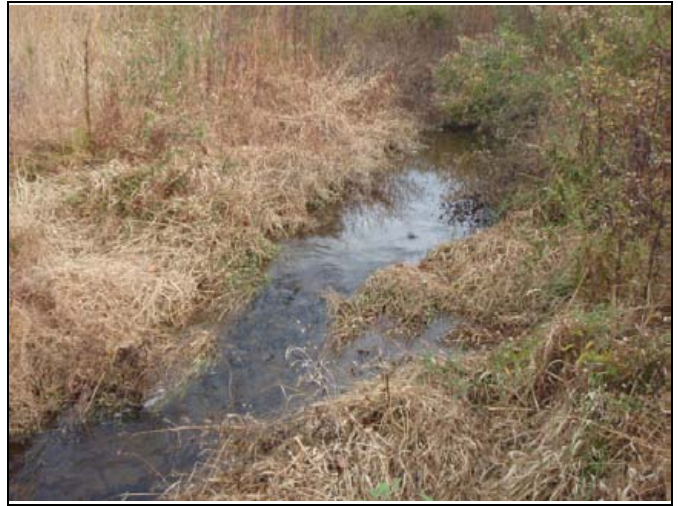
PP 20 STA 48+75, Constructed Riffle

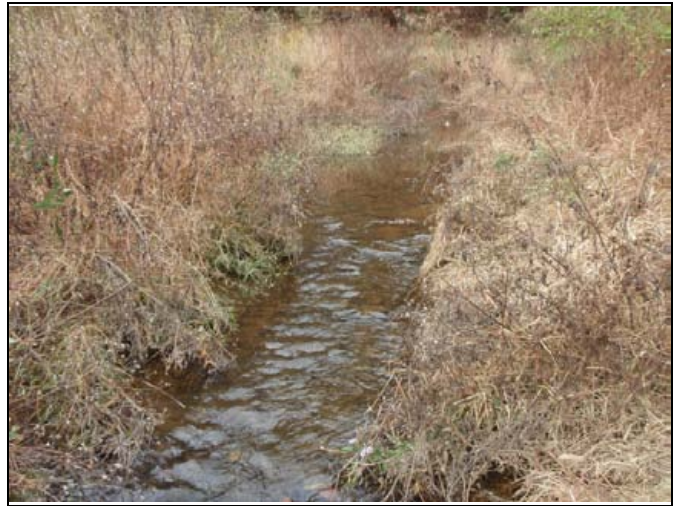
PP 22 STA 47+25, Constructed Riffle

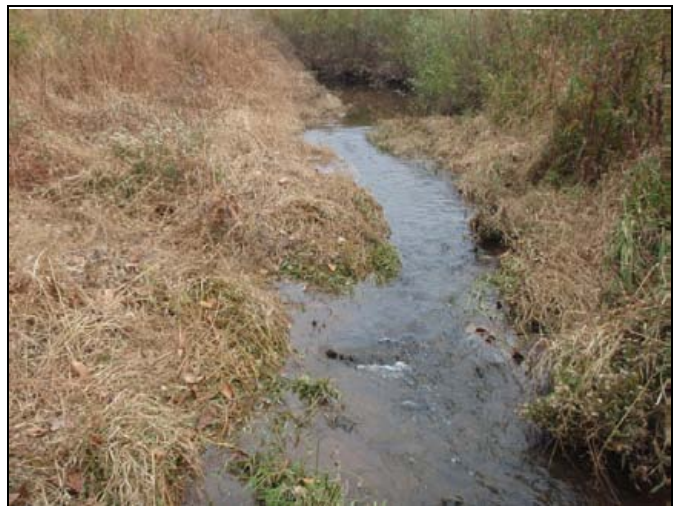
PP 24 STA 46+00, Constructed Riffle
