CANDIFF CREEK RESTORATION PROJECT
ANNUAL MONITORING REPORT FOR 2015 (YEAR 4)

NCDEQ-DMS Project Number: 92767

November 2015
FINAL

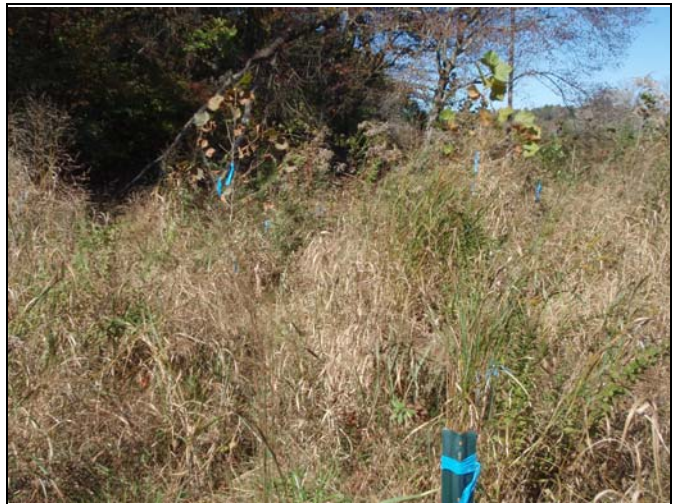
Vegetation Plot 4

During Year 4 monitoring, volunteer species including tulip poplar (*Liriodendron tulipifera*) and redbud (*Cercus canadensis*) were noted in plots 8 and 4, respectively. All plots will continue to be assessed during Year 5 monitoring for occurrence of volunteer species.

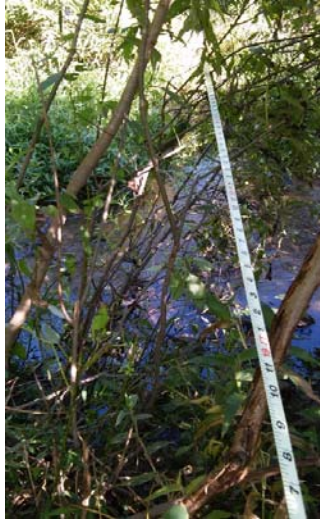
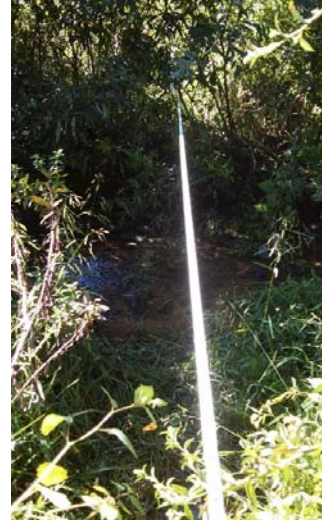
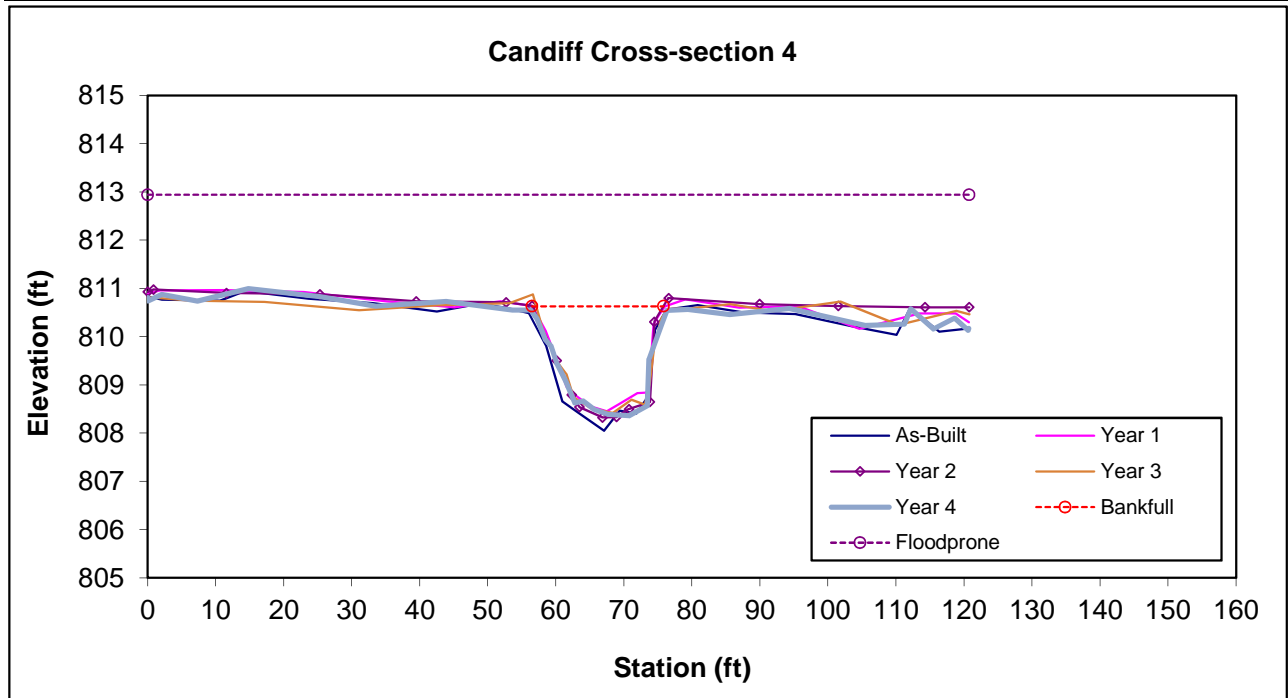
Permanent Cross-section 4

Feature	Stream Type	BKF Area	BKF Width	BKF Depth	Max BKF Depth	W/D	BH Ratio	ER	BKF Elev	TOB Elev
Riffle	C	29.4	19.95	1.47	2.17	13.55	0.9	6.1	810.53	810.3

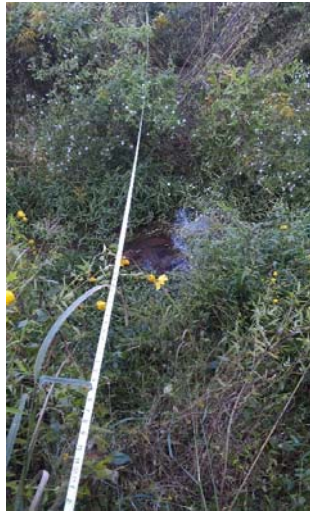
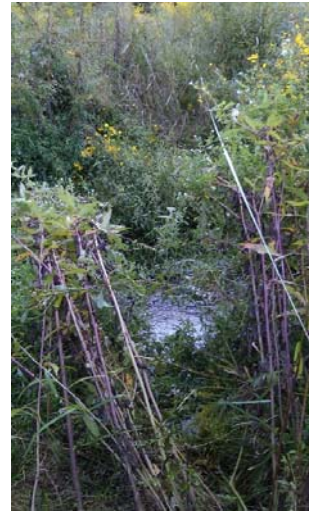
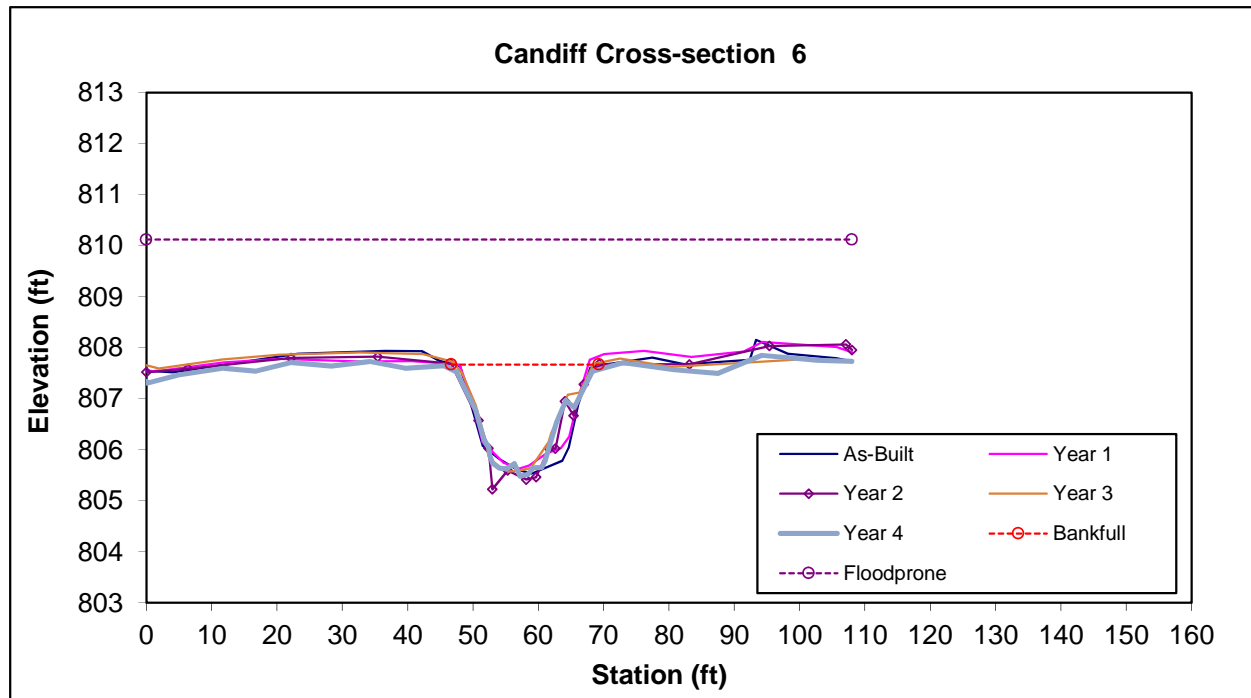
Permanent Cross-section 6
(Year 4 Data - Collected September 2015)

Feature	Stream Type	BKF Area	BKF Width	BKF Depth	Max BKF Depth	W/D	BH Ratio	ER	BKF Elev	TOB Elev
Riffle	C	25.9	22.49	1.15	2.09	19.51	1	4.8	807.57	807.52

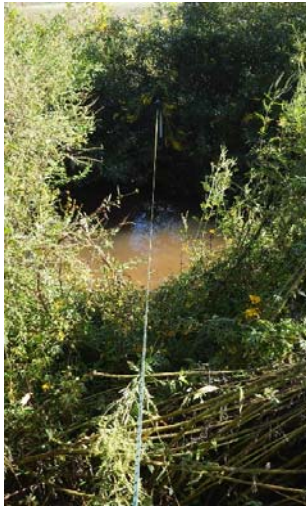
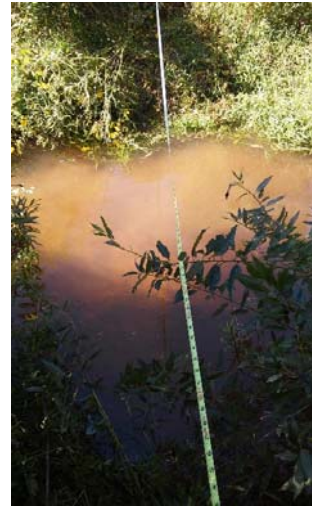
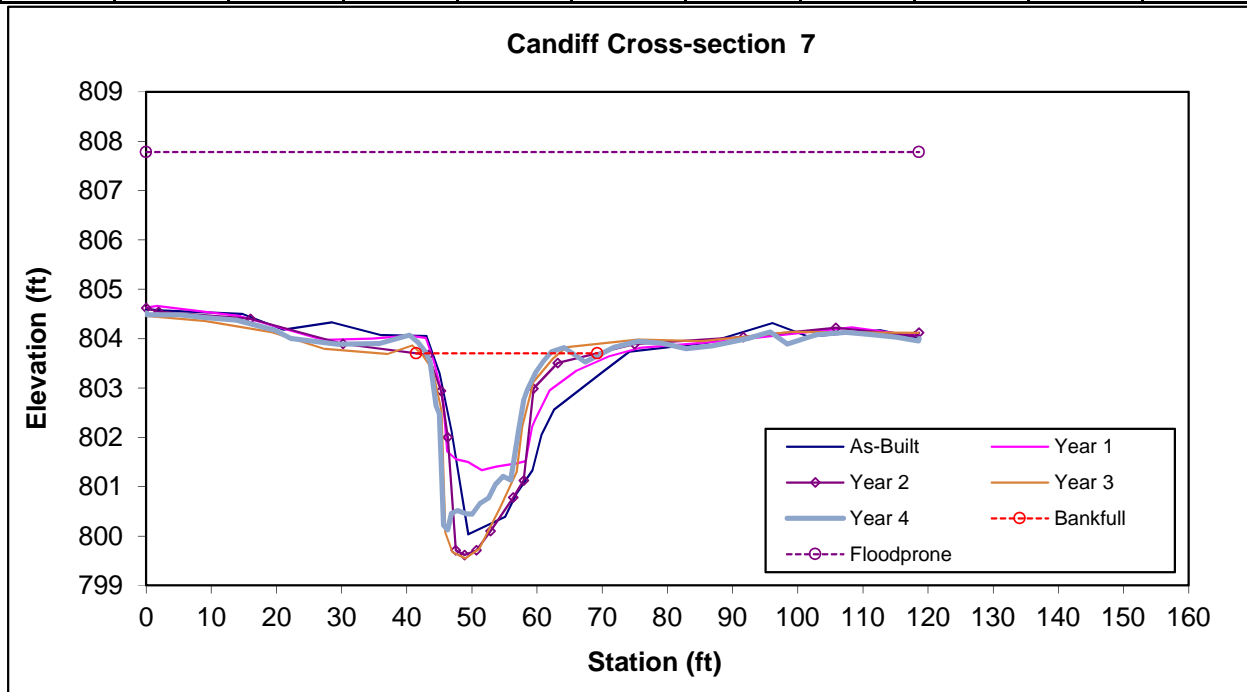
Permanent Cross-section 7

Feature	Stream Type	BKF Area	BKF Width	BKF Depth	Max BKF Depth	W/D	BH Ratio	ER	BKF Elev	TOB Elev
Pool		38.9	19.03	2.04	3.58	9.31	0.9	6.2	803.7	803.32

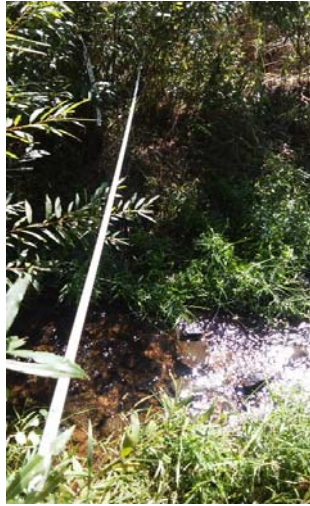
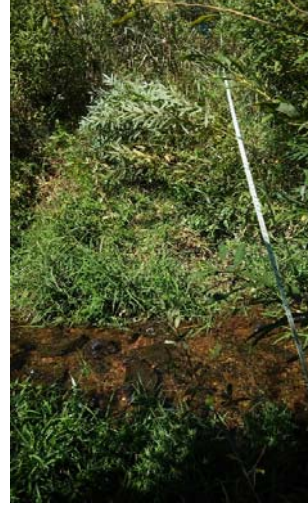
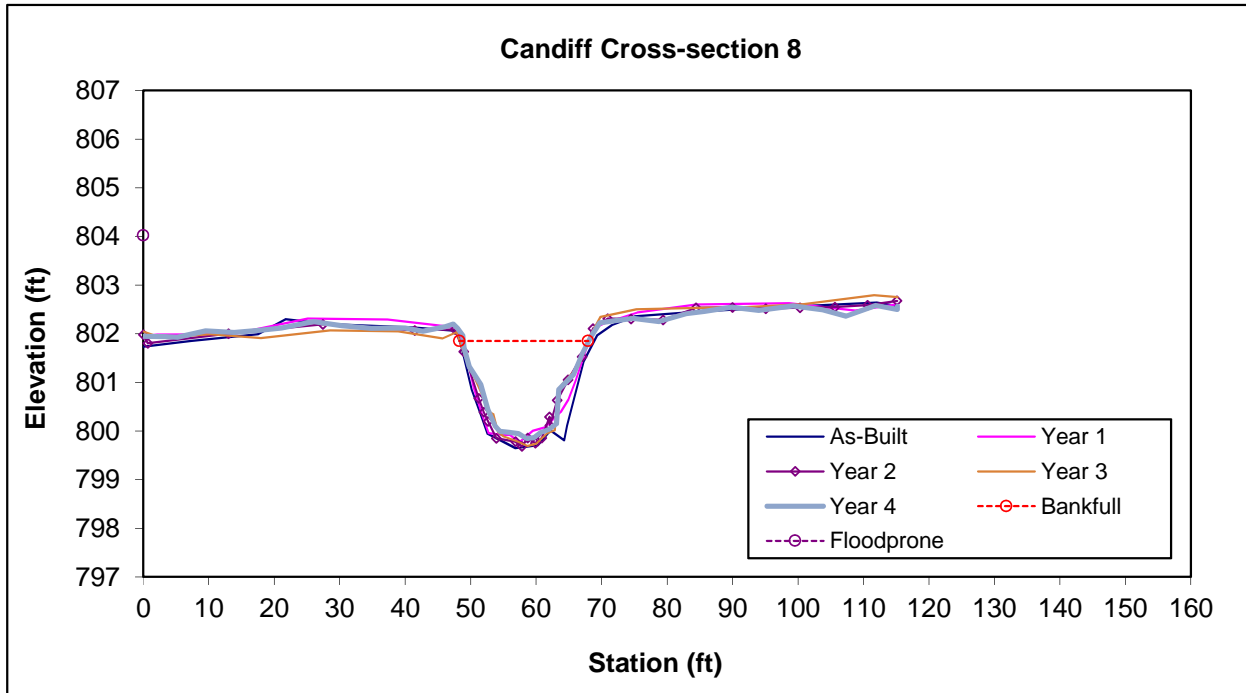
Permanent Cross-section 8

Feature	Stream Type	BKF Area	BKF Width	BKF Depth	Max BKF Depth	W/D	BH Ratio	ER	BKF Elev	TOB Elev
Riffle	C	25.4	19.15	1.32	2	14.47	1.1	6	801.85	802.1

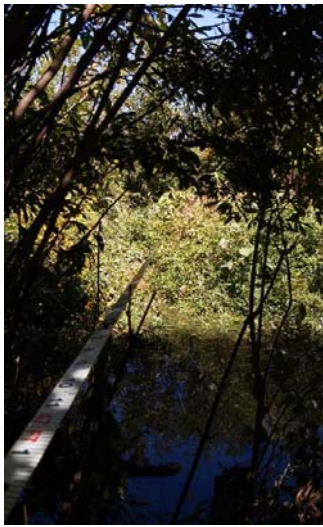
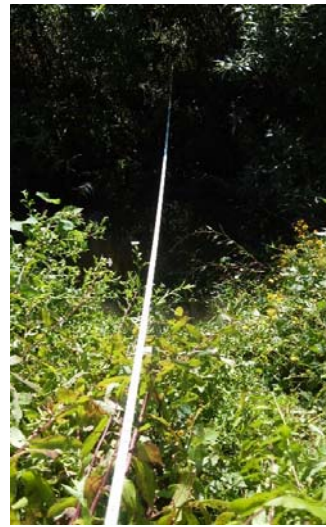
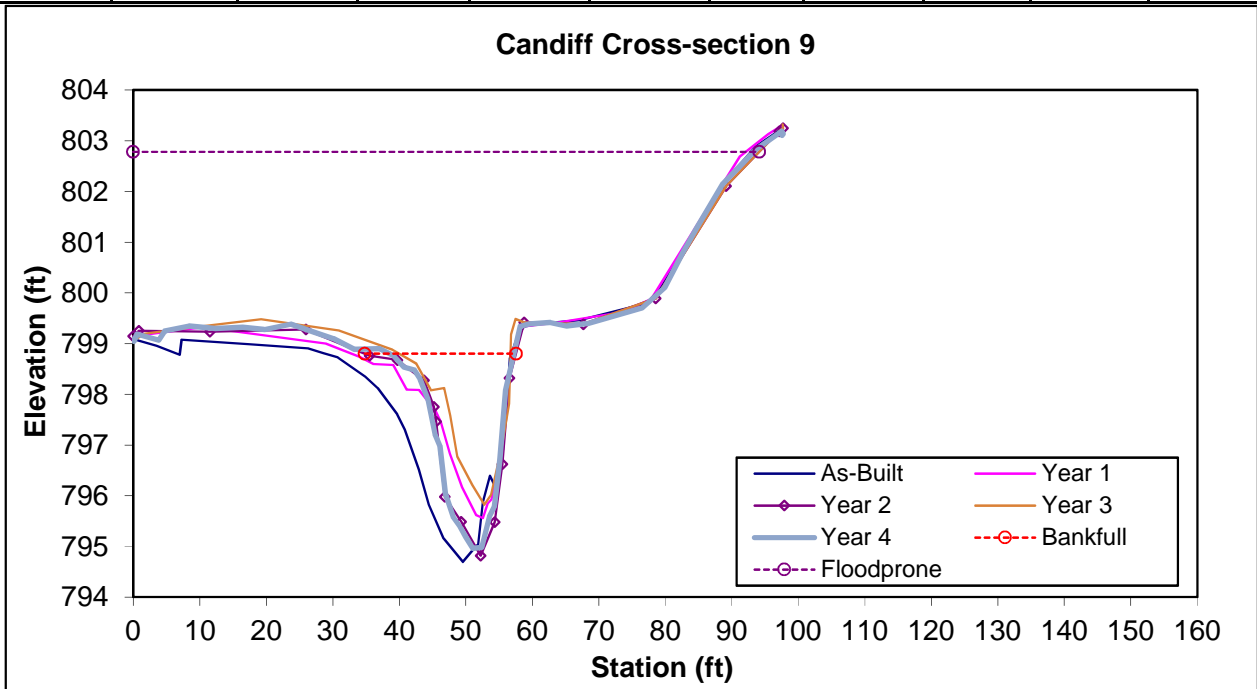
Permanent Cross-section 9

Feature	Stream Type	BKF Area	BKF Width	BKF Depth	Max BKF Depth	W/D	BH Ratio	ER	BKF Elev	TOB Elev
Pool		22.2	11.51	1.93	2.89	5.97	1.2	7.2	797.85	798.48

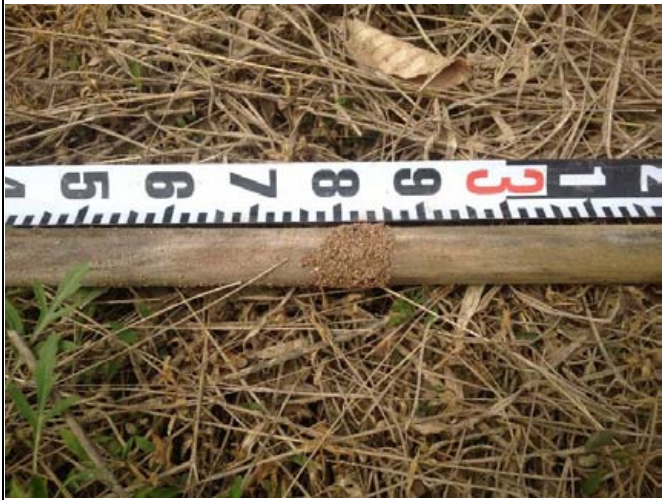
According to the on-site crest gauge, the Site experienced at least two significant bankfull flow events during Year 4 monitoring. The largest on-site bankfull flow event documented at the M3 crest gauge occurred on April 20, 2015. It is estimated that the height of highest flow at the M3 crest gauge observed in Year 4 was approximately 2.85 feet above bankfull stage.

M3 crest gauge STA 55+50, April 30, 2015. Crest gauge reading of 2.85 feet.

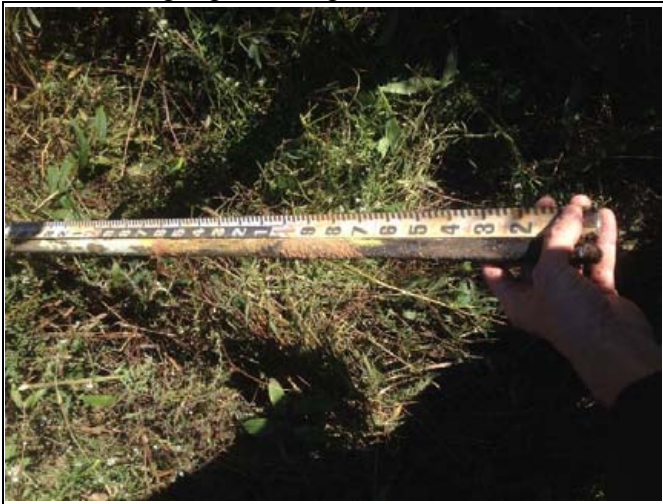
M3 crest gauge bankfull evidence. April 30, 2015.

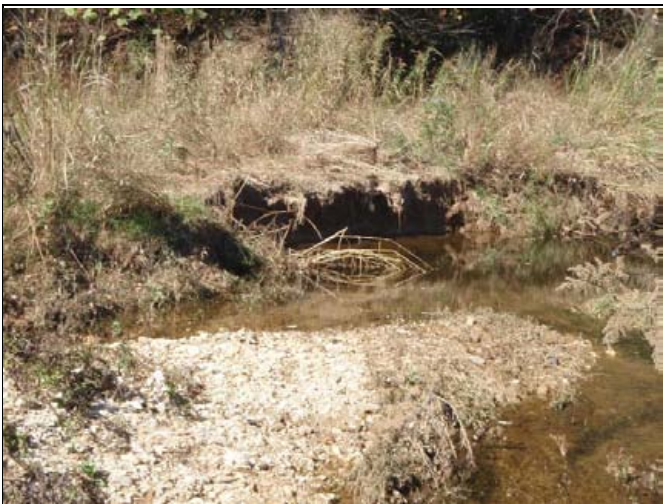
M3 crest gauge bankfull evidence. October 19, 2015.

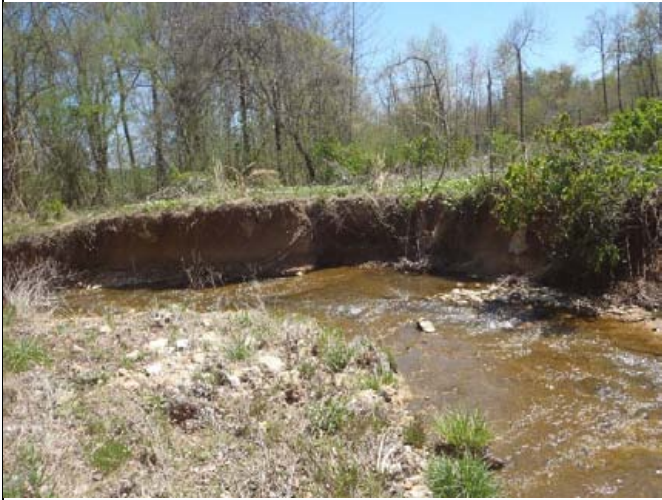
Two pools located at stations 46+50 and 55+50 have exhibited areas of erosion during Year 4 monitoring. The erosional areas observed are occurring on the outer bend below the root wads and are approximately 10 feet or less in length. These areas are isolated and do not suggest a trend towards long-term instability.

Stream Problem Area 2 - STA 55+50. M3 bank erosion on outer portion of meander bend.

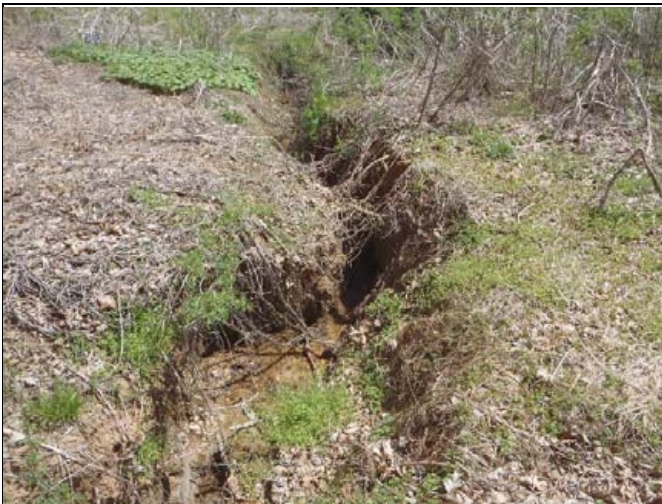
M1 before enhancement activities, April 2015.

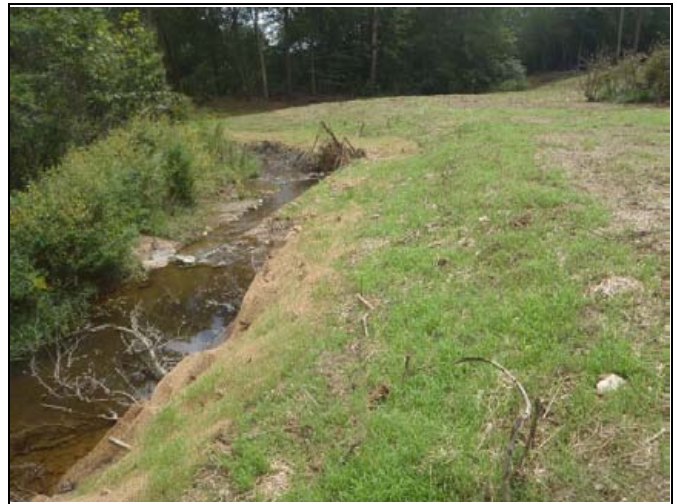
M1 after enhancement activities, September 2015.

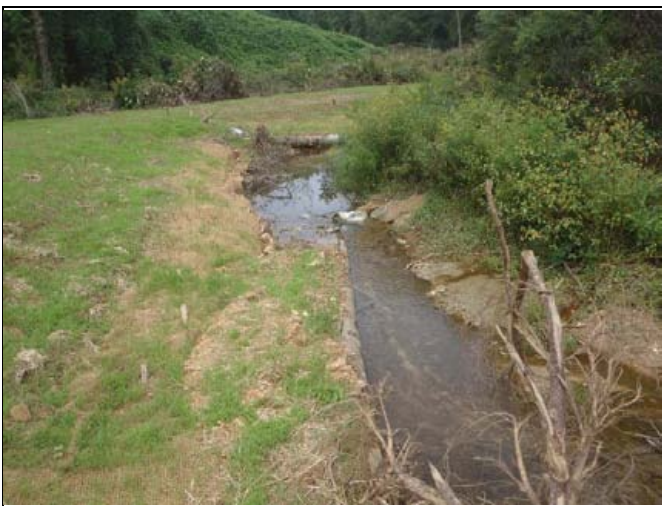
M1 after enhancement activities, September 2015.

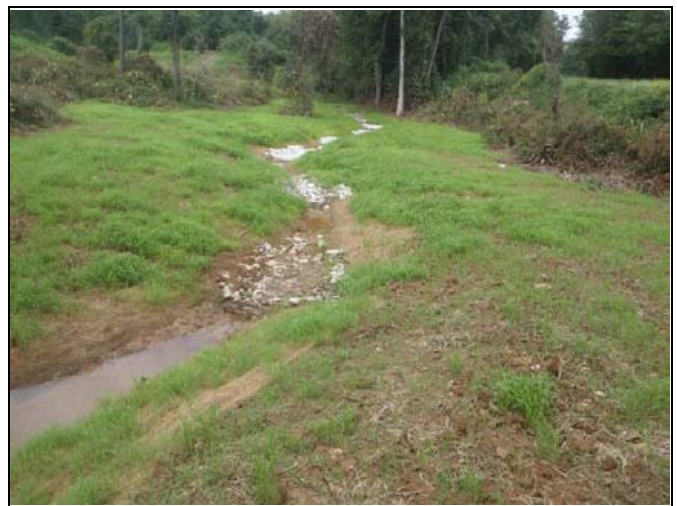
M1 after enhancement activities, September 2015.
