CANDIFF CREEK RESTORATION PROJECT
ANNUAL MONITORING REPORT FOR 2016 (YEAR 5)

NCDEQ-DMS Project Number: 92767

November 2016
FINAL

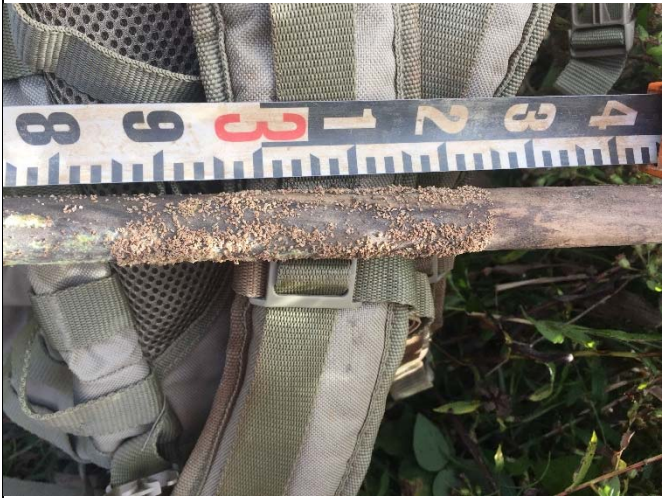
M3 crest gauge STA 55+50, October 11, 2016.
Crest gauge reading of 3.24 feet.
