# MONITORING YEAR 2 ANNUAL REPORT

## CANDY CREEK MITIGATION SITE

Guilford County, NC

DEQ Contract 5794

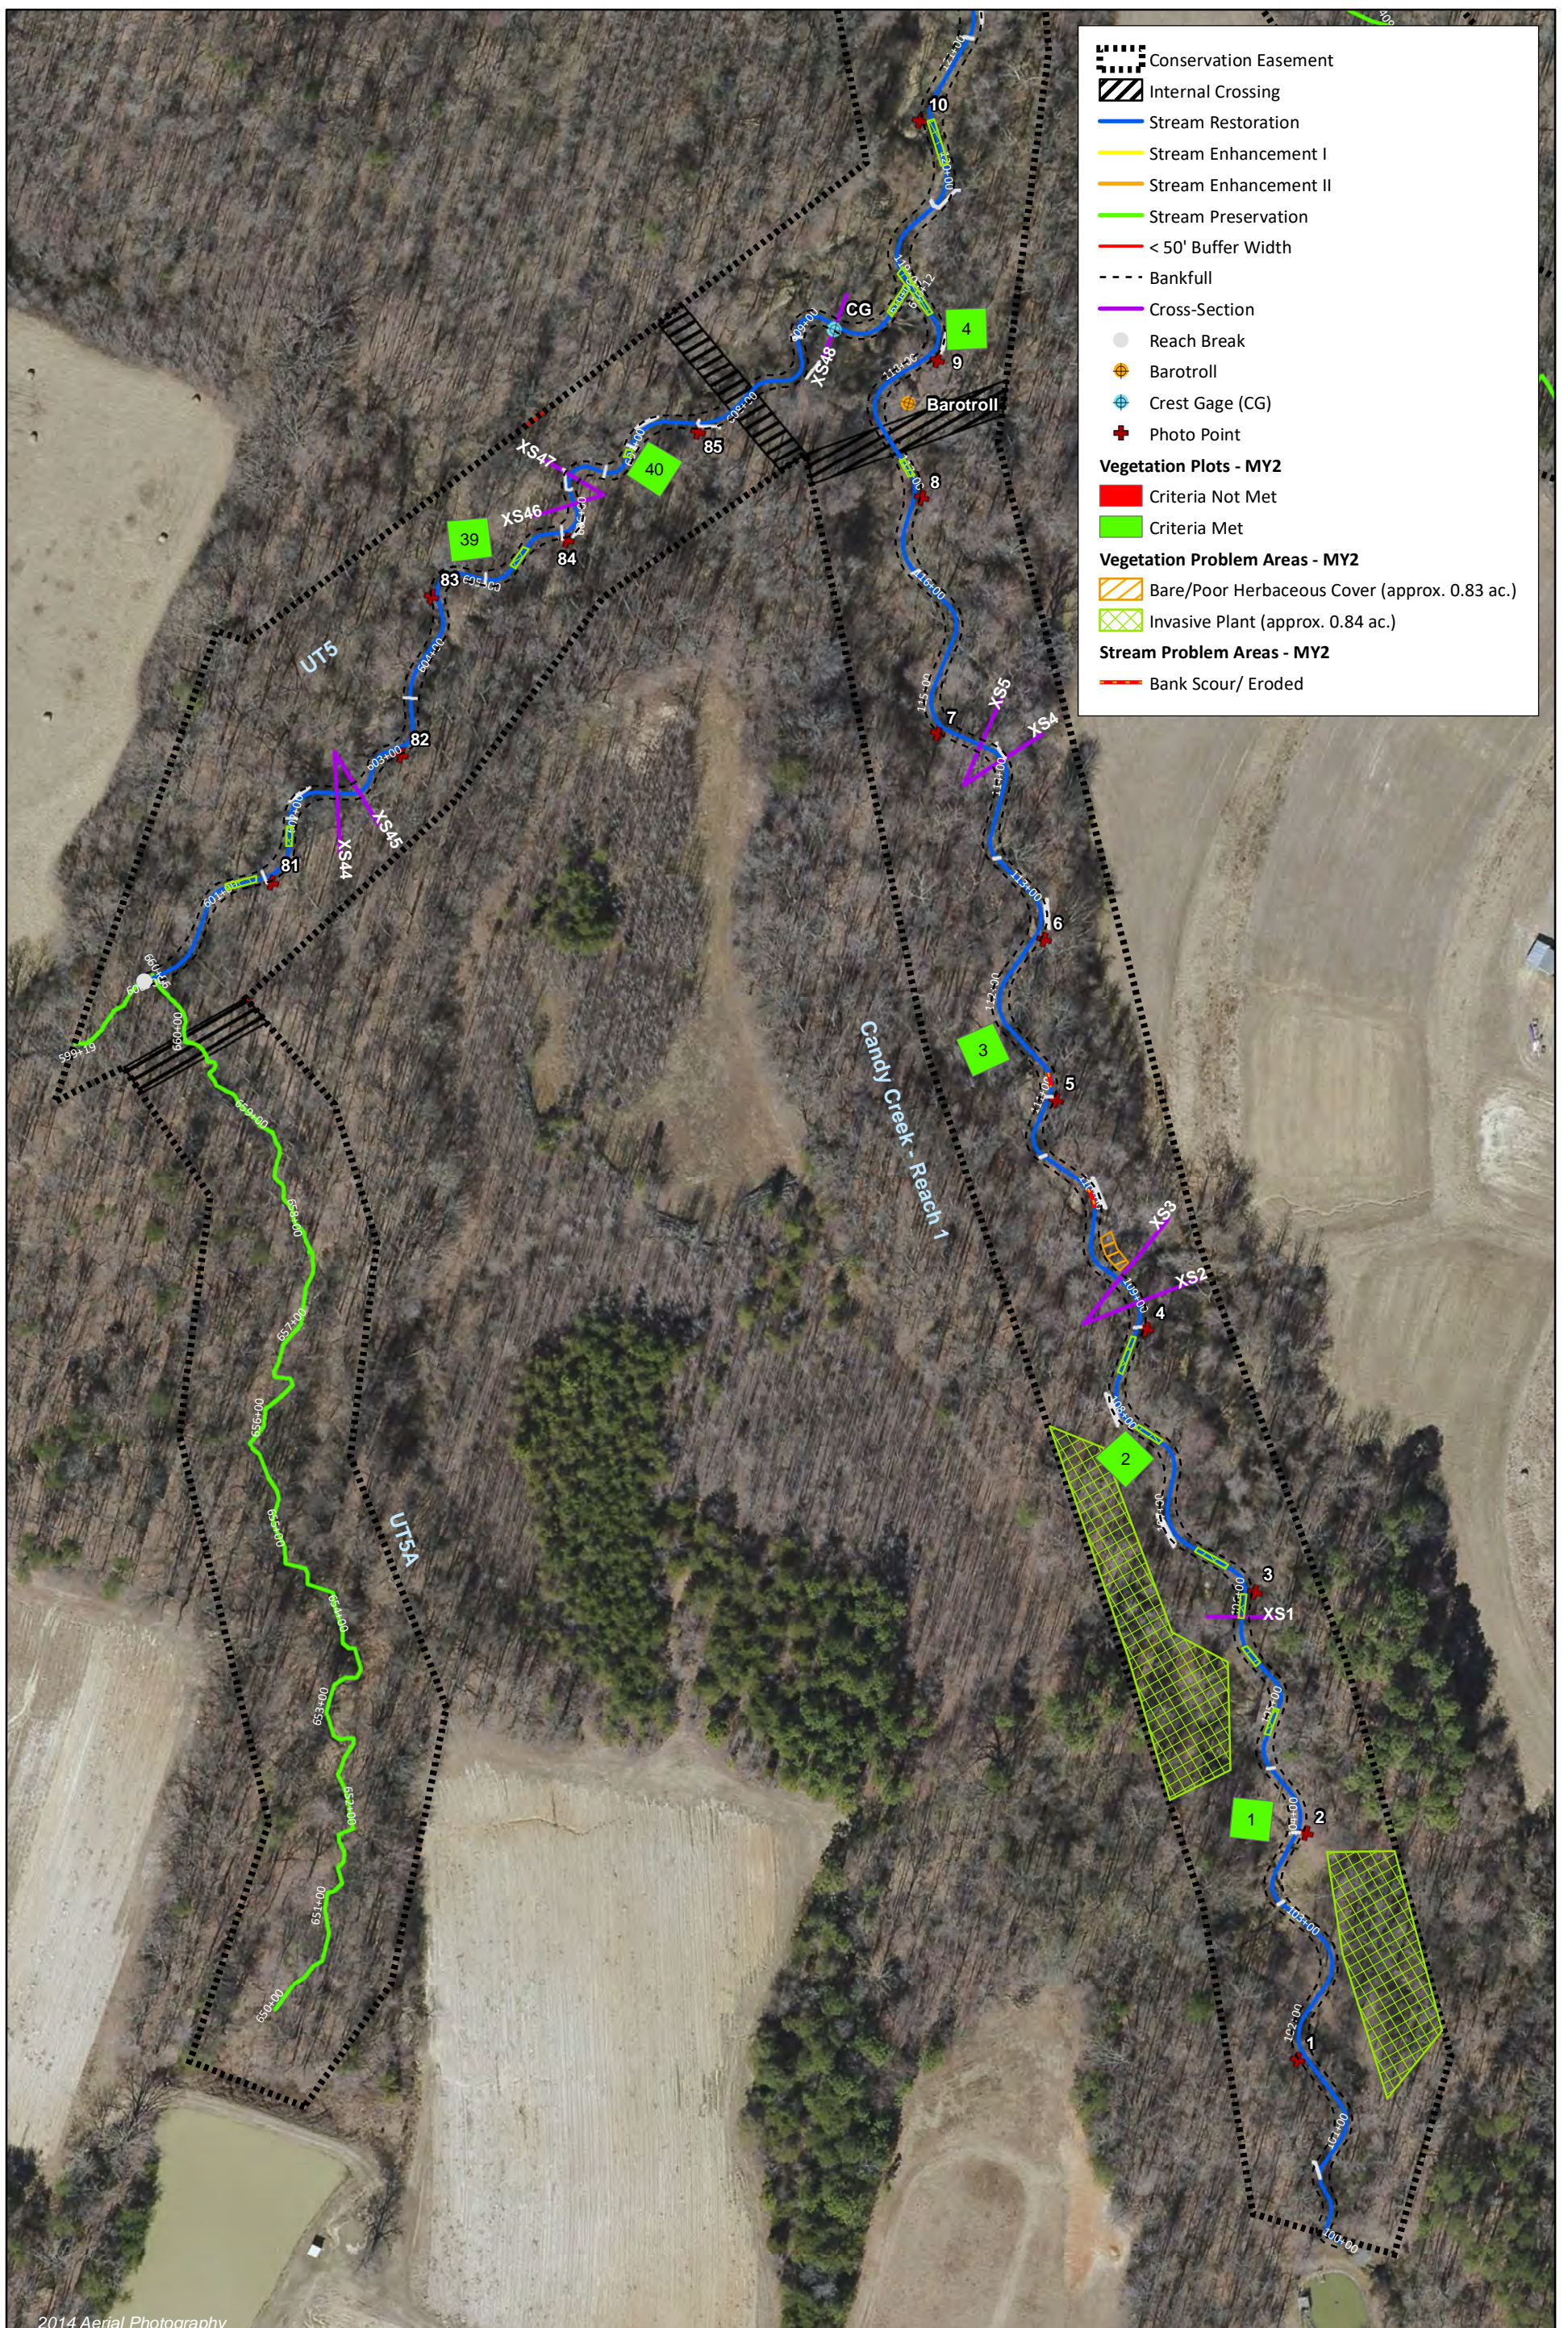
Figure 3.1 Integrated Current Condition Plan View  
 Candy Creek Mitigation Site  
 DMS Project No. 96315  
 Monitoring Year 2 - 2018  
 Guilford County, NC

Morphological surveys for MY2 were conducted in June 2018. Bank erosion was observed within some isolated outside meander bends along Candy Creek Reach 1, 3 and 4, and slight scouring was also noted at cross-sections 32 and 33 on UT2 Reach 1; however, none of these areas are significant and the streams are functioning as designed. The remainder of the cross-sections appear consistent and all streams appear stable. Entrenchment ratios vary slightly from year to year due to minor changes in bankfull widths. Pools are deepening with point bar deposition occurring. Small adjustments in riffle widths occur due to vegetation, sediment deposition, and many other factors. These minor changes do not indicate channel instability. Refer to Appendix 2 for the visual stability assessment table, CCPV map, and reference photographs. Refer to Appendix 4 for the morphological data and plots.

Stream areas of concern include minor instances of bank erosion and sediment deposition. A maintenance repair was implemented to stabilize the isolated areas of bank erosion along Candy Creek. The minor repairs consisted of both brush mattress and live stake installation. The minor areas of scour along UT2 will continue to be monitored and a maintenance plan will be established if deemed necessary. All fallen trees over the streams will be removed and dispersed within the site to create additional habitat.

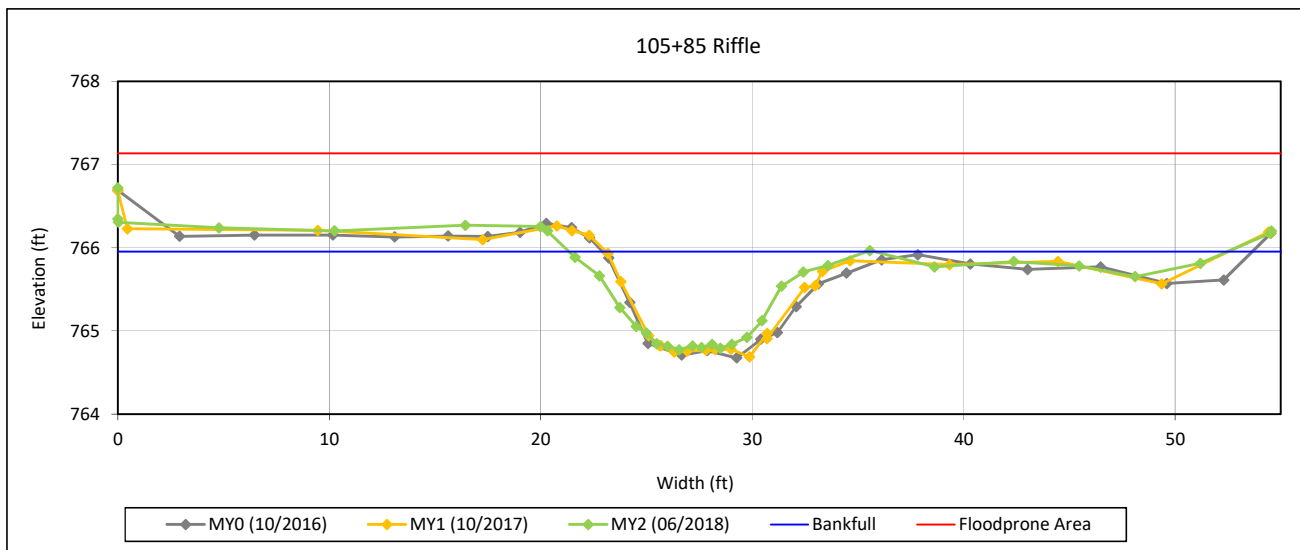
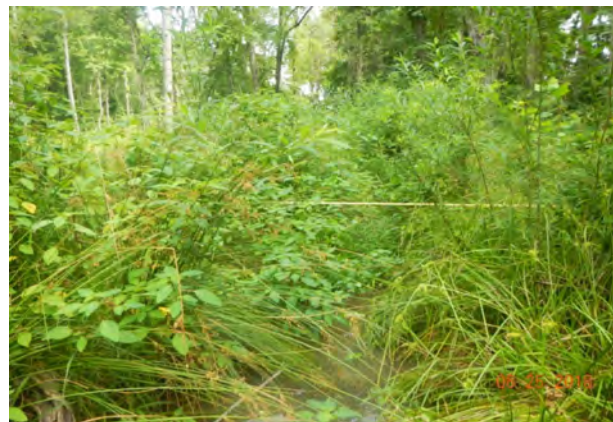
#### Cross-Section 1 - Candy Creek Reach 1

8.9	x-section area (ft.sq.)
12.2	width (ft)
0.7	mean depth (ft)
1.2	max depth (ft)
12.5	wetted perimeter (ft)
0.7	hydraulic radius (ft)
16.8	width-depth ratio
71.0	W flood prone area (ft)
5.8	entrenchment ratio
1.0	low bank height ratio

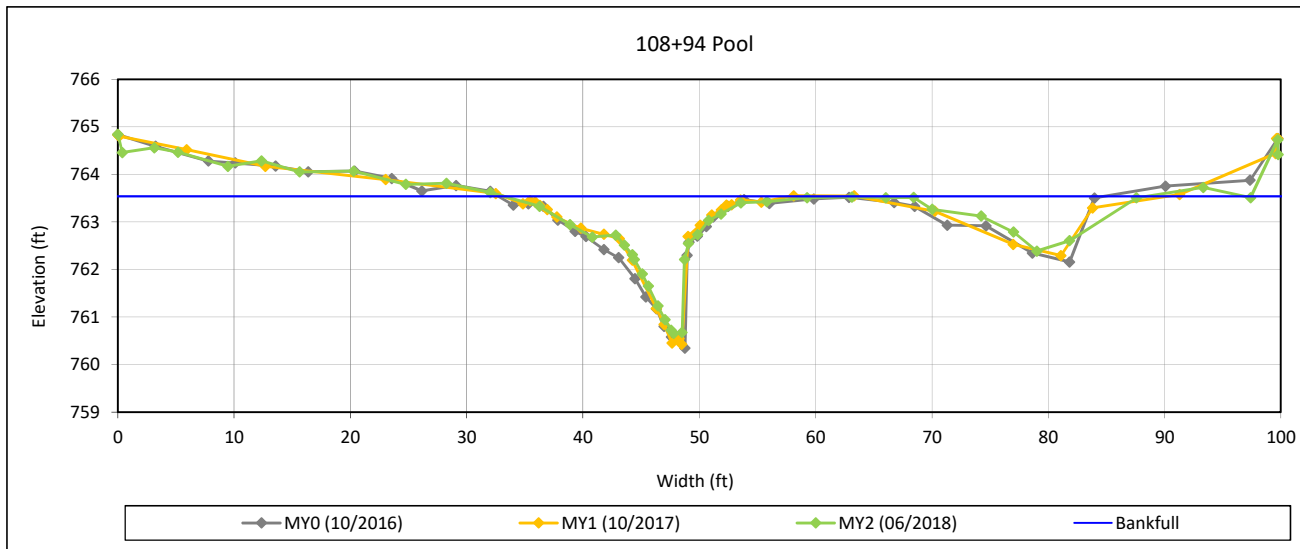
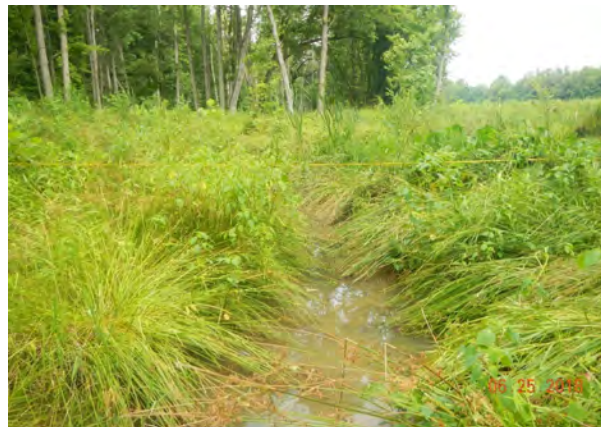
### Cross-Section 2 - Candy Creek Reach 1

18.4	x-section area (ft.sq.)
19.5	width (ft)
0.9	mean depth (ft)
2.9	max depth (ft)
21.6	wetted perimeter (ft)
0.9	hydraulic radius (ft)
20.7	width-depth ratio

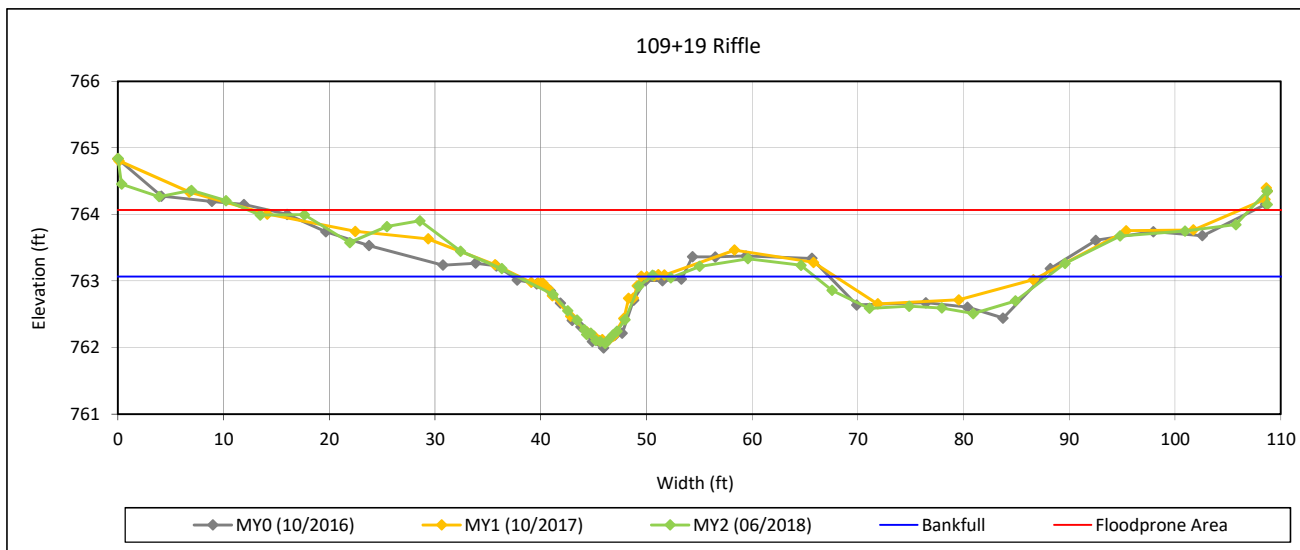
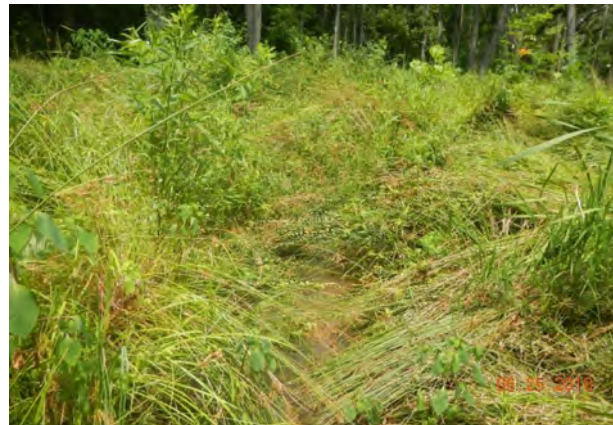
### Cross-Section 3 - Candy Creek Reach 1

5.7	x-section area (ft.sq.)
11.8	width (ft)
0.5	mean depth (ft)
1.0	max depth (ft)
12.0	wetted perimeter (ft)
0.5	hydraulic radius (ft)
24.5	width-depth ratio
97.0	W flood prone area (ft)
8.2	entrenchment ratio
1.0	low bank height ratio

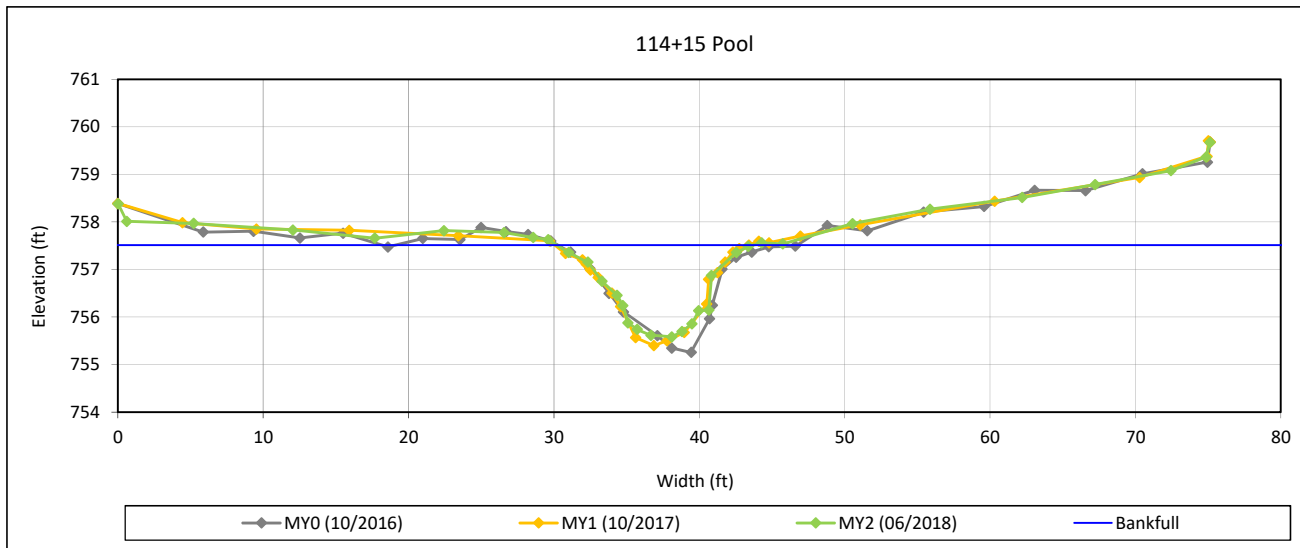
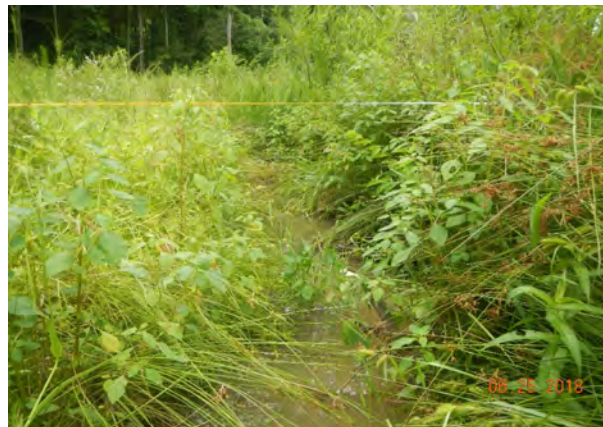
### Cross Section 4 - Candy Creek Reach 1

13.5	x-section area (ft.sq.)
13.5	width (ft)
1.0	mean depth (ft)
1.9	max depth (ft)
14.6	wetted perimeter (ft)
0.9	hydraulic radius (ft)
13.5	width-depth ratio

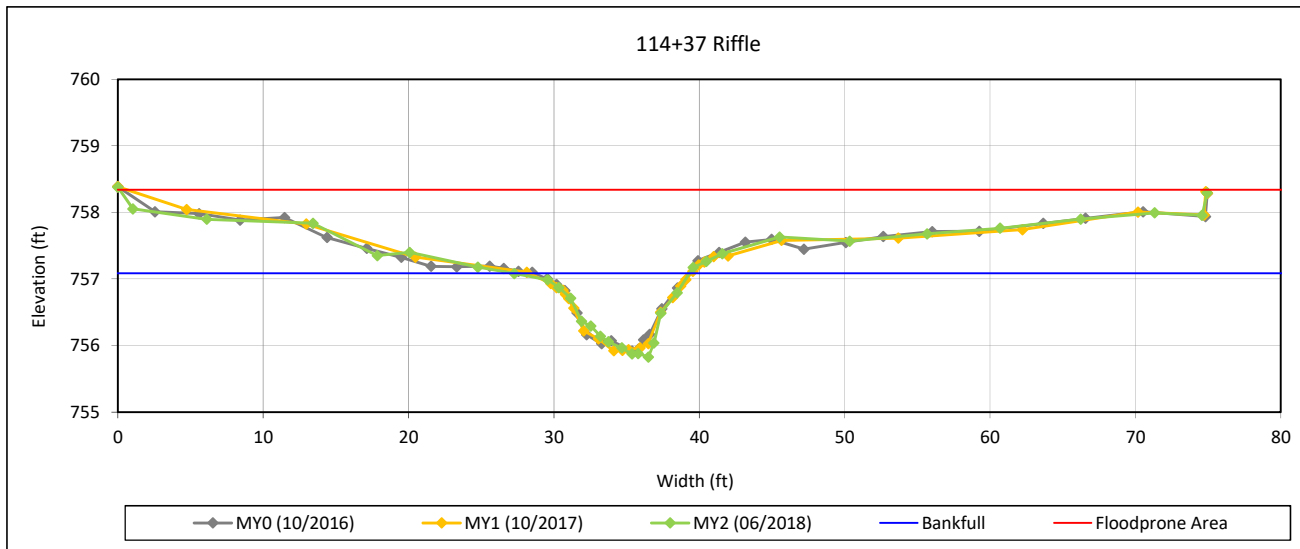
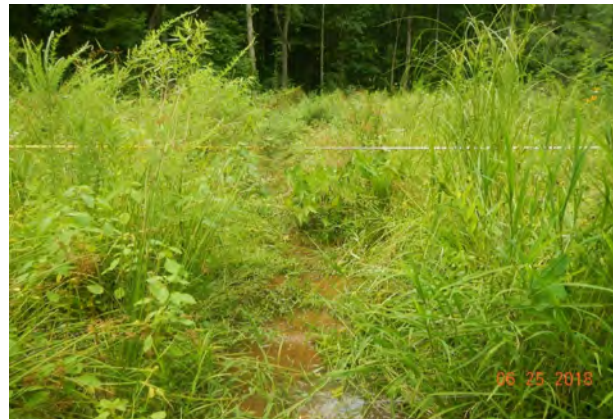
### Cross-Section 5 - Candy Creek Reach 1

7.1	x-section area (ft.sq.)
12.1	width (ft)
0.6	mean depth (ft)
1.3	max depth (ft)
12.5	wetted perimeter (ft)
0.6	hydraulic radius (ft)
20.5	width-depth ratio
53.0	W flood prone area (ft)
4.4	entrenchment ratio
1.0	low bank height ratio

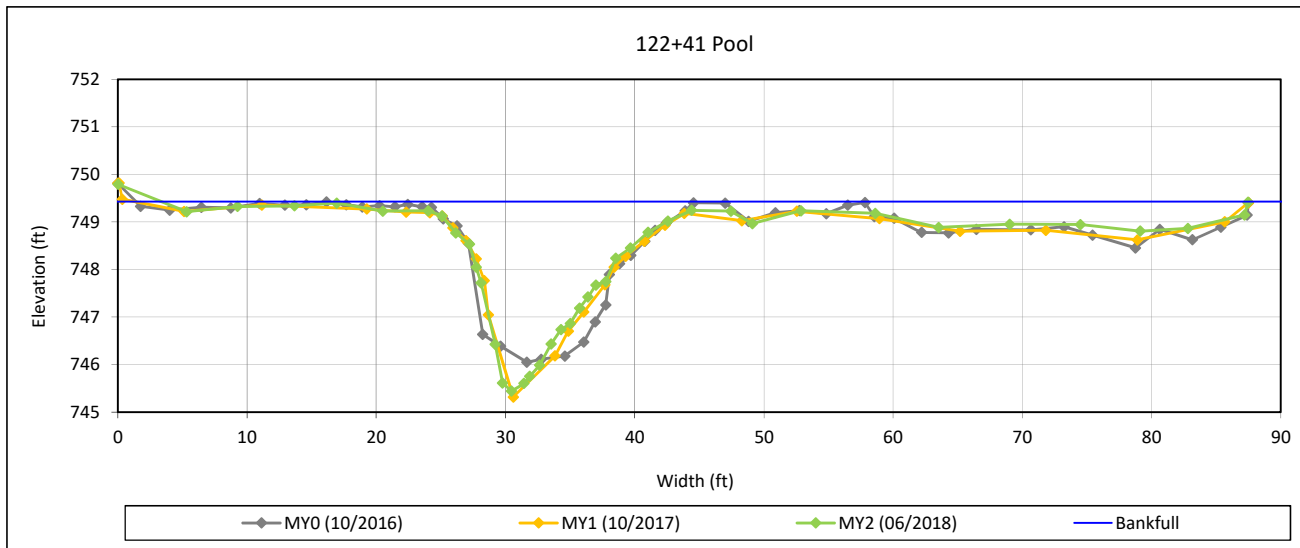
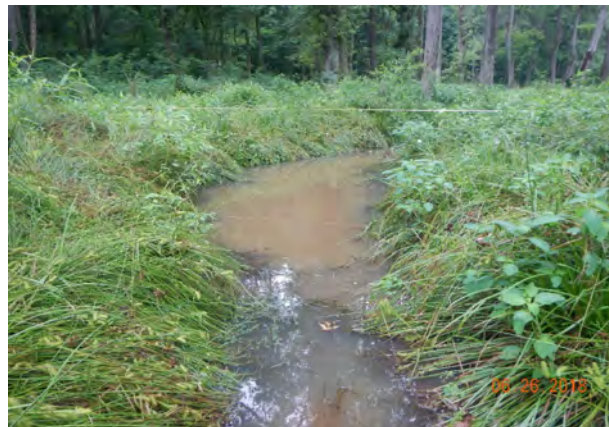
#### Cross-Section 6 - Candy Creek Reach 1

35.5	x-section area (ft.sq.)
20.4	width (ft)
1.7	mean depth (ft)
4.0	max depth (ft)
22.5	wetted perimeter (ft)
1.6	hydraulic radius (ft)
11.7	width-depth ratio

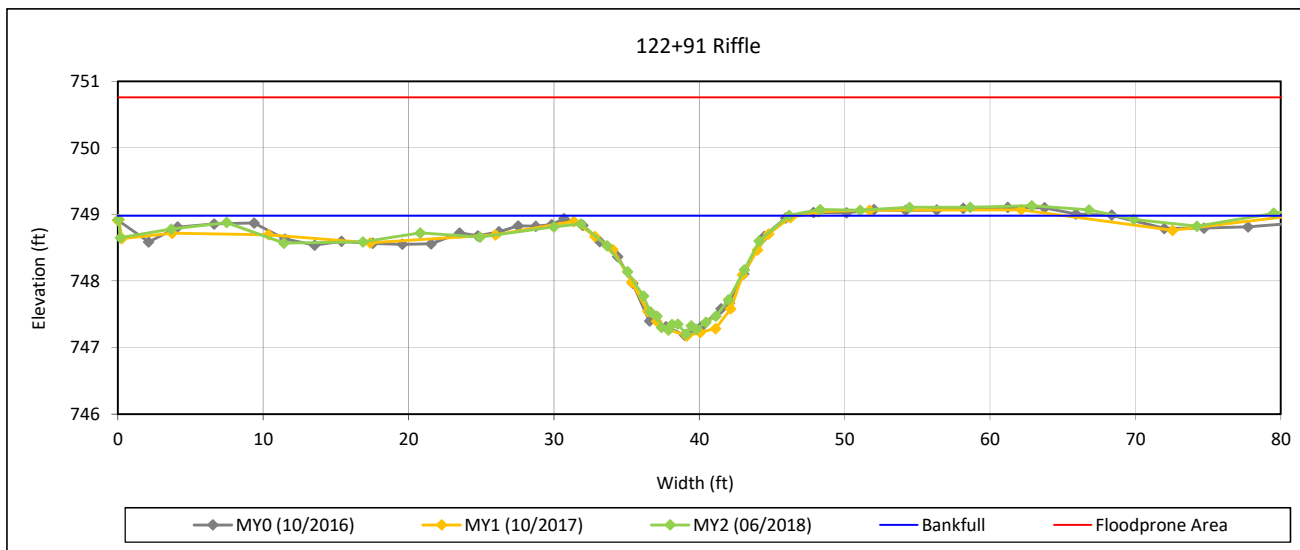
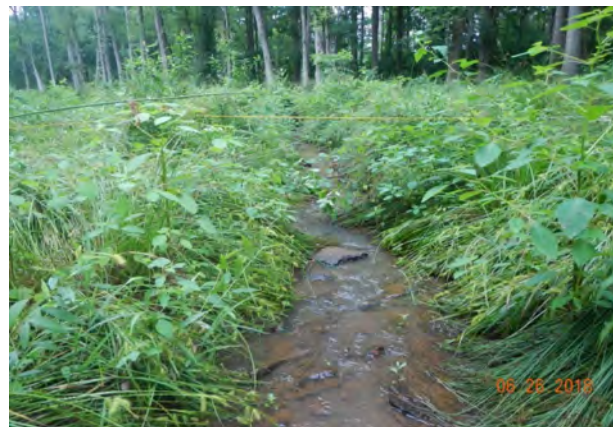
### Cross-Section 7 - Candy Creek Reach 1

13.9	x-section area (ft.sq.)
14.3	width (ft)
1.0	mean depth (ft)
1.8	max depth (ft)
14.9	wetted perimeter (ft)
0.9	hydraulic radius (ft)
14.7	width-depth ratio
164.0	W flood prone area (ft)
11.5	entrenchment ratio
0.93	low bank height ratio

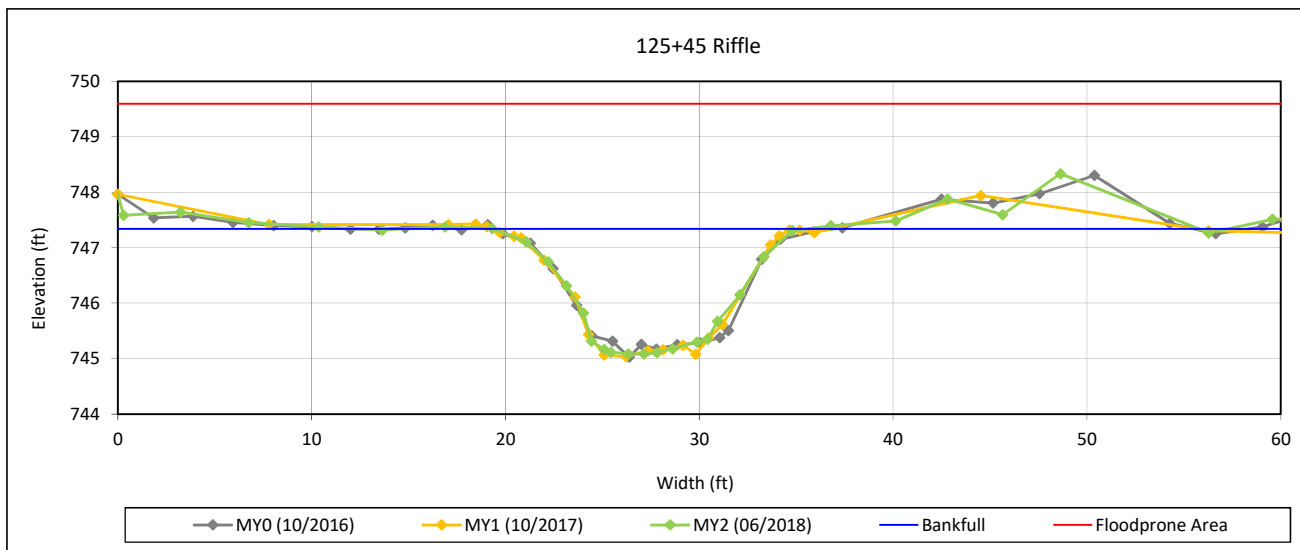
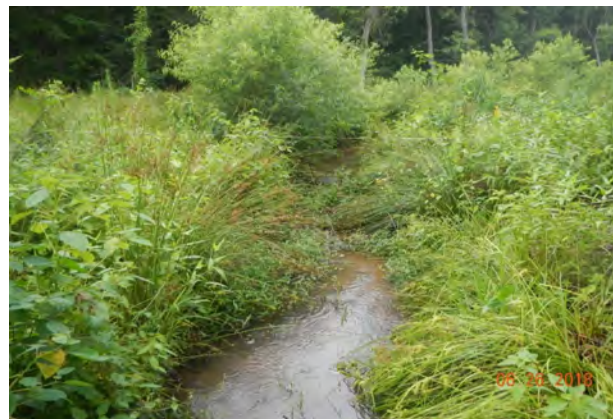
### Cross-Section 8 - Candy Creek Reach 1

20.3	x-section area (ft.sq.)
15.4	width (ft)
1.3	mean depth (ft)
2.3	max depth (ft)
16.5	wetted perimeter (ft)
1.2	hydraulic radius (ft)
11.7	width-depth ratio
292.0	W flood prone area (ft)
18.9	entrenchment ratio
1.0	low bank height ratio

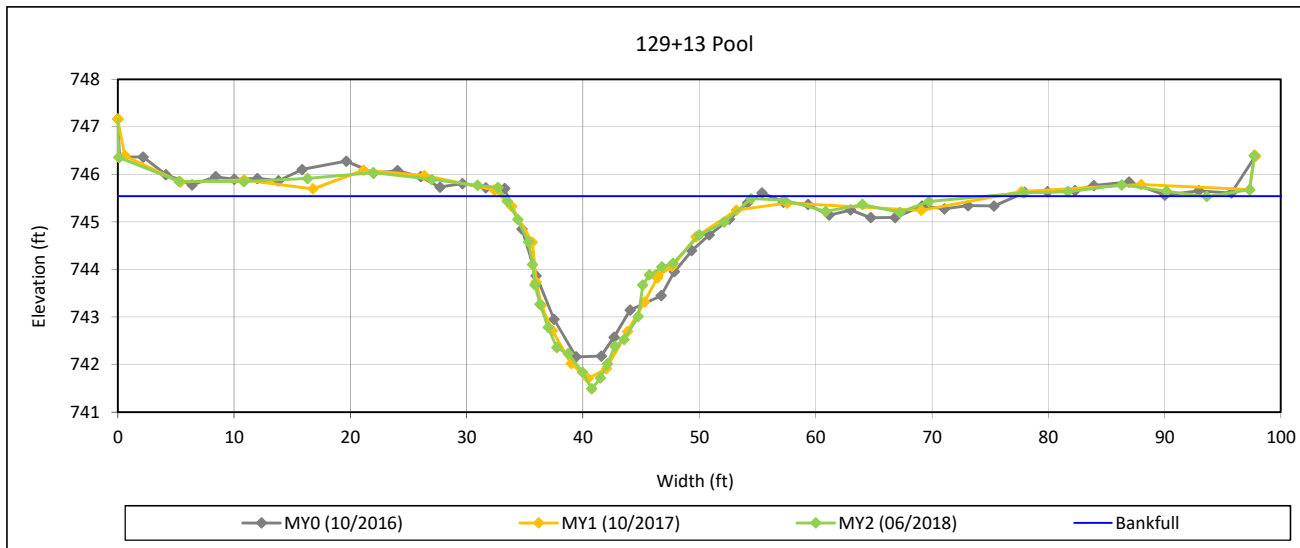
### Cross-Section 9 - Candy Creek Reach 2

40.1	x-section area (ft.sq.)
24.1	width (ft)
1.7	mean depth (ft)
4.1	max depth (ft)
26.3	wetted perimeter (ft)
1.5	hydraulic radius (ft)
14.5	width-depth ratio

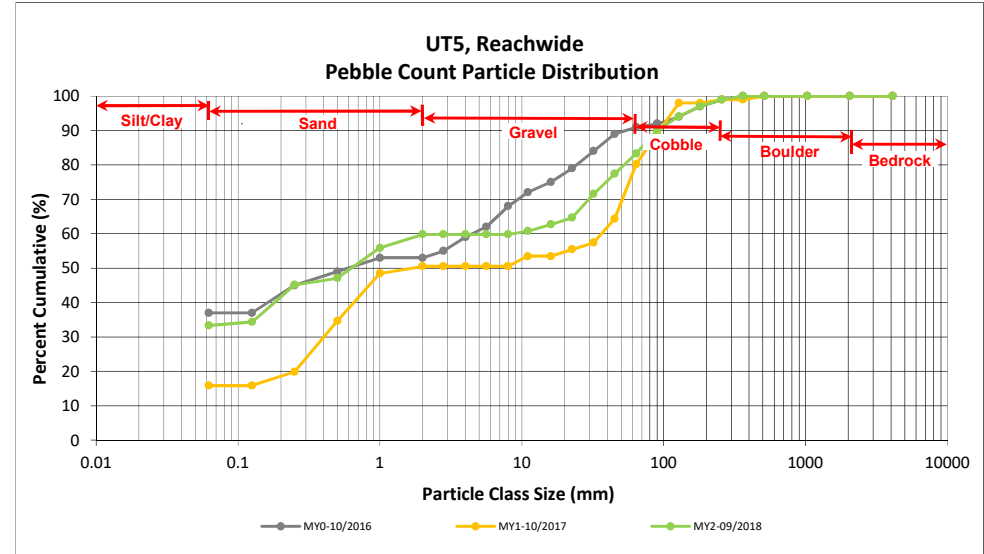
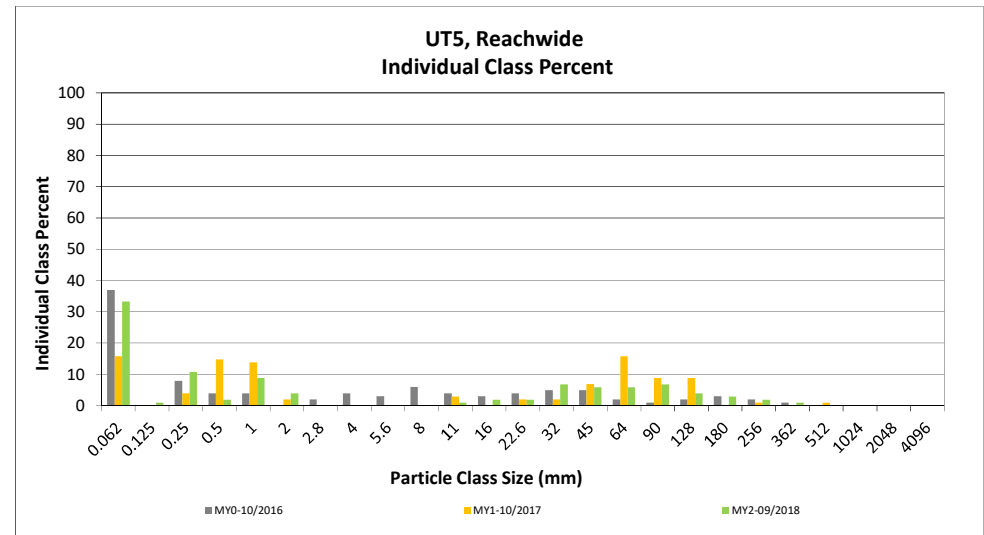
Reachwide	
Channel materials (mm)	
D <sub>16</sub> =	Silt/Clay
D <sub>35</sub> =	0.13
D <sub>50</sub> =	0.6
D <sub>84</sub> =	66.2
D <sub>95</sub> =	141.8
D <sub>100</sub> =	362.0

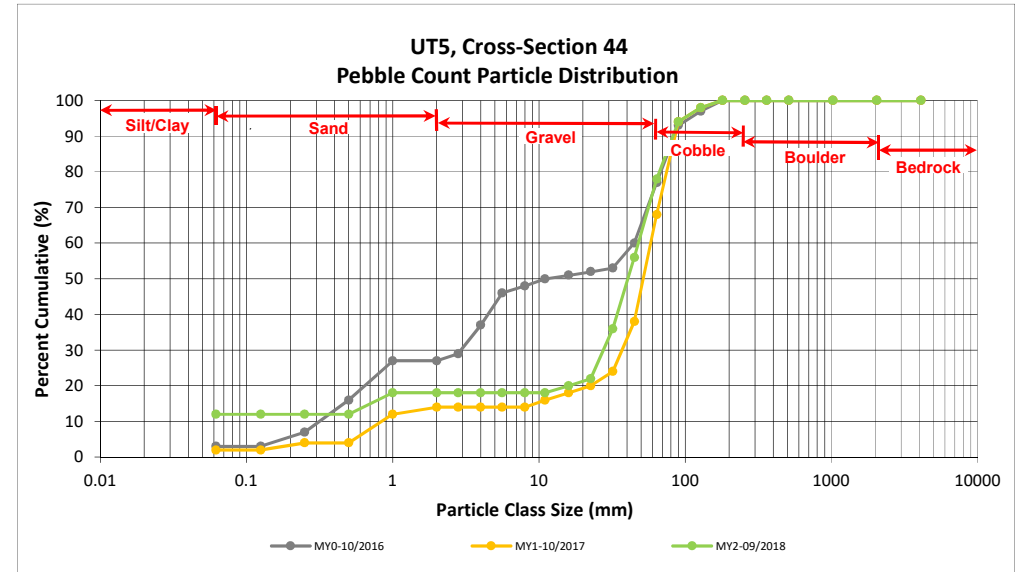
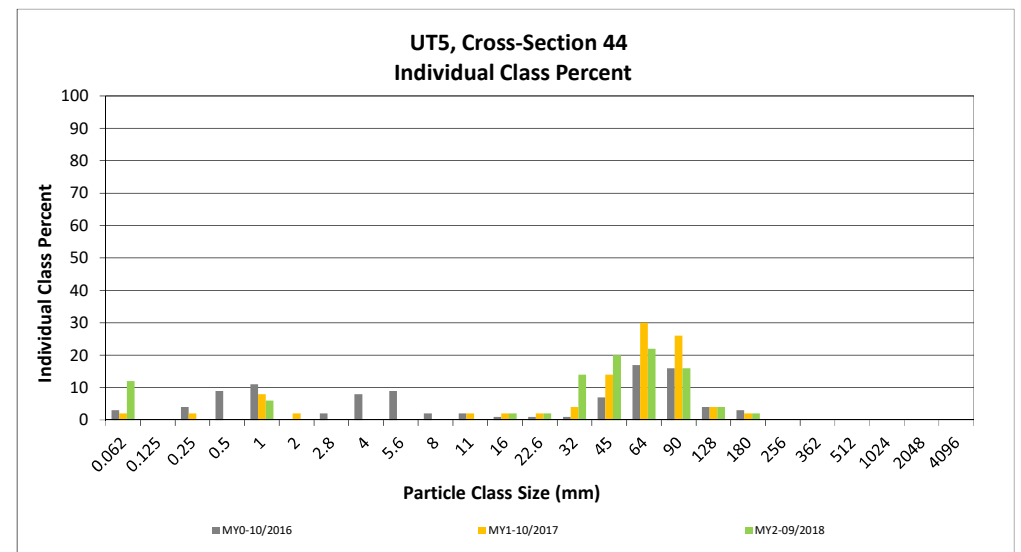
Cross-Section 44	
Channel materials (mm)	
D <sub>16</sub> =	0.79
D <sub>35</sub> =	31.21
D <sub>50</sub> =	40.6
D <sub>84</sub> =	72.7
D <sub>95</sub> =	98.3
D <sub>100</sub> =	180.0

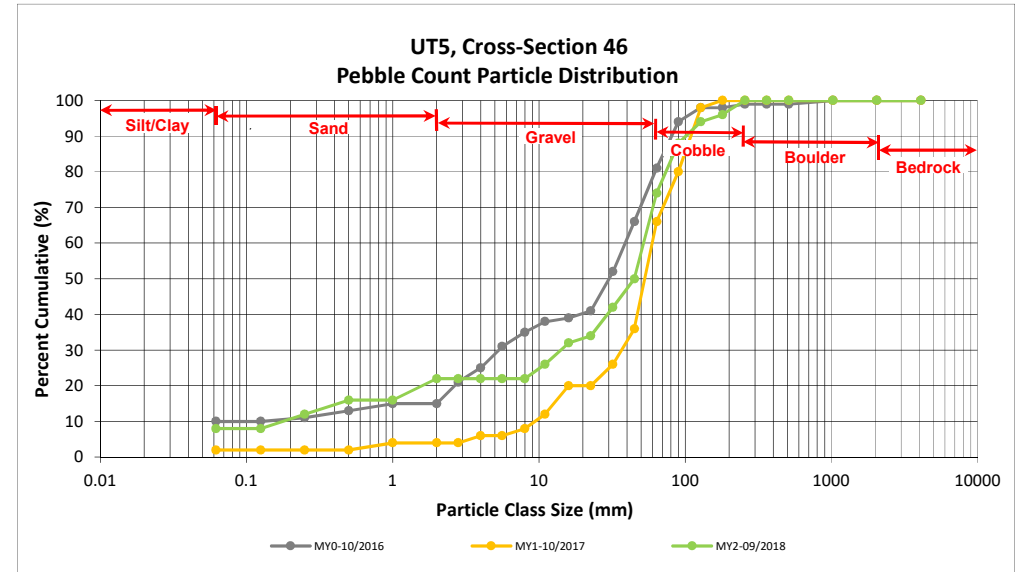
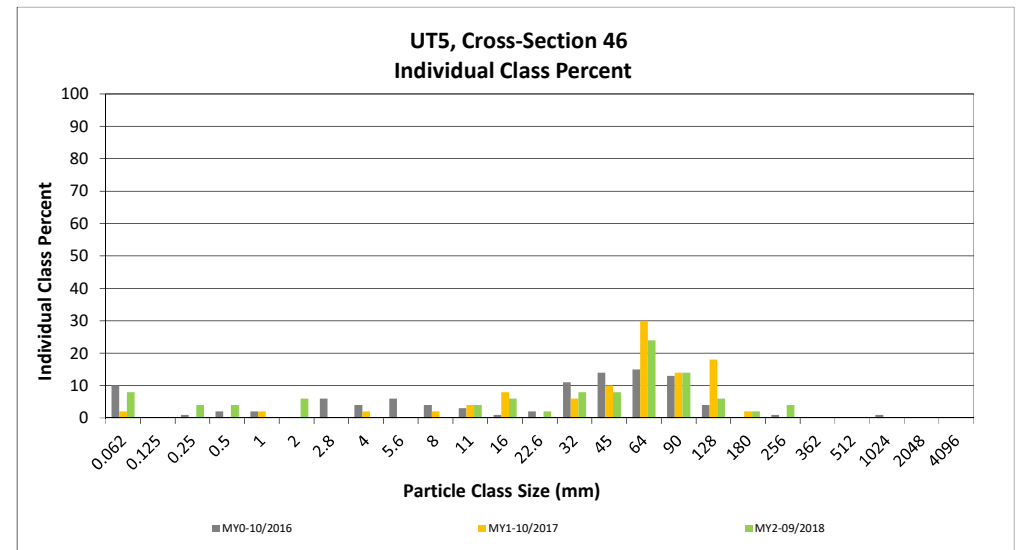
Cross-Section 46	
Channel materials (mm)	
D <sub>16</sub> =	0.50
D <sub>35</sub> =	23.60
D <sub>50</sub> =	45.0
D <sub>84</sub> =	81.6
D <sub>95</sub> =	151.8
D <sub>100</sub> =	256.0

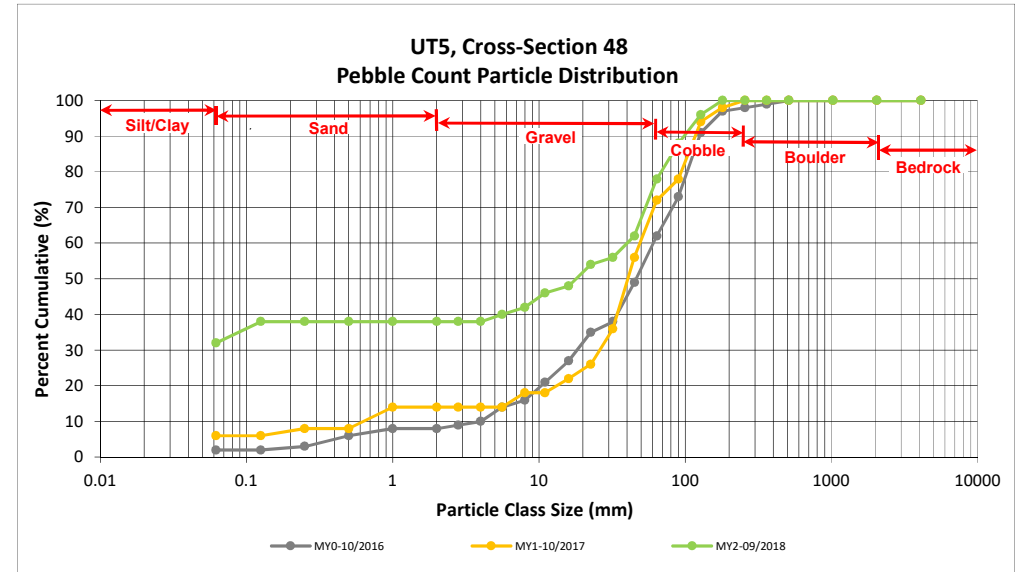
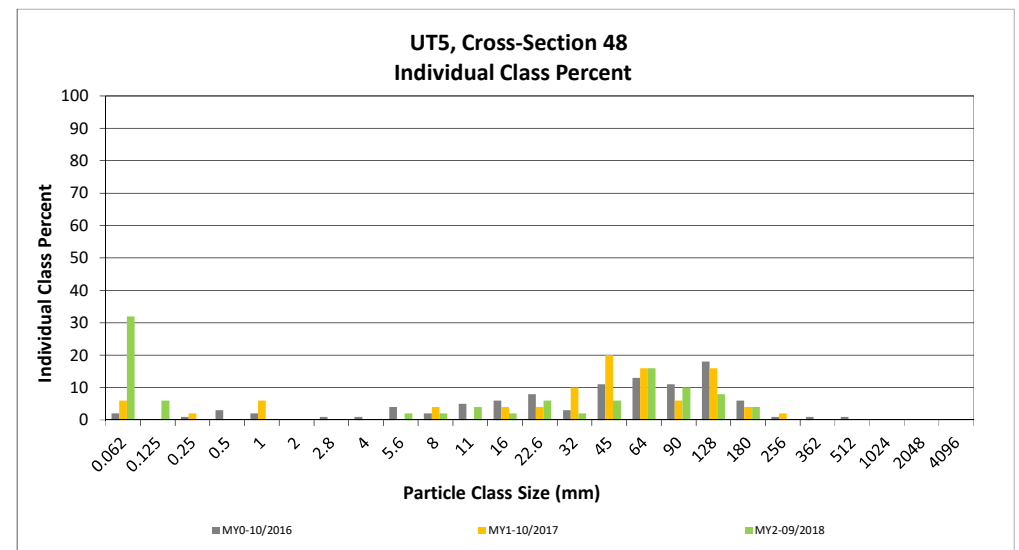
Cross-Section 48	
Channel materials (mm)	
D <sub>16</sub> =	Silt/Clay
D <sub>35</sub> =	0.09
D <sub>50</sub> =	18.0
D <sub>84</sub> =	78.5
D <sub>95</sub> =	122.5
D <sub>100</sub> =	180.0

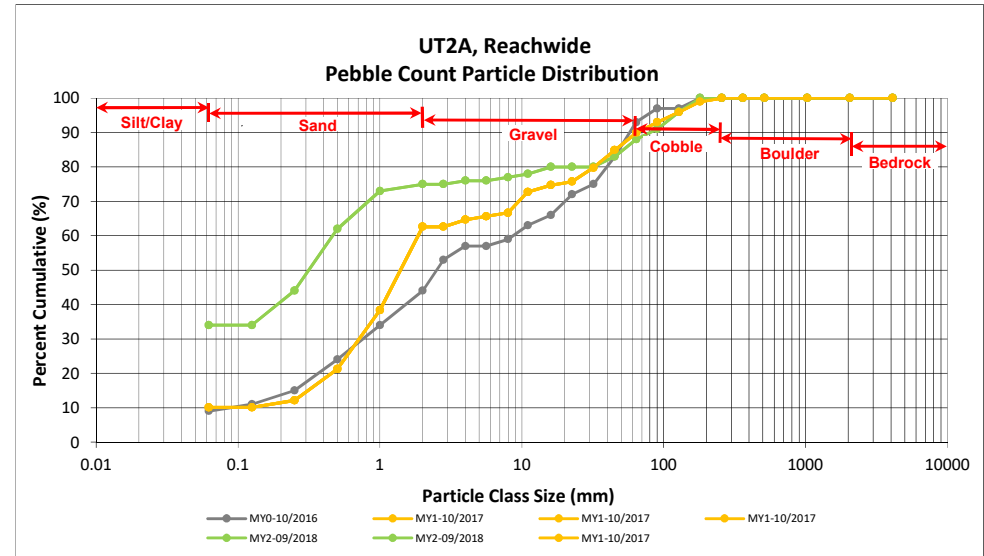
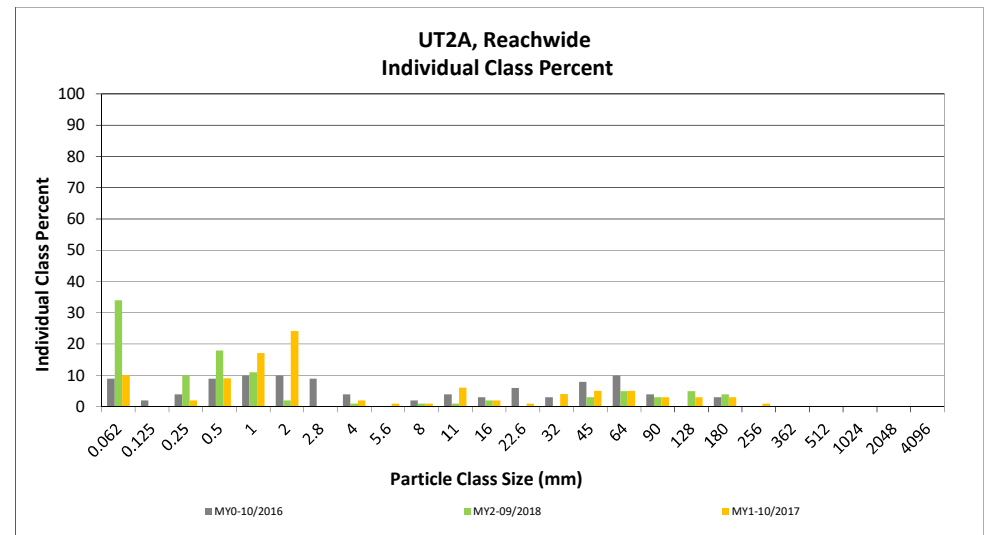
Reachwide Channel materials (mm)	
D <sub>16</sub> =	0.34
D <sub>35</sub> =	0.87
D <sub>50</sub> =	1.4
D <sub>84</sub> =	42.5
D <sub>95</sub> =	114.5
D <sub>100</sub> =	256.0

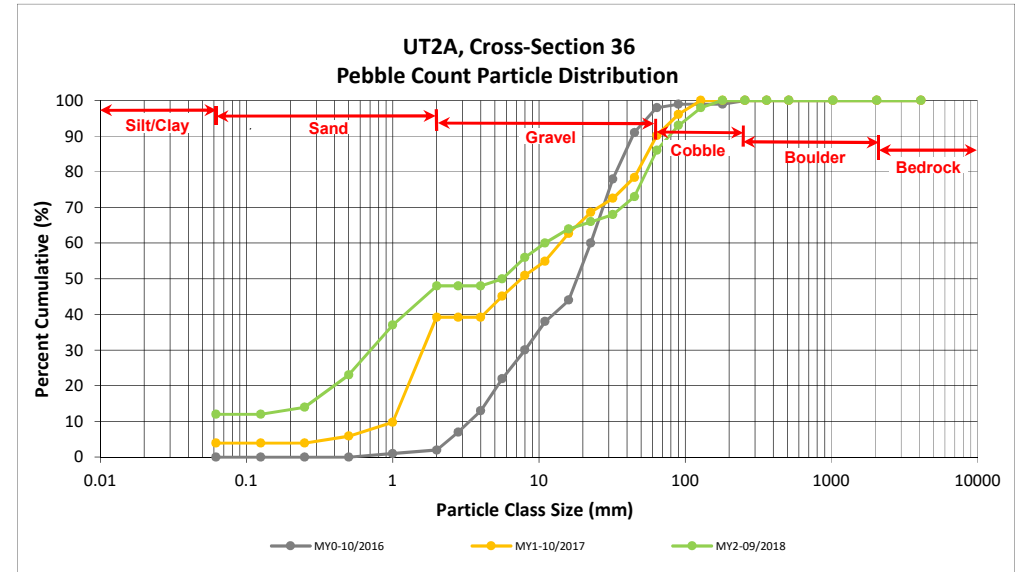
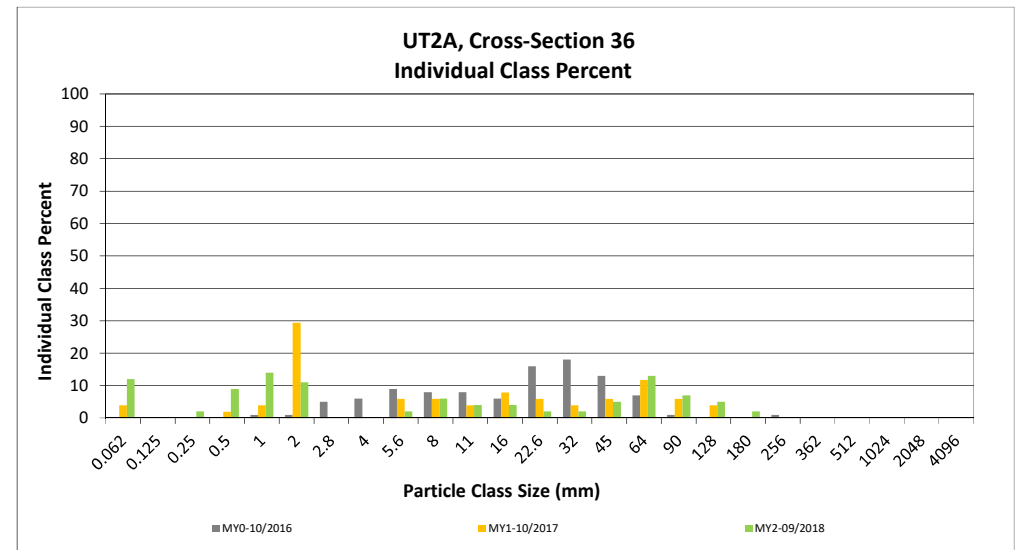
Cross-Section 36	
Channel materials (mm)	
D <sub>16</sub> =	0.29
D <sub>35</sub> =	0.91
D <sub>50</sub> =	5.6
D <sub>84</sub> =	60.6
D <sub>95</sub> =	103.6
D <sub>100</sub> =	180.0
