**YEAR 2 (2009)**  
**ANNUAL MONITORING REPORT**  
**CANE CREEK RESTORATION SITE**  
**RUTHERFORD COUNTY, NORTH CAROLINA**

**(CONTRACT D06027-E)**  
**FULL DELIVERY PROJECT**  
**BROAD RIVER BASIN**  
**CATALOGING UNIT 03050105**

**October 2009**

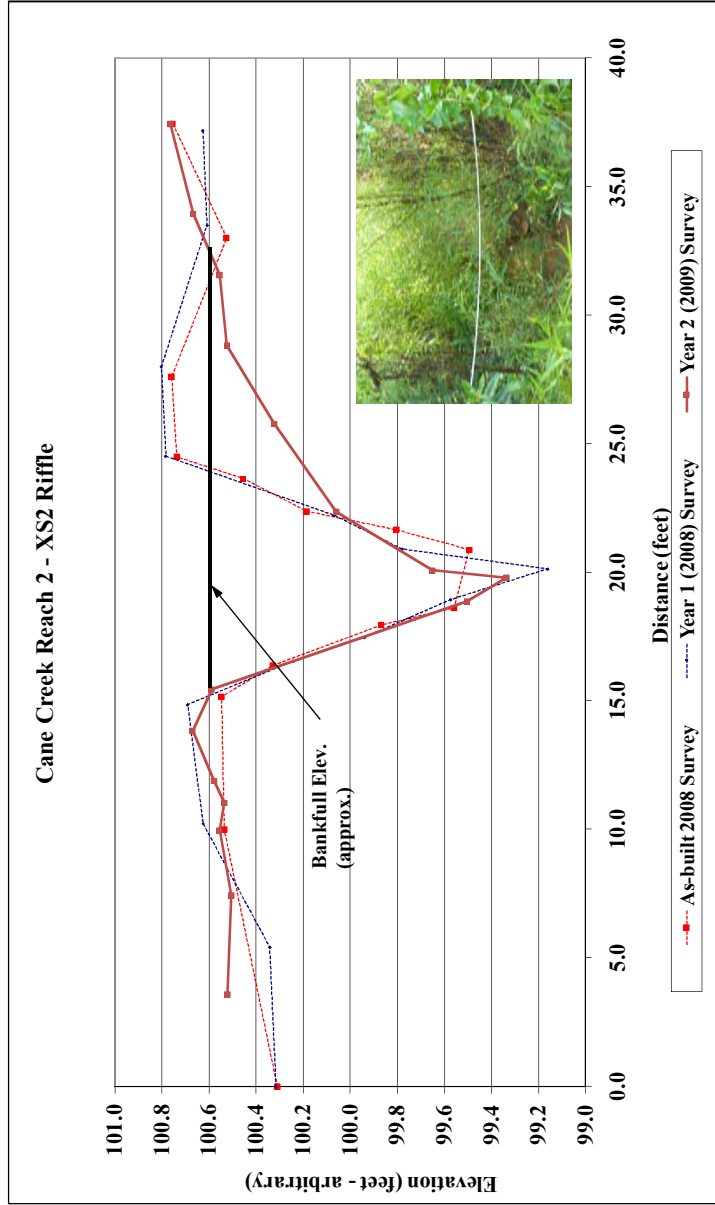
As-built	2008	2009	2010
Area	5.1	6.3	5.9*	
Width	9.2	9.3	13.3*	
Mean Depth	0.6	0.7	0.4*	
Max Depth	1.1	1.5	1.2*	
W/D Ratio	16.5	13.6	29.9*

\* Note: One cross section end point could not be located.

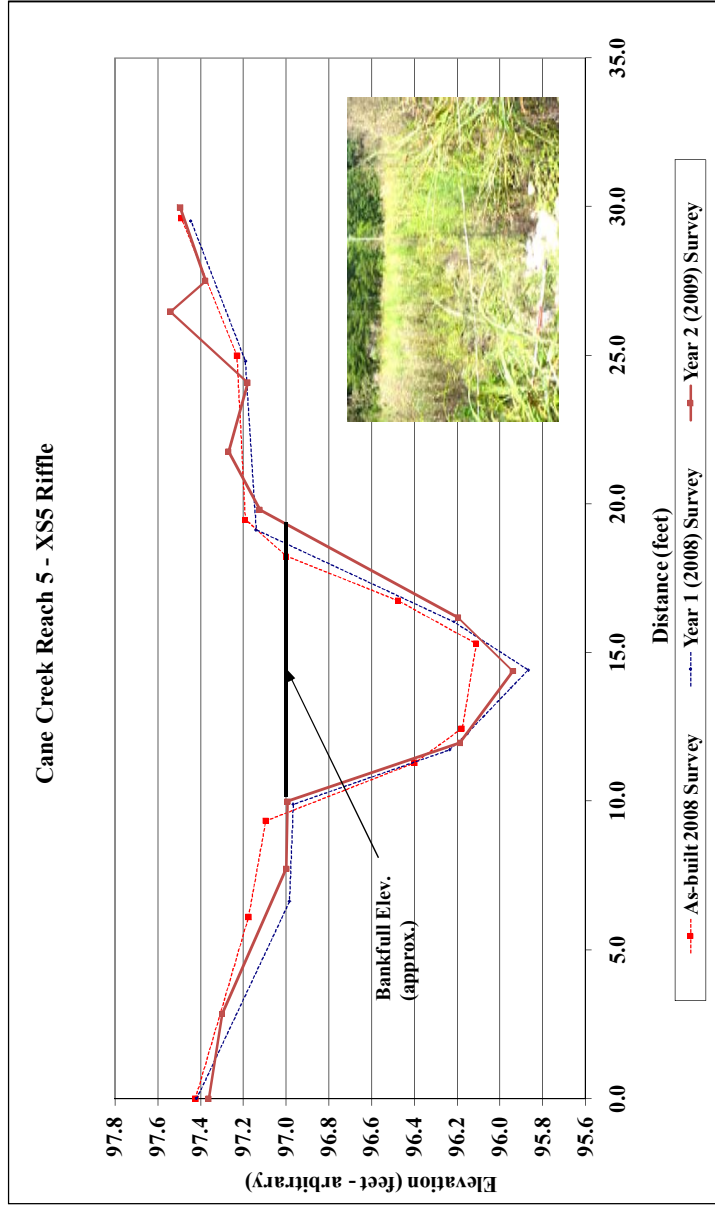
As-built	2008	2009	2010
Area	6.0	5.5	5.9	
Width	9.4	8.6	9.3	
Mean Depth	0.6	0.6	0.6	
Max Depth	1.0	1.1	1.1	
W/D Ratio	14.9	13.4	14.5

Project Name Cane Creek  
 Cross Section R5-XS6  
 Feature Pool  
 Date 8/6/09  
 Crew Adamsme, Perkinson, Dean

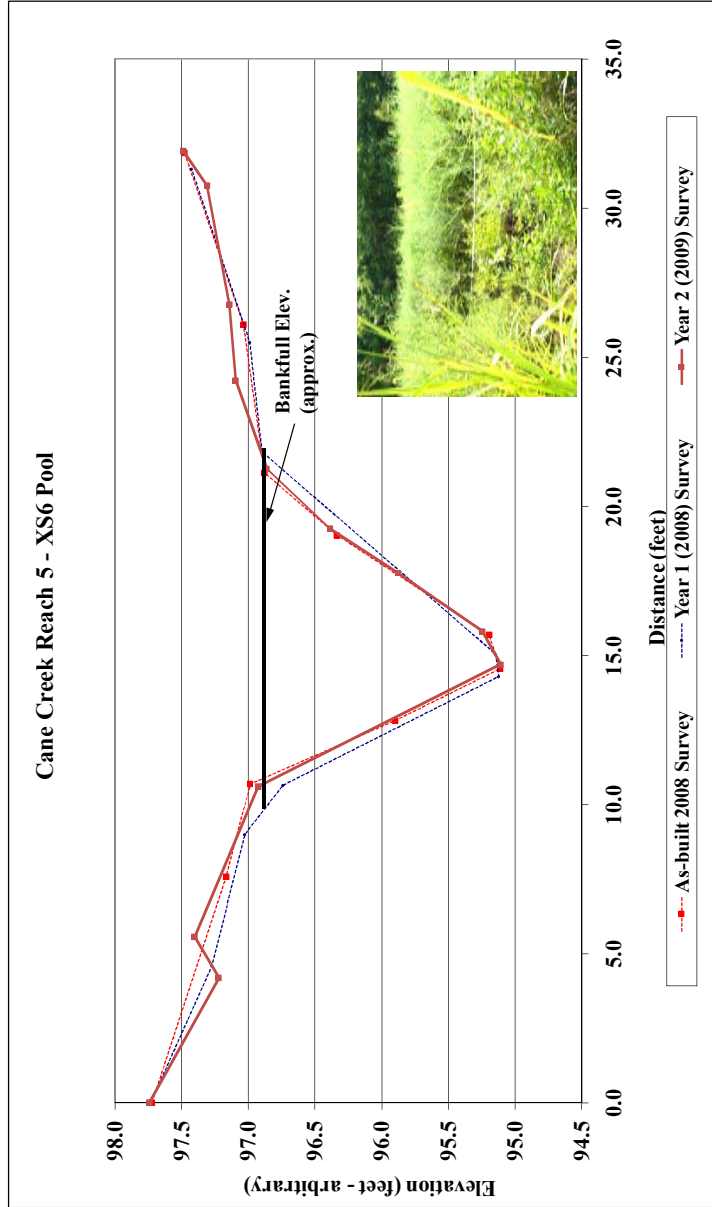
As-built	2008	2009	2010
Area	8.5	10.9	10.2	
Width	9.6	12.1	11.6	
Mean Depth	0.9	0.9	0.9	
Max Depth	1.7	1.8	1.8	
W/D Ratio	NA	NA	NA	NA

<b>Project Name</b> Cane Creek		<b>2008</b>		<b>2009</b>		<b>2010</b>	
<b>Cross Section</b> R5-XS7	<b>Feature</b> Pool	<b>2008 Survey Station</b>	<b>2008 Survey Elevation</b>	<b>2009 Survey Station</b>	<b>2009 Survey Elevation</b>	<b>2010 Survey Station</b>	<b>2010 Survey Elevation</b>
<b>Date</b> 8/6/09	<b>Crew</b> Adams, Perkinson, Dean	0.0	96.7	0.0	96.8		
		6.8	96.7	1.8	96.8		
		10.0	96.7	3.1	96.7		
		13.5	95.7	6.1	96.8		
		17.2	94.9	7.1	96.9		
		18.3	94.8	8.9	96.7		
		20.2	95.7	10.9	96.3		
		22.1	96.7	13.3	95.7		
		29.1	96.5	14.2	95.6		
		34.5	96.4	17.6	94.7		
				21.6	96.6		
				22.1	96.7		
				23.9	96.7		
				26.0	96.6		
				29.6	96.5		
				34.6	96.6

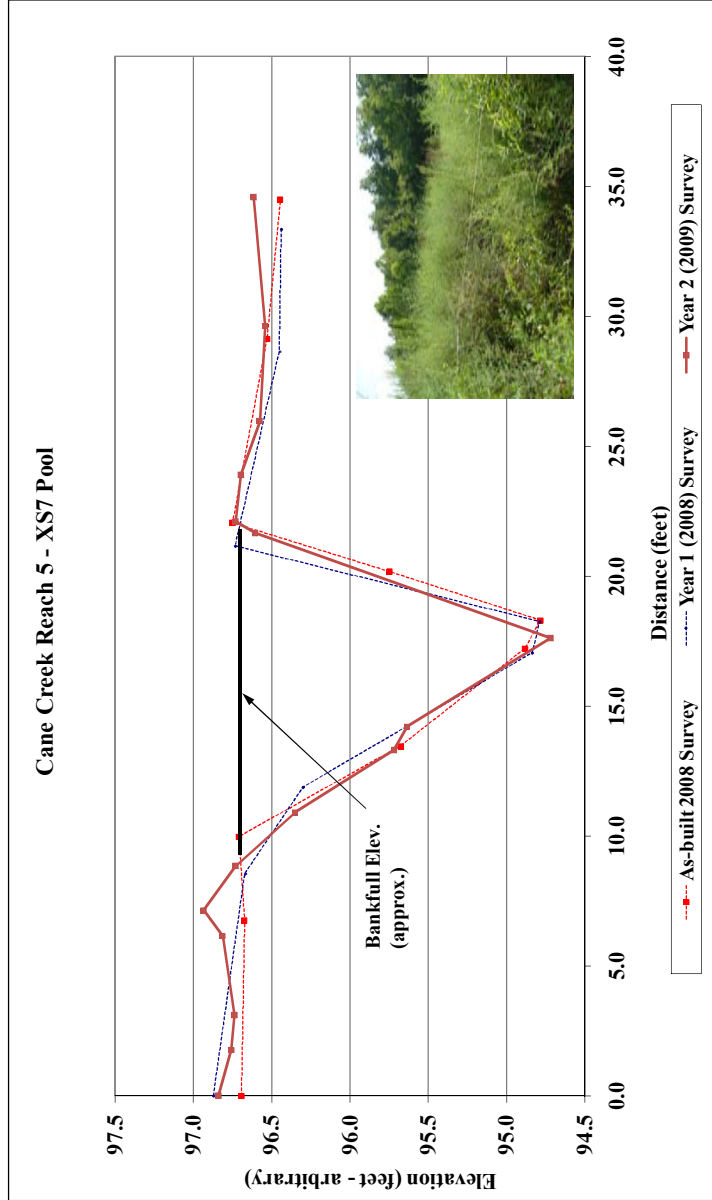
<b>Area</b>	<b>As-built</b>	<b>2008</b>	<b>2009</b>	<b>2010</b>
<b>Width</b>	12.3	11.2	12.5	
<b>Mean Depth</b>	11.8	12.5	13.2	
<b>Max Depth</b>	1.0	0.9	1.0	
<b>W/D Ratio</b>	1.9	1.9	2.0	
	N/A	NA	NA	NA

<b>Project Name</b>	Cane Creek											
<b>Cross Section</b>	R5-XS8											
<b>Feature</b>	Riffle											
<b>Date</b>	8/6/09											
<b>Crew</b>	Adasme, Perkinson, Dean											
	<b>As-built</b>			<b>2008 Survey</b>			<b>2009 Survey</b>			<b>2010 Survey</b>		
	<b>Station</b>	<b>Elevation</b>		<b>Station</b>	<b>Elevation</b>		<b>Station</b>	<b>Elevation</b>		<b>Station</b>	<b>Elevation</b>	
	0.0	96.4		0.0	96.6		0.2	96.5		0.0	96.6	
	7.9	96.0		8.2	96.0		2.1	96.3		10.7	96.0	
	10.6	96.0		10.7	96.0		5.5	96.0		11.7	95.4	
	11.0	95.8		12.3	95.2		10.3	96.0		13.5	95.4	
	12.2	95.3		13.5	95.2		11.7	95.4		14.3	95.2	
	15.6	95.2		14.6	95.4		13.5	95.4		15.5	95.3	
	16.8	95.8		15.7	95.2		14.3	95.2		17.5	96.0	
	17.7	96.0		17.7	96.0		15.5	95.3		19.7	96.1	
	23.4	95.9		20.3	96.0		17.5	96.0		22.1	96.0	
	28.8	96.1		28.7	96.1		24.5	96.0		26.1	96.1	
							28.8	96.3

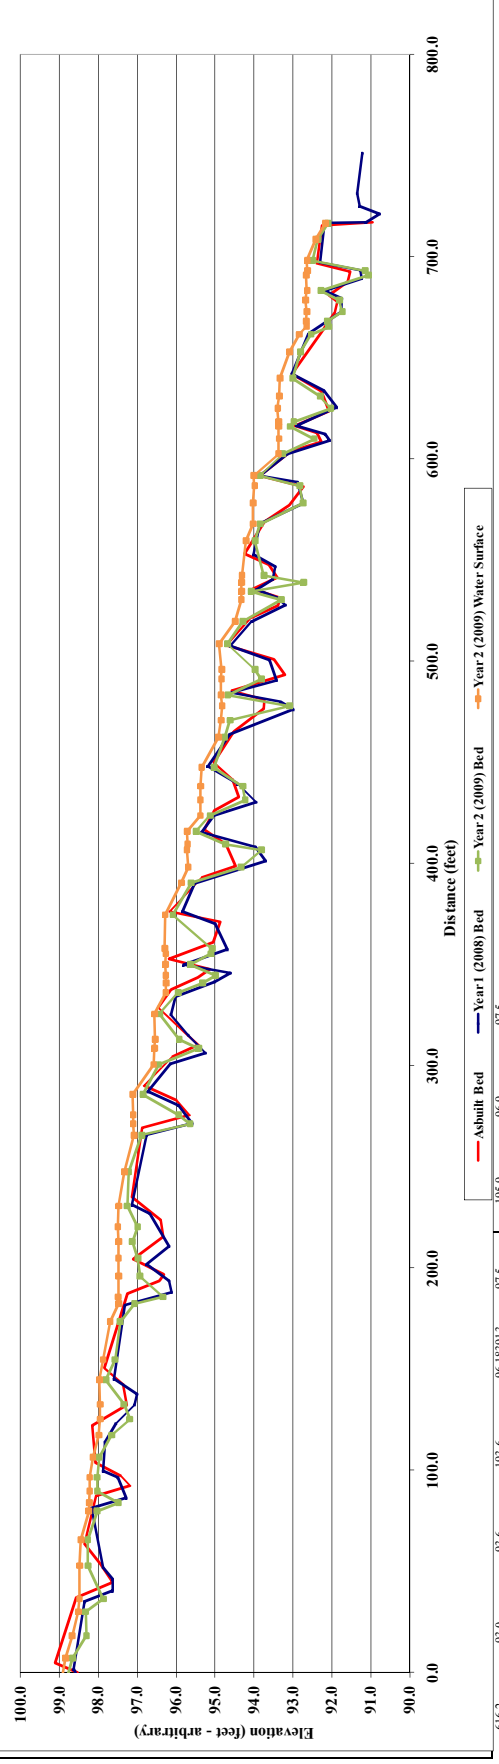
Cane Creek Year 1 Profile - Reach 1

AsBuilt		2008	2009	2010
Avg. Water Surface Slope	0.0092	0.0092	0.0092	0.0092
Riffle Length		19.7	18.6	18.6
Avg. Riffle Slope		0.0263	0.0220	0.0220
Pool Length		33.9	23.9	23.9
Avg. Pool Slope		0.0017	0.0018	0.0018

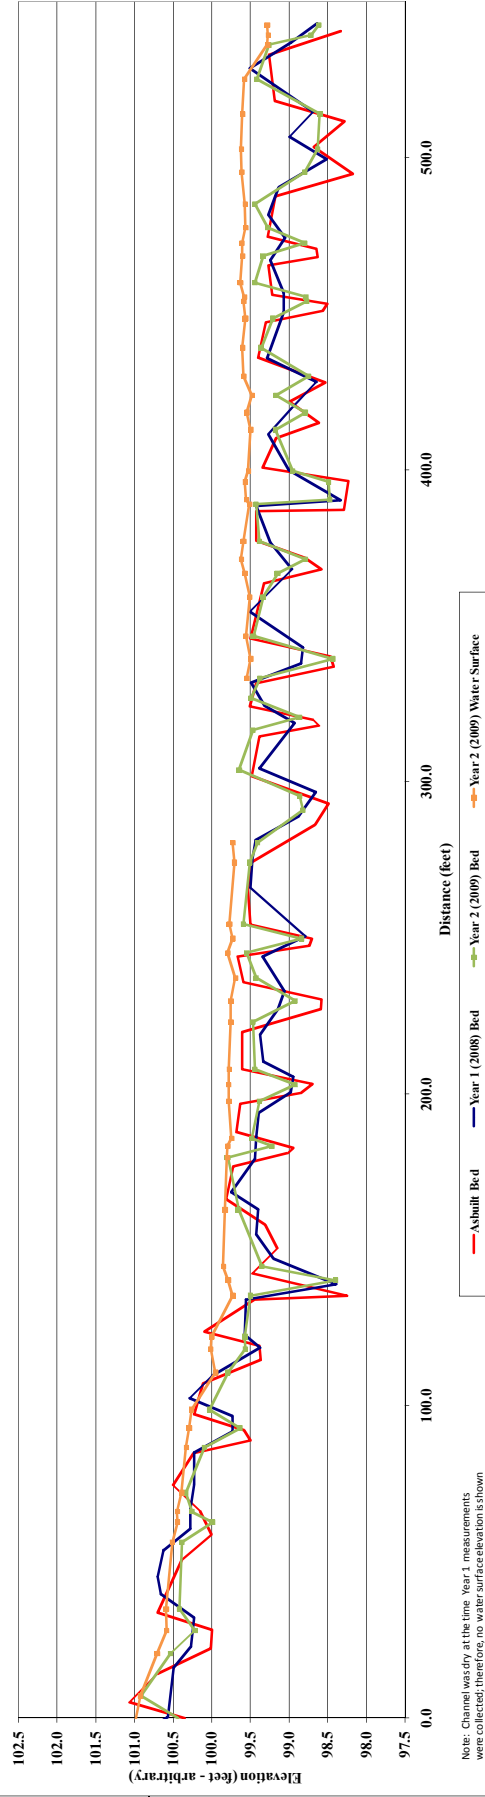
Cane Creek Profile - Reach 2

\* No water in channel due to drought conditions

Note: Channel was dry at the time Year 1 measurements were collected; therefore, no water surface elevation is shown

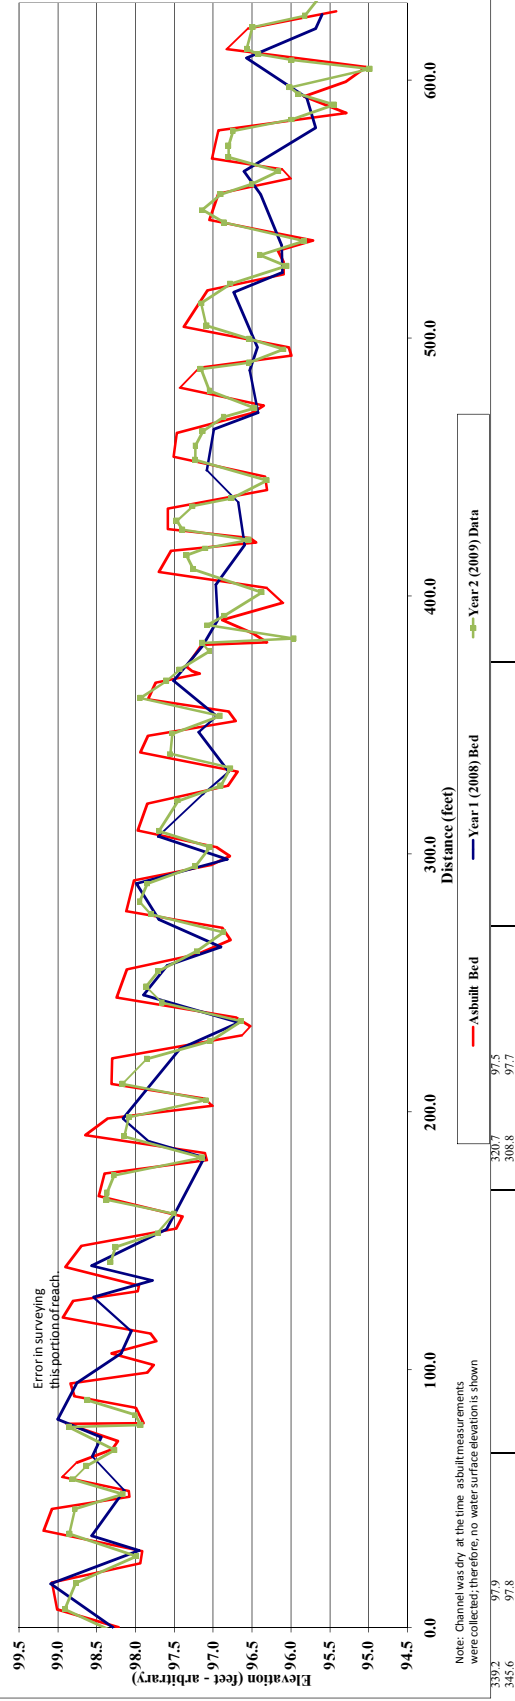
Cane Creek Profile - Reach 3

\* No water in channel due to drought conditions

Note: Channel was dry at the time asbuilt measurements were collected; therefore, no water surface elevation is shown

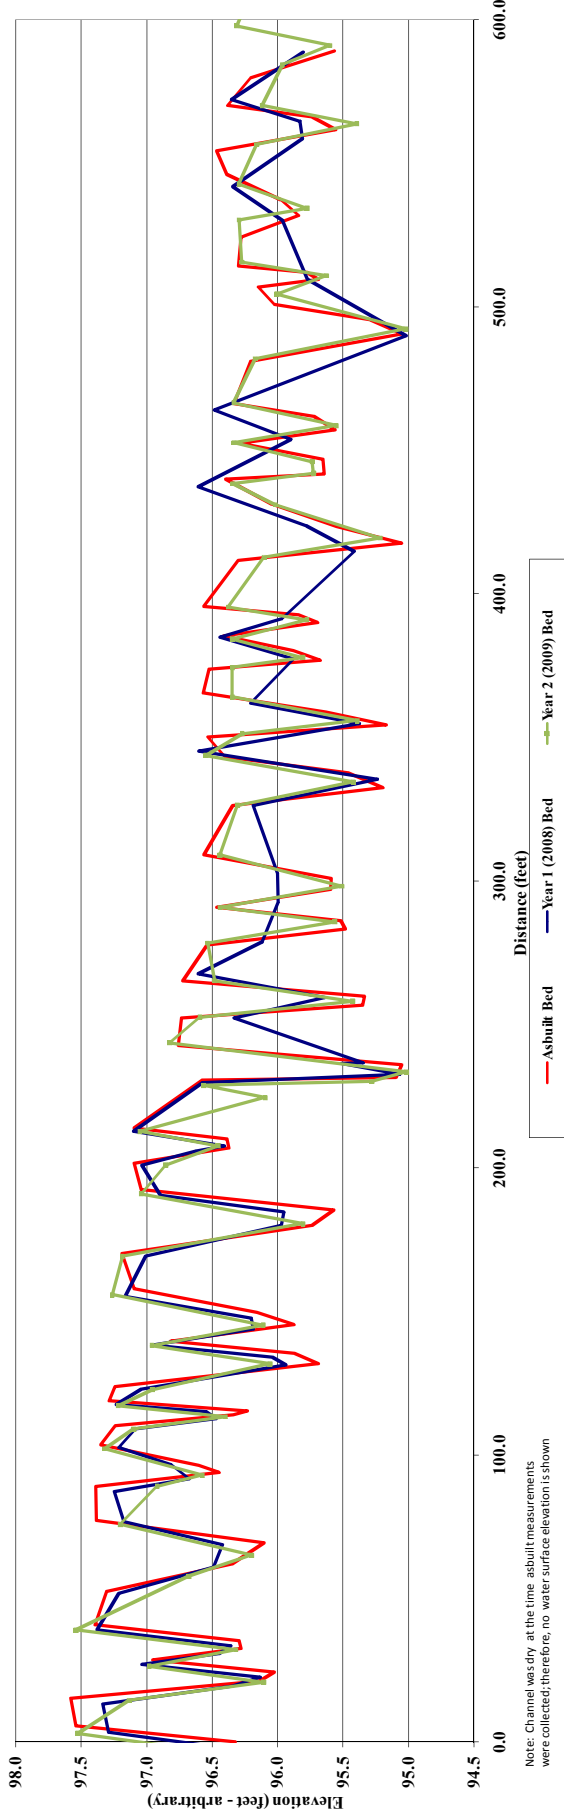
Cane Creek Profile - Reach 4

\* No water in channel due to drought conditions

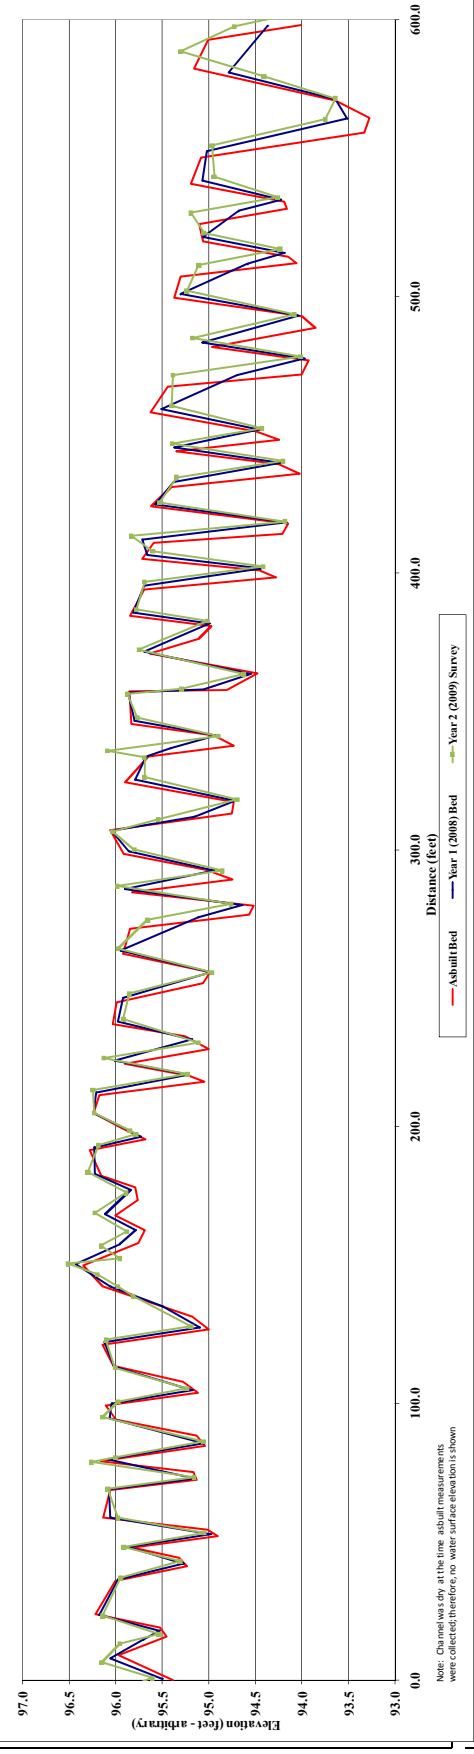
Cane Creek Profile - Reach 5

\* No water in channel due to drought conditions.

Note: Channel was dry at the time asbuilt measurements were collected; therefore, no water surface elevation is shown
