YEAR 3 (2010)
ANNUAL MONITORING REPORT
CANE CREEK RESTORATION SITE
RUTHERFORD COUNTY, NORTH CAROLINA

(CONTRACT D06027-E)
FULL DELIVERY PROJECT
BROAD RIVER BASIN
CATALOGING UNIT 03050105

September 2010

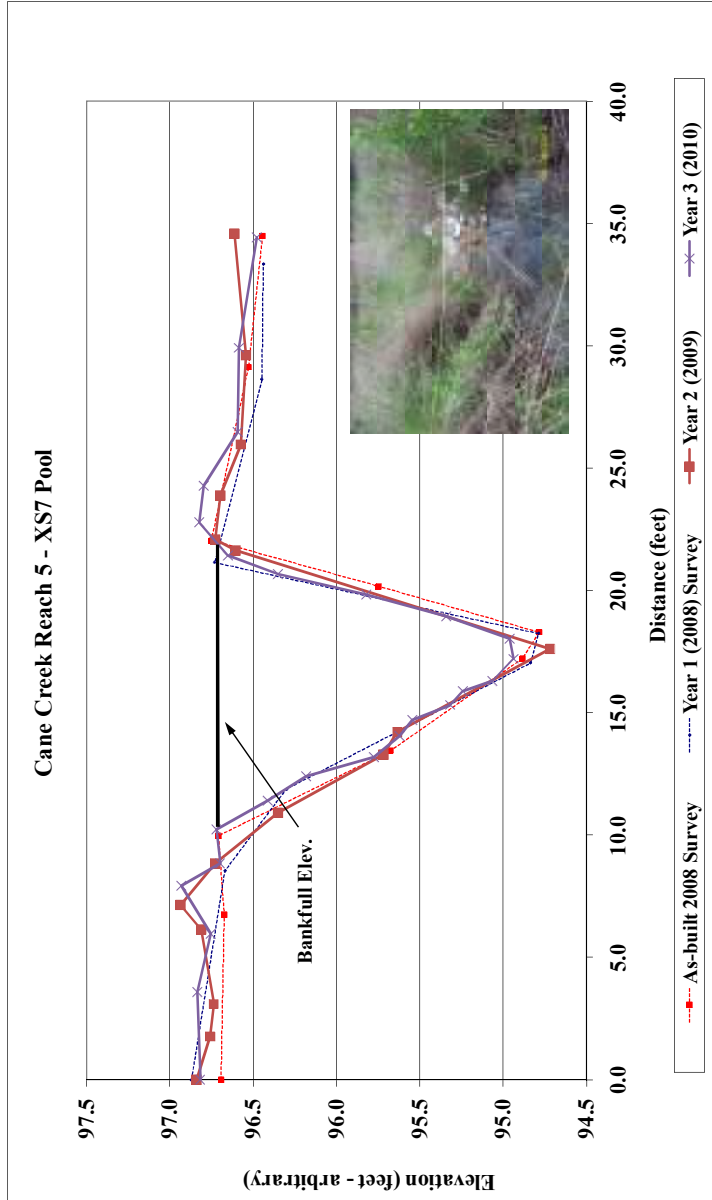
As-built	2008	2009	2010
Area	8.5	10.9	10.2	9.5
Width	9.6	12.1	11.6	10.8
Mean Depth	0.9	0.9	0.9	0.9
Max Depth	1.7	1.8	1.8	1.8
W/D Ratio	NA	NA	NA	NA

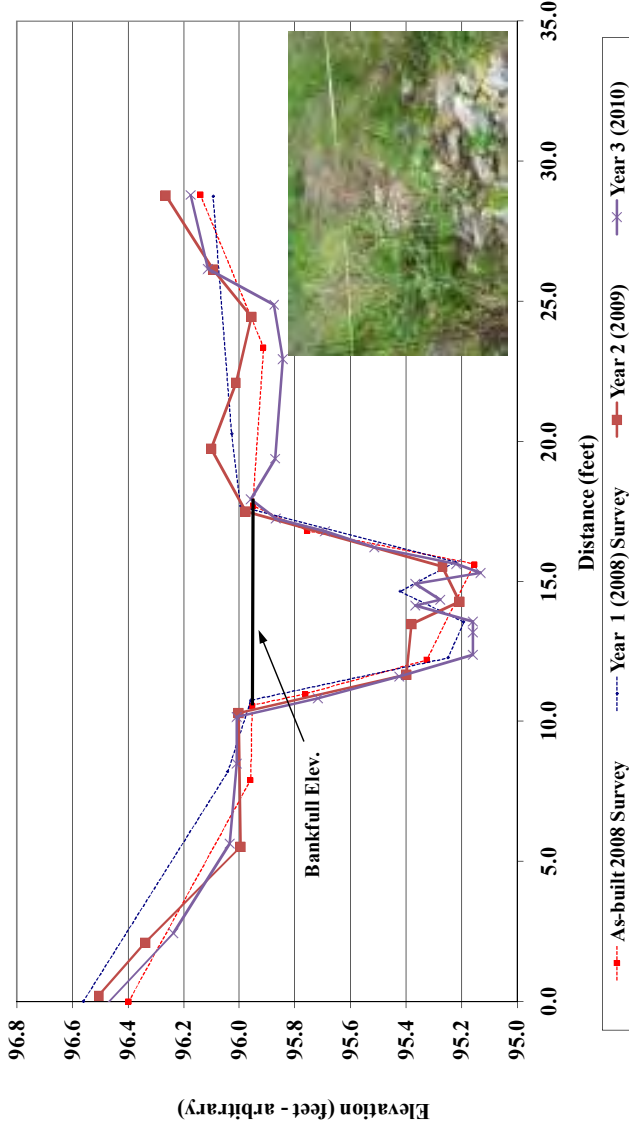
Cane Creek Reach 5 - XS8 Riffle

As-built	2008	2009	2010
Area	3.6	3.6	3.8	3.8
Width	7.1	6.8	7.6	7.6
Mean Depth	0.5	0.5	0.5	0.5
Max Depth	0.8	0.8	0.8	0.8
W/D Ratio	13.9	13.1	15.2	14.9

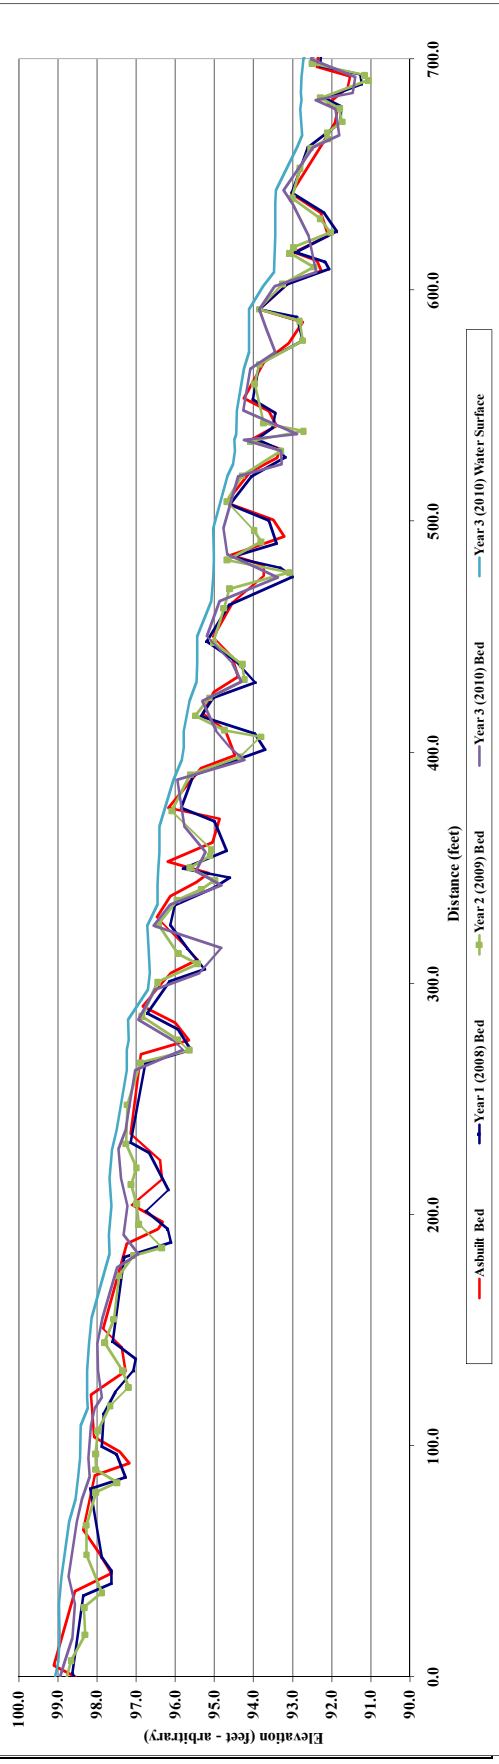
Cane Creek Year 1 Profile - Reach 1

Asphalt	2008	2009	2010
Avg. Water Surface Slope	0.0092	0.0092	0.0091
Riffle Length	20	20	18
Avg. Riffle Slope	0.0263	0.0220	0.0206
Pool Length	34	24	27
Avg. Pool Slope	0.0017	0.0018	0.0038

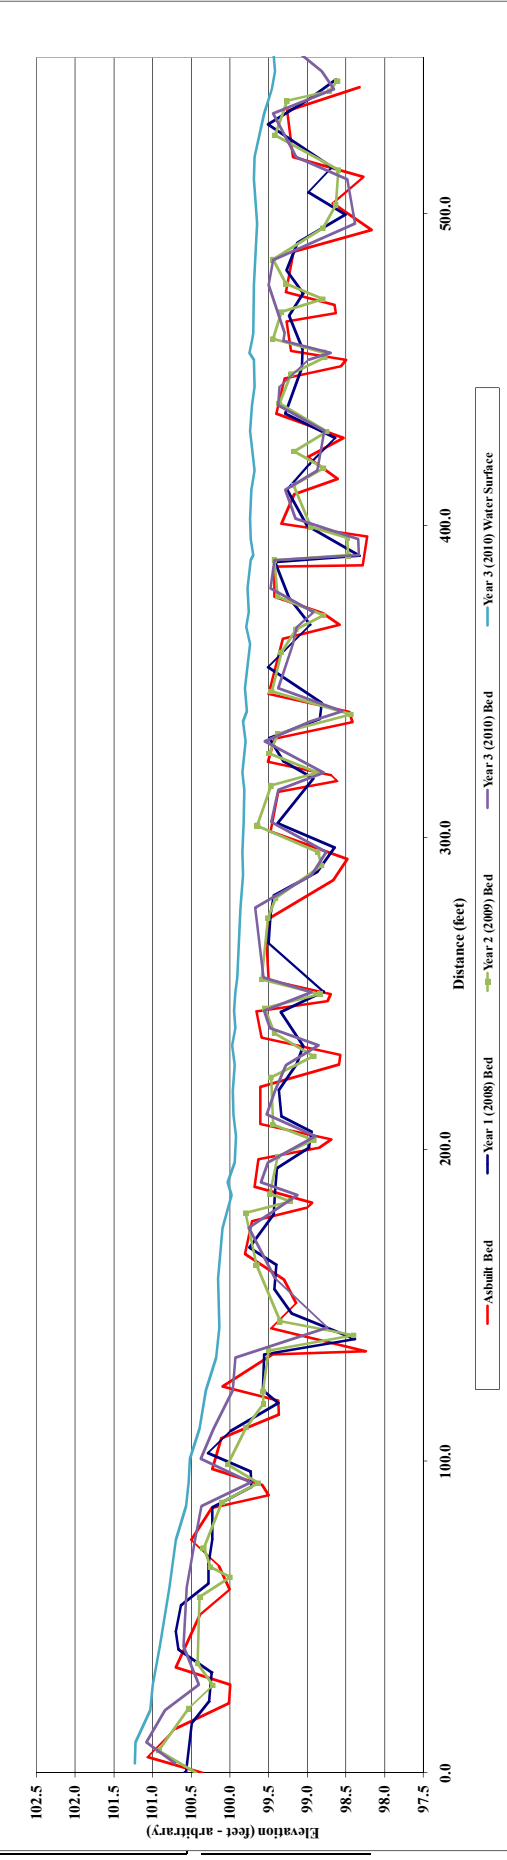
Cane Creek Profile - Reach 2

Asphalt	2008	2009	2010
Avg. Water Surface Slope	0.0036	0.0058	0.0029
Riffle Length	15	13	10
Avg. Riffle Slope	*NA	0.0036	0.0044
Pool Length	18	11	19
Avg. Pool Slope	*NA	0.0002	0.0007

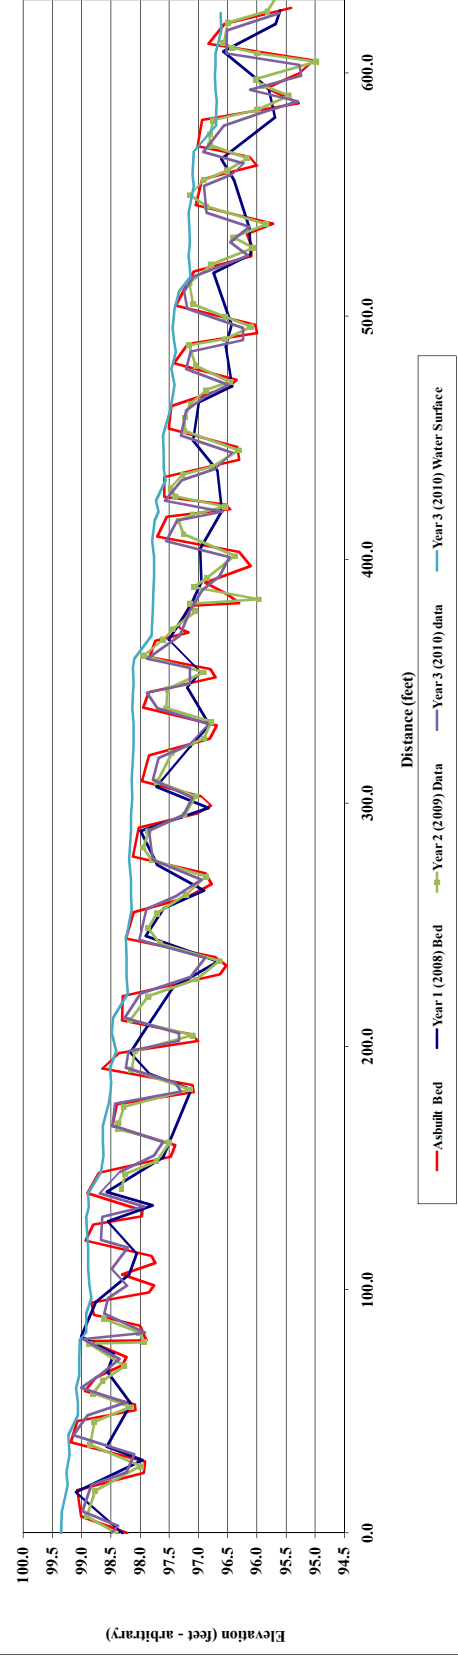
Cane Creek Profile - Reach 3

* No water in channel due to drought conditions

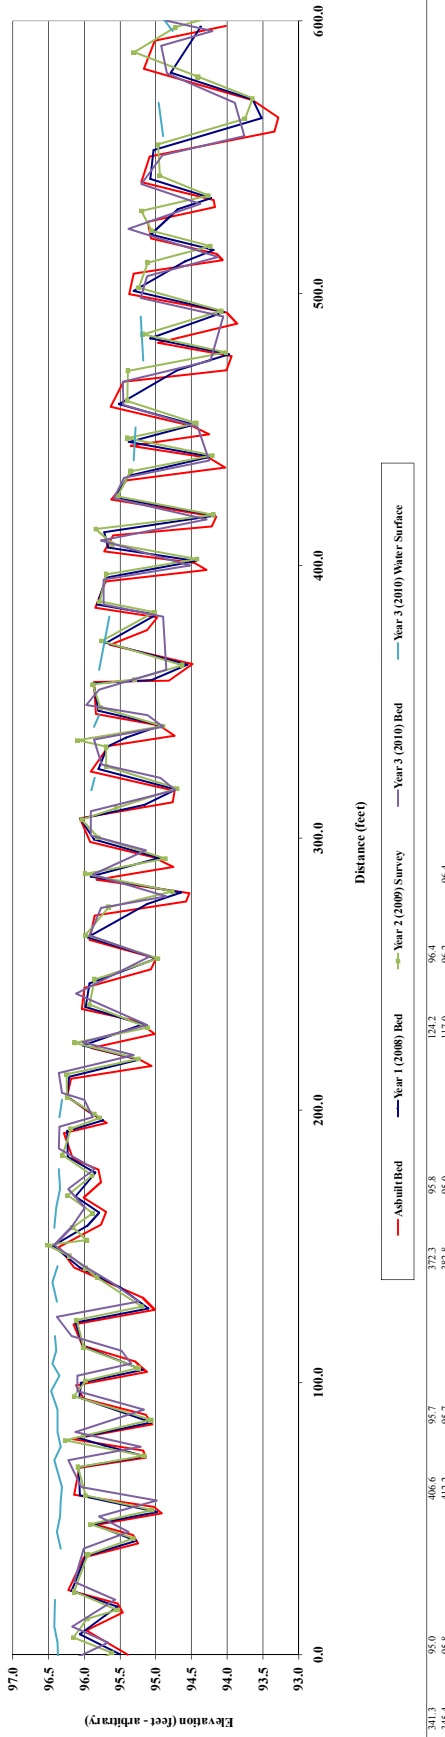
Cane Creek Profile - Reach 5

* No water in channel due to drought conditions.

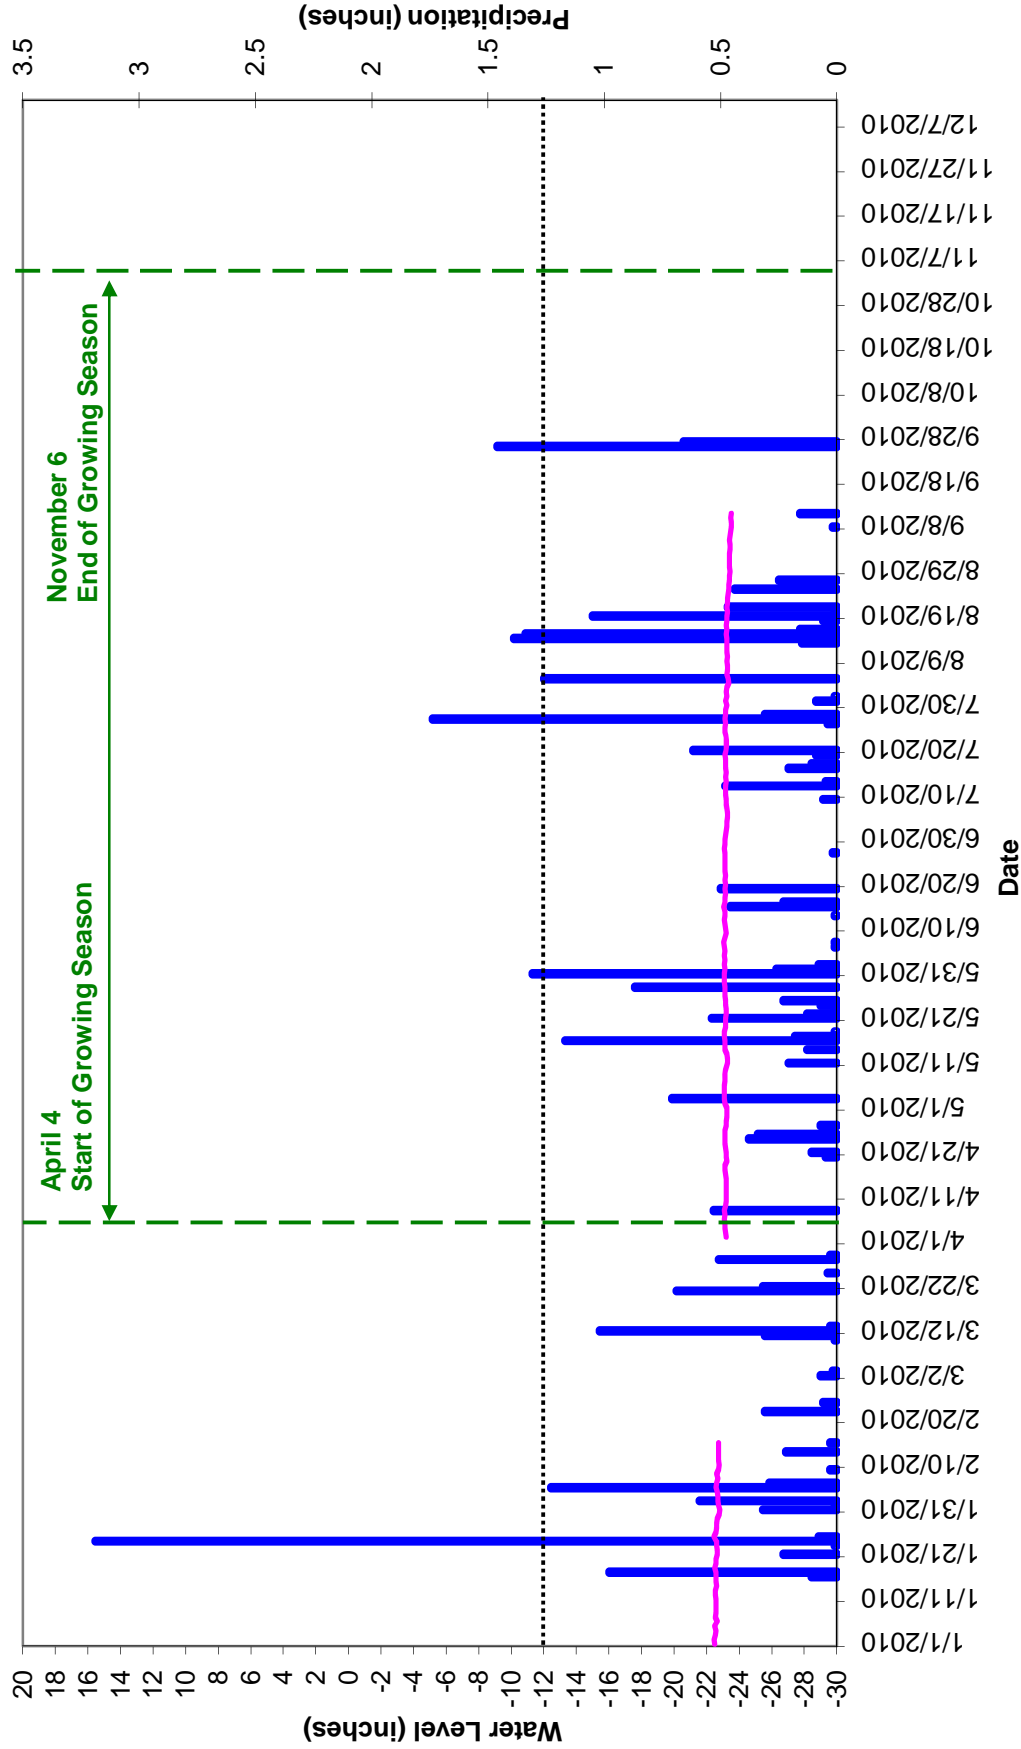
Cane Creek - Groundwater Gauge 1 Year 3 (2010 Data)

None of the five monitored gauges within restoration areas or the reference gauge were inundated/saturated within 12 inches of the surface for greater than 5 percent of the growing season, which extends from April 4 to November 6 (217 days).
