**YEAR 5 (2012)**  
**ANNUAL MONITORING REPORT**  
**CANE CREEK RESTORATION SITE**  
**RUTHERFORD COUNTY, NORTH CAROLINA**

**(CONTRACT D06027-E)**  
**FULL DELIVERY PROJECT**  
**BROAD RIVER BASIN**  
**CATALOGING UNIT 03050105**

**November 2012**

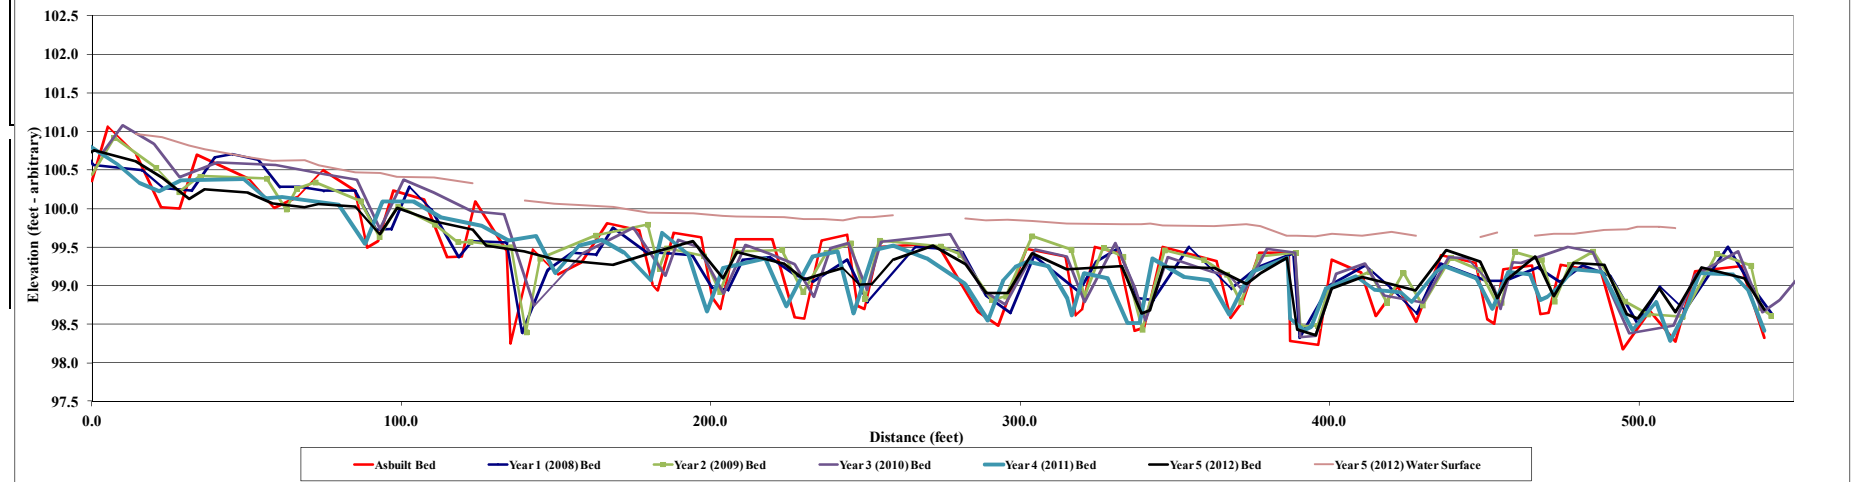
Cane Creek Profile - Reach 2

As-built	2008	2009	2010	2011	2012
Avg. Water Surface Slope	0.0036	0.0058	0.0028	0.0029	0.0030	0.0026
Riffle Length		15	13	10	16	15
Avg. Riffle Slope		*NA	0.0036	0.0044	0.0043	0.0049
Pool Length		18	11	19	15	19
Avg. Pool Slope		*NA	0.0002	0.0007	0.0031	0.0022

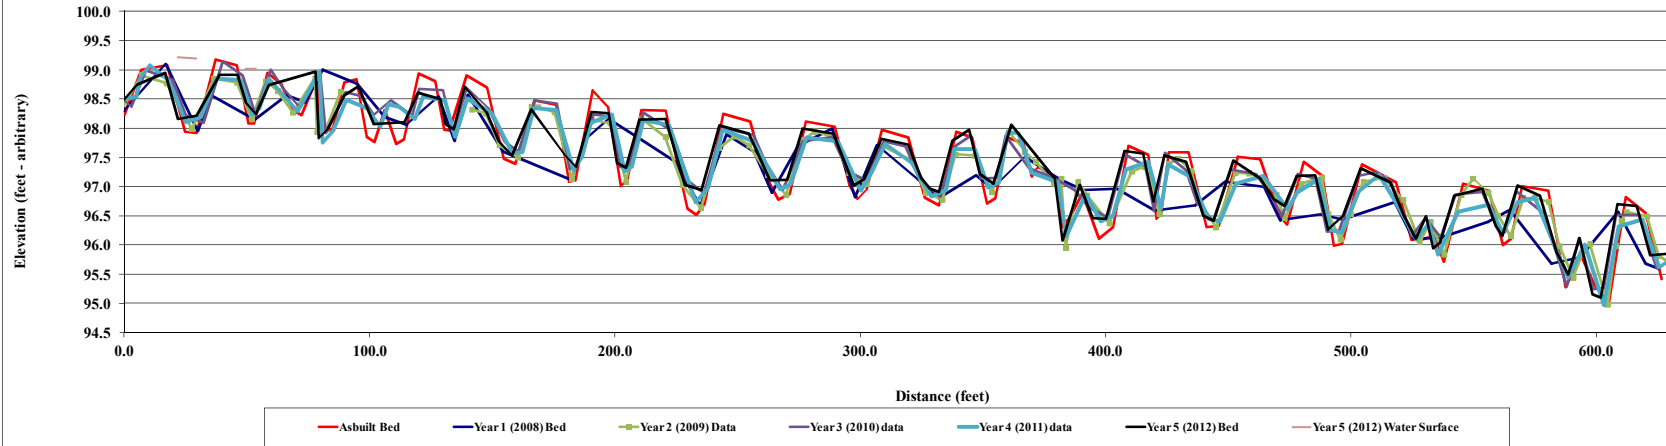
Cane Creek Profile - Reach 3

\* No water in channel due to drought conditions

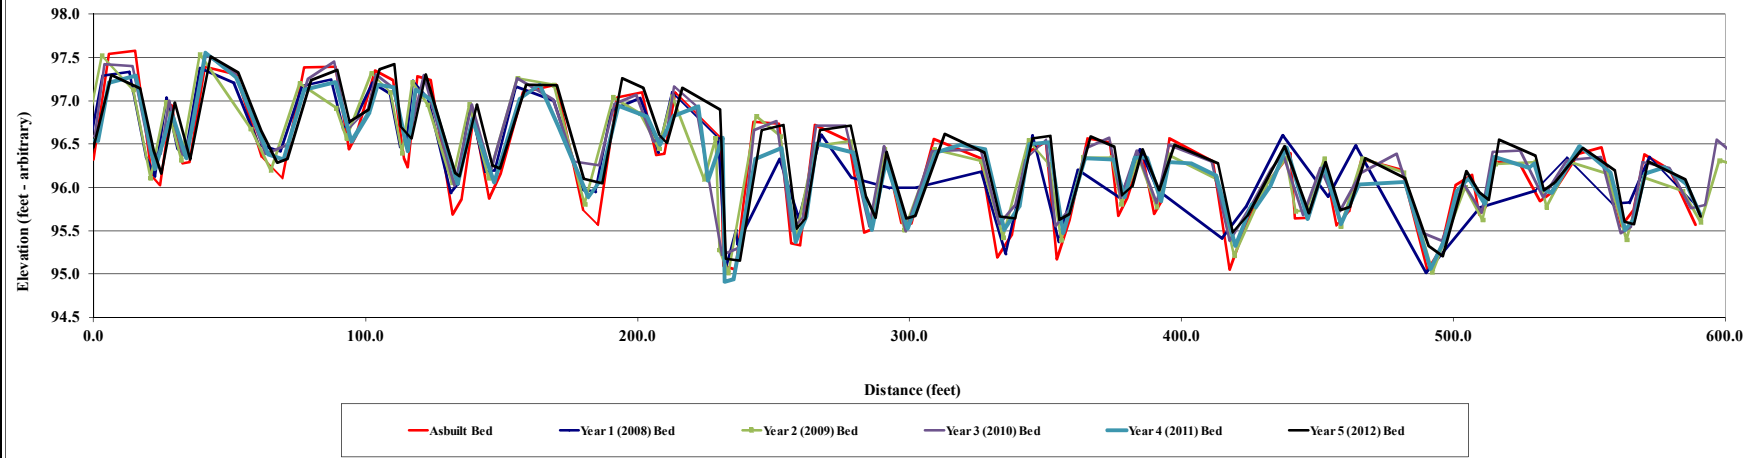
Cane Creek Profile - Reach 4

\* No water in channel due to drought conditions

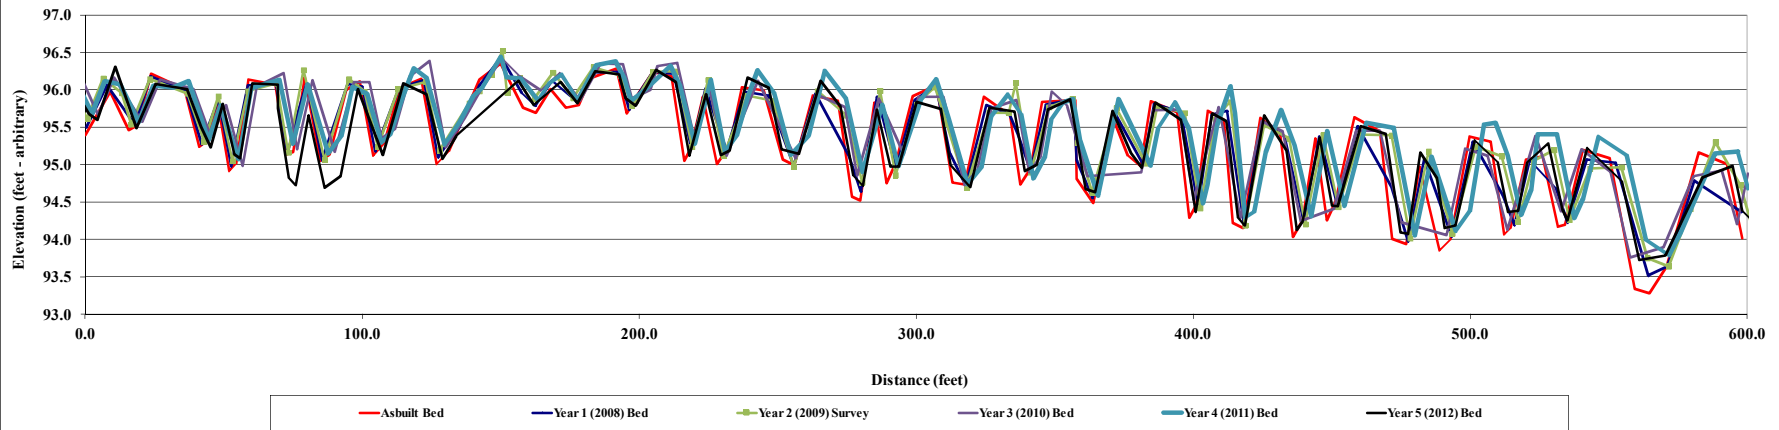
Cane Creek Profile - Reach 5

\* No water in channel due to drought conditions

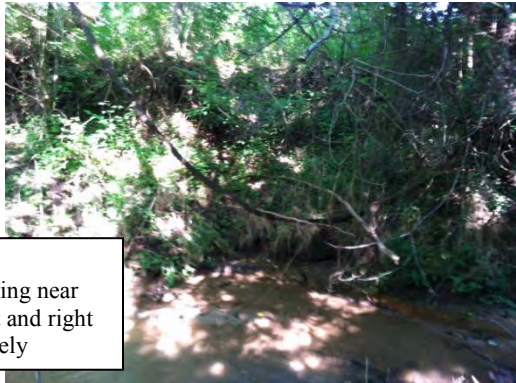
Photos 6-7  
Stabilization and staking near  
downstream end of left and right  
banks, respectively
