MONITORING YEAR 2 ANNUAL REPORT FINAL

CARPENTER BOTTOM MITIGATION SITE

Gaston County, NC
Catawba River Basin
HUC 03050102
(03050103 Expanded Service Area)

DMS Project No. 100090
NC DEQ Contract No. 7731
DMS RFQ No. 16-007133-CT03
Date of Issue: April 24, 2017
USACE Action ID No. SAW-2018-02062
DWR Project No. 2019-0049
Data Collection Dates: January – November 2023

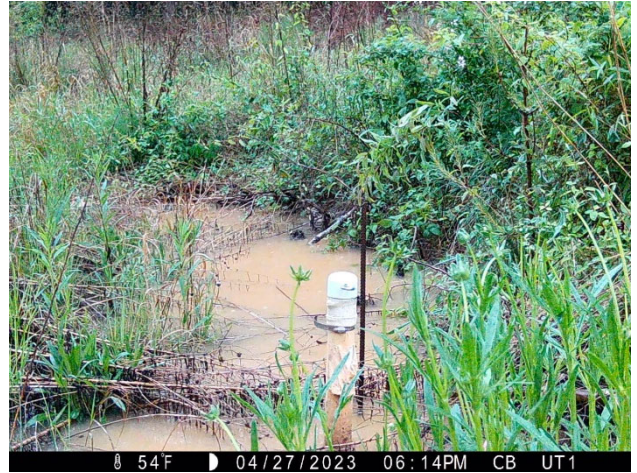
Photo 2 – UT1 – High flow (6PM) just prior to the bankfull event (3AM the following morning) (04/27/2023)

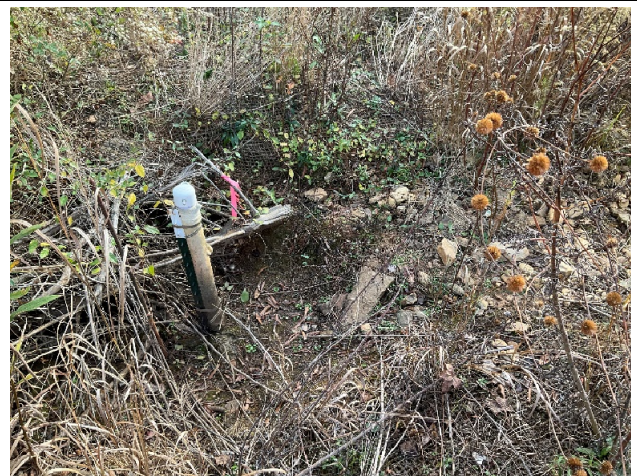
Photo 4 – UT1 – No flow. This photo was taken during a site visit and confirms the water level data shown in the Recorded In-Stream Flow Events Plot (11/14/2023)

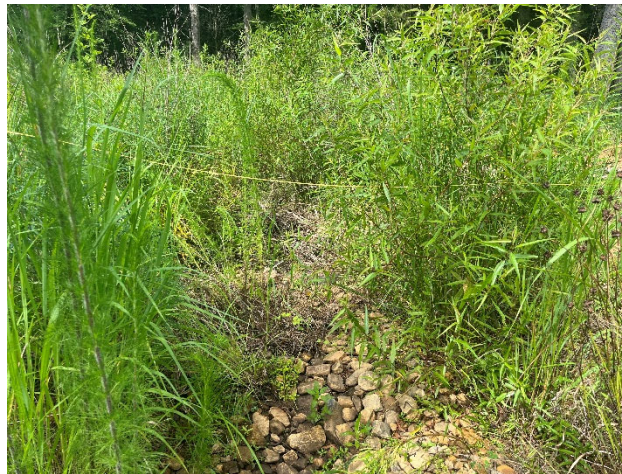
Photo 5 – UT1 – Cross-section photo confirming no flow over the riffle (07/03/2023)
