**As-built report for the Carp Mitigation Site,  
Unnamed Tributary to Laxon Creek,  
Watauga County**

**North Carolina Wildlife Resources Commission**

**May 2001**

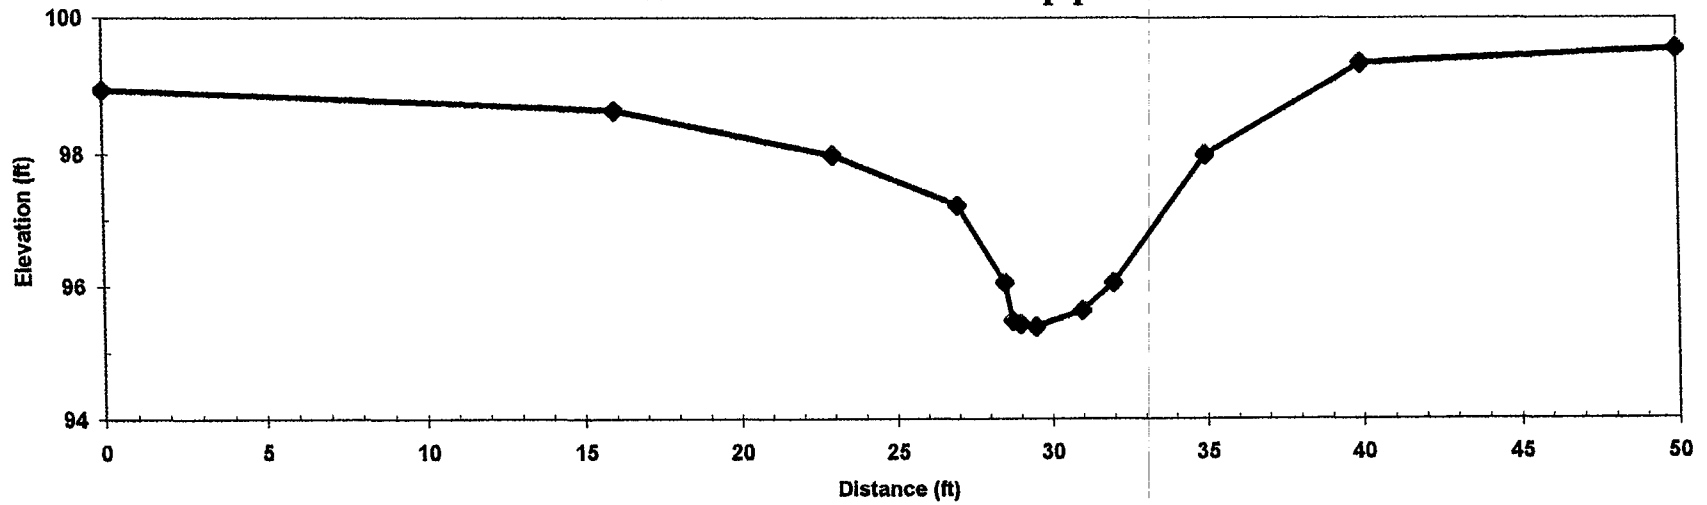
**Figure 6a. Carp - UT Laxon Creek  
Cross Section STN #1+69 Stair step pool**

Figure 6 shows post construction cross-sections of the new channel. These cross-sections will be used to monitor long-term channel stability. Based on data from the riffle cross-section at station 2+24 (Figure 6c), the new channel is classified as a C4e (Table 1).
