Year 3 Monitoring Report

CATBIRD SITE

NCDMS Project #100022 (Contract #7186)
USACE Action ID: SAW-2017-01506
DWR Project #20171039

RE: Catbird Site: Year 3 Monitoring Report (NCDMS ID 100022)

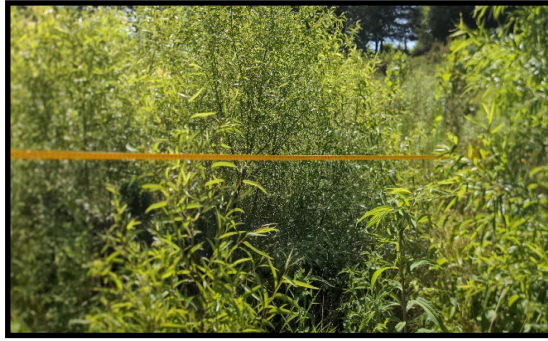
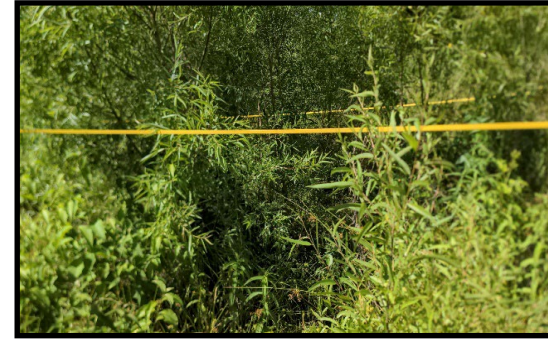
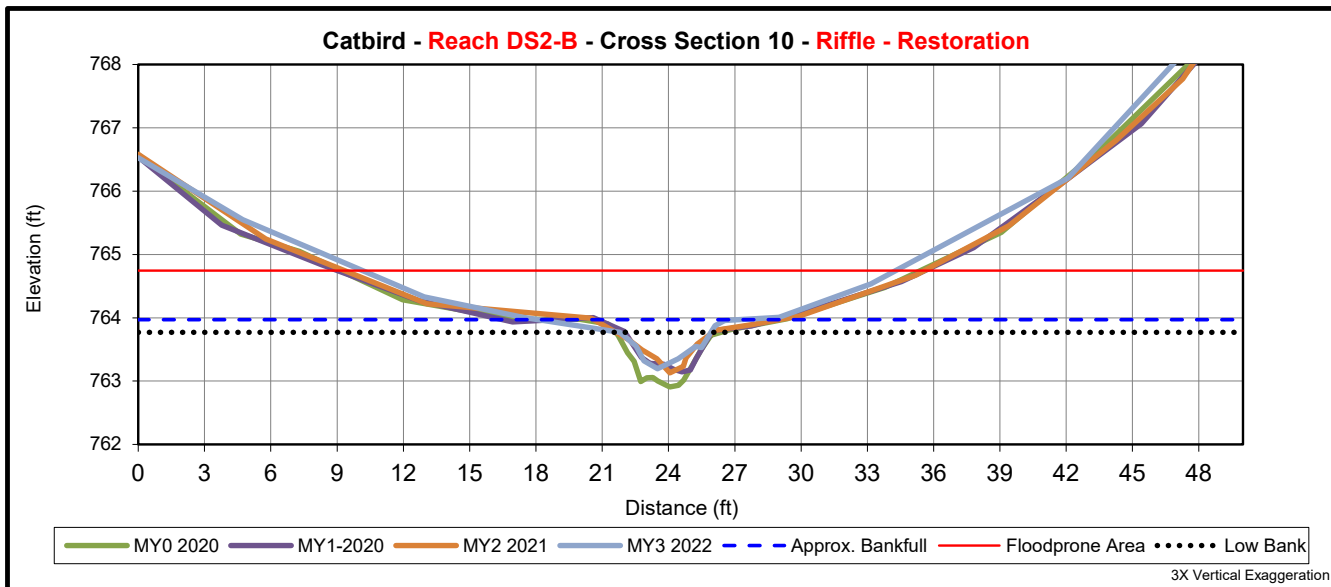
Cross Section 10 (Riffle)						
	MY0	MY1	MY2	MY3	MY5	MY7	MY+
Bankfull Elevation (ft) - Based on AB-XSA¹	763.73	763.9	763.9	764.0			
Bankfull Width (ft) ¹	4.2	4.7	3.5	4.3			
Floodprone Width (ft) ¹	24	25.3	25.8	>24.1			
Bankfull Max Depth (ft) ²	0.8	0.6	0.7	0.6			
Low Bank Elevation (ft)	763.73	763.8	763.8	763.8			
Bankfull Cross Sectional Area (ft ²) ²	2.2	1.7	1.5	1.3			
Bankfull Entrenchment Ratio ¹	11.8	5.4	3.5	5.6			
Bankfull Bank Height Ratio ¹	1.0	0.9	0.8	0.7

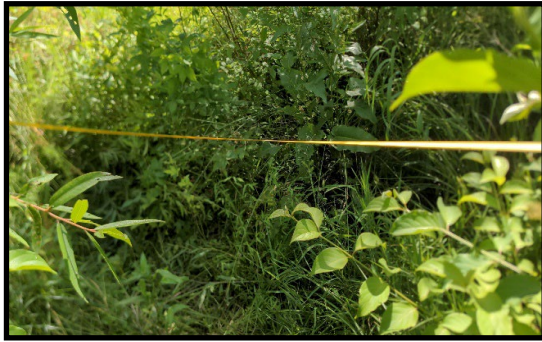
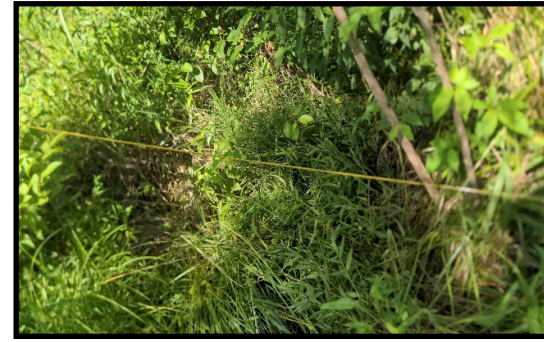
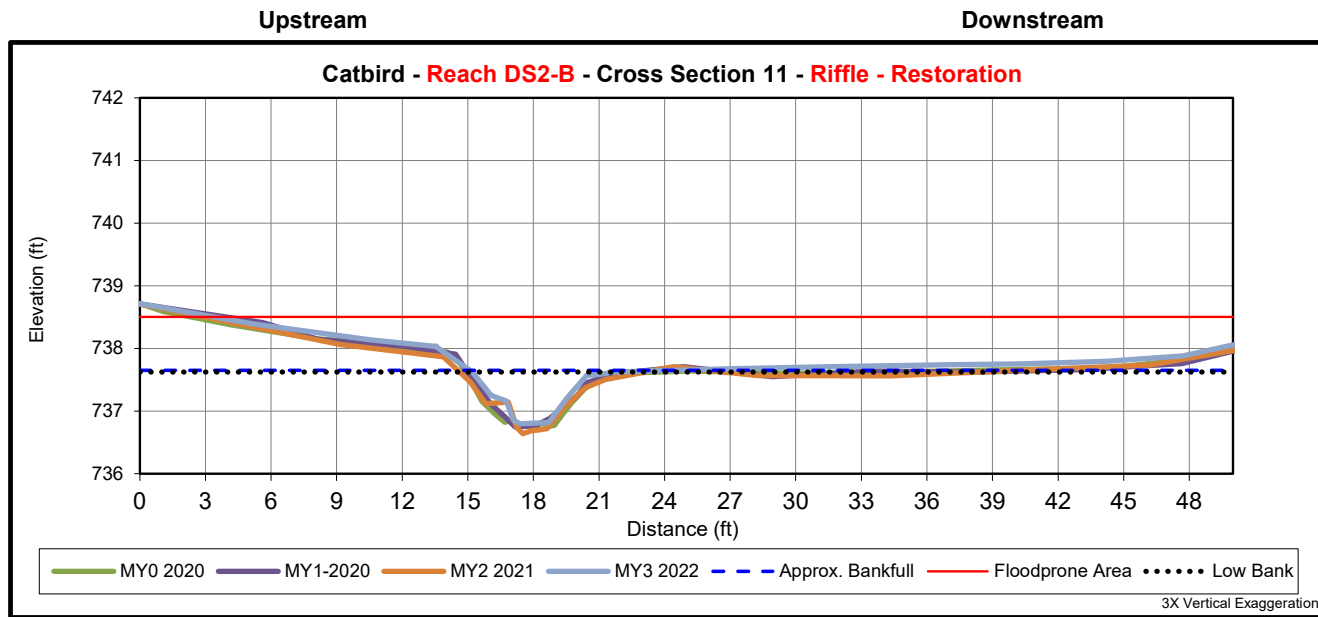
Cross Section 11 (Riffle)						
	MY0	MY1	MY2	MY3	MY5	MY7	MY+
Bankfull Elevation (ft) - Based on AB-XSA¹	737.51	737.6	737.5	737.7			
Bankfull Width (ft) ¹	5.7	5.3	6.8	6.4			
Floodprone Width (ft) ¹	>43.9	>44.2	>46.1	>46.7			
Bankfull Max Depth (ft) ²	0.8	0.7	1.1	0.8			
Low Bank Elevation (ft)	737.51	737.5	737.7	737.6			
Bankfull Cross Sectional Area (ft ²) ²	2.9	2.3	4.4	2.7			
Bankfull Entrenchment Ratio ¹	>8.7	>8.7	>6.8	>7.3			
Bankfull Bank Height Ratio ¹	1.0	0.9	1.2	1.0

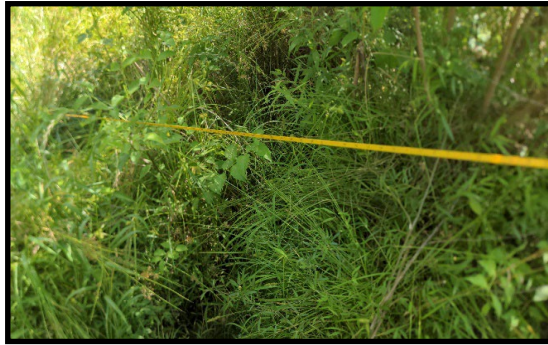
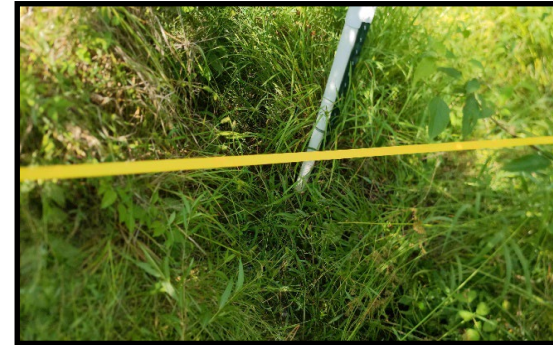
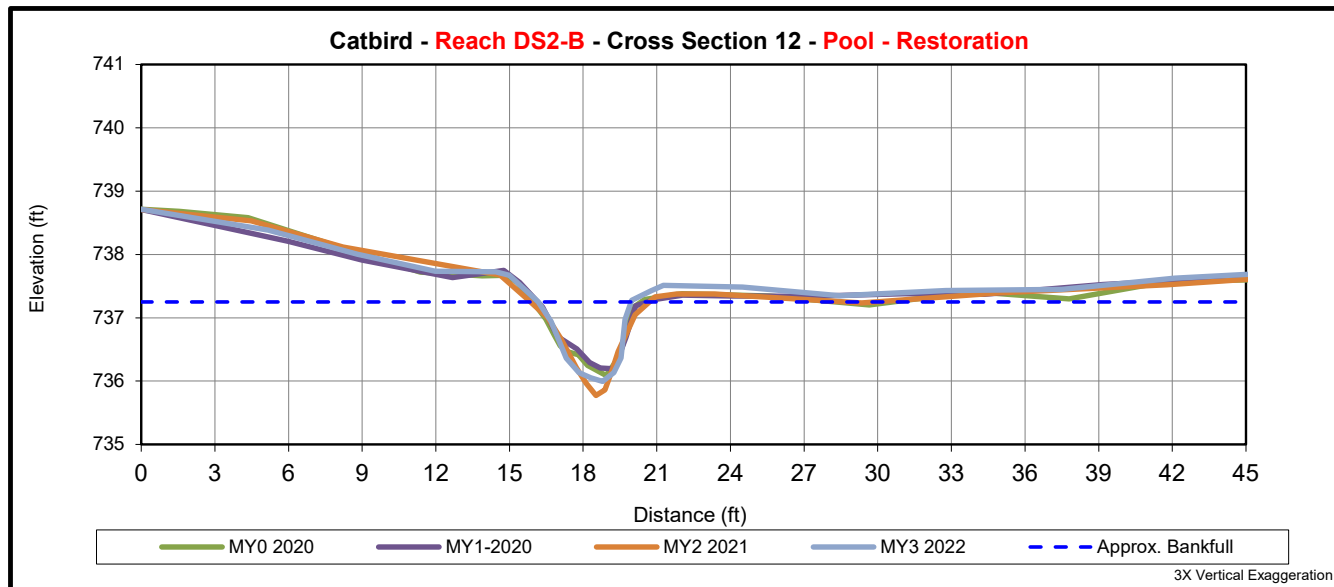
Cross Section 12 (Pool)						
	MY0	MY1	MY2	MY3	MY5	MY7	MY+
Bankfull Elevation (ft) - Based on AB-XSA¹	737.29	737.3	737.2	737.3			
Bankfull Width (ft) ¹	4.6	5.0	4.5	3.8			
Floodprone Width (ft) ¹	-	-	-	-			
Bankfull Max Depth (ft) ²	1.2	0.7	1.6	1.5			
Low Bank Elevation (ft)	737.29	737.3	737.4	737.5			
Bankfull Cross Sectional Area (ft ²) ²	3.1	2.3	4.4	4.3			
Bankfull Entrenchment Ratio ¹	-	-	-	-			
Bankfull Bank Height Ratio ¹	-	-	-	-

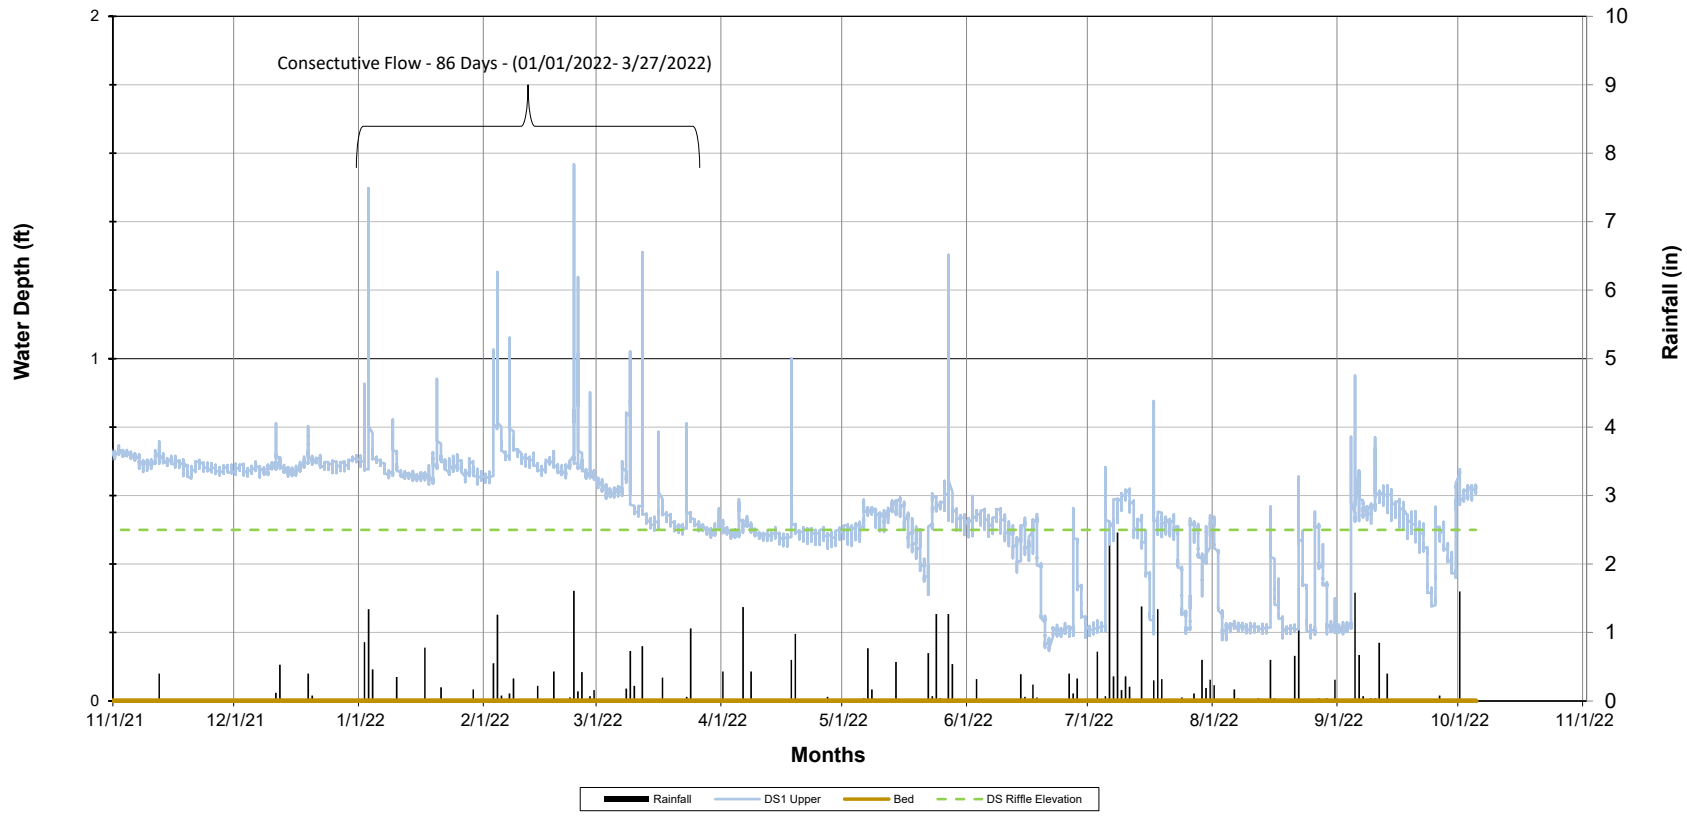
MY3 Catbird Flow Gauge DS1 Upper Stream Flow Hydrograph

Table 13. Documentation of Geomorphically Significant Flow Events			
Year	Number of Bankfull Events	Maximum Bankfull Height (ft above TOB)	Date of Maximum Bankfull Event
Stage Recorder DS1 (Lower)			
MY1 2020	8	0.92	8/15/2020
MY2 2021	16	0.61	5/3/2021
MY3 2022	6	0.36	2/23/2022
Stage Recorder DS2-B (Lower)			
MY1 2020	8	0.62	8/15/2020
MY2 2021	1	0.08	5/3/2021
MY3 2022	4	0.23	2/23/2022
Year	Number of Flow Events	Maximum Consecutive Flow Days	Maximum Cumulative Flow Days
Flow Gauge DS1 (Upper)			
MY1 2020	1	215	215
MY2 2021	1	278	278
MY3 2022	11	86	140
