**Year 4 Monitoring Report**

**CATBIRD SITE**

NCDMS Project #100022 (Contract #7186)  
USACE Action ID: SAW-2017-01506  
DWR Project #20171039

RE: Catbird Site: Year 4 Monitoring Report (NCDMS ID 100022)

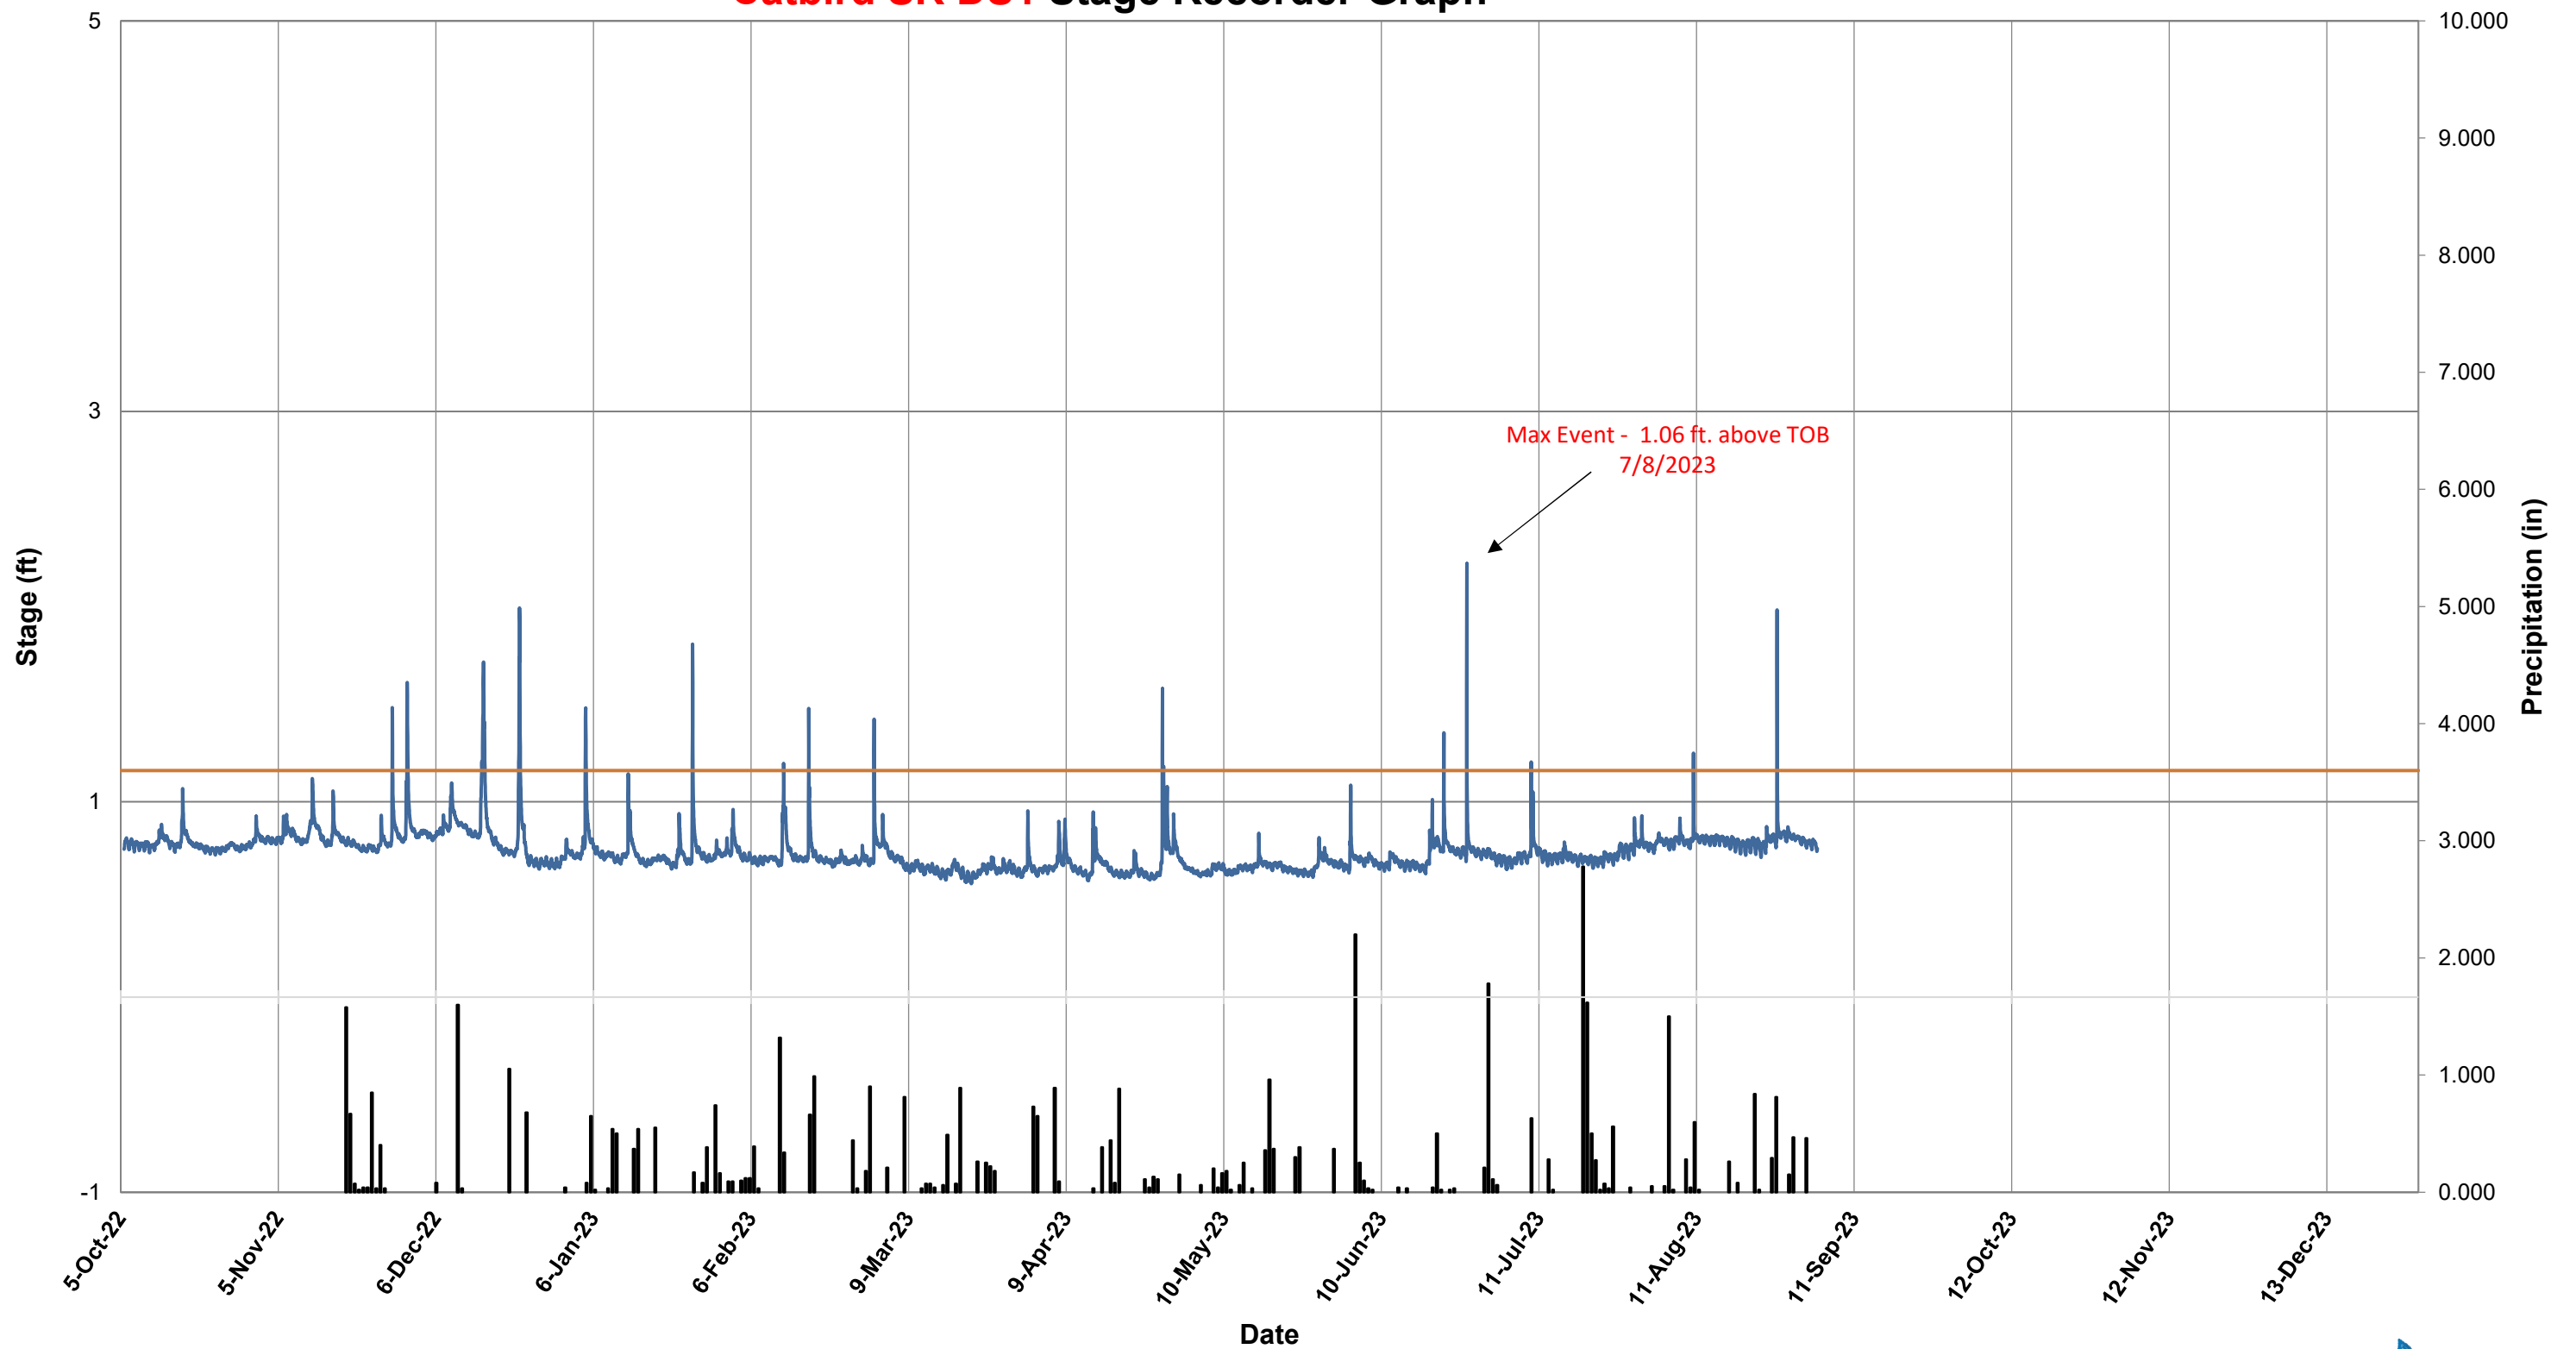
# Catbird SR DS1 Stage Recorder Graph

Two stage recorders and one flow gauge were installed on March 4, 2020: one stage recorder on DS1 (Lower), one stage recorder on DS2-B (Lower), and one flow gauge on DS1 (Upper). The stage recorder on DS1 (Lower) recorded 11 bankfull events in MY4 with the highest reading being 1.06 feet above top of bank. The stage recorder on DS2-B (Lower) recorded four bankfull events with the highest reading being 2.64 feet above top of bank. The flow gauge on DS1 (Upper) recorded two flow events with the longest flow event lasting 165 consecutive days. Gauge locations can be found on Figure 2 and data is located in **Appendix E**.
