MONITORING YEAR 3 ANNUAL REPORT FINAL

CATFISH POND MITIGATION SITE

Durham County, NC
Neuse River Basin
HUC 03020201

DMS Project No. 100039
NCDEQ Contract No. 007424
NCDWR Project No. 2018-0196
USACE Action ID No. 2018-00424
Data Collection Dates: January - November 2022

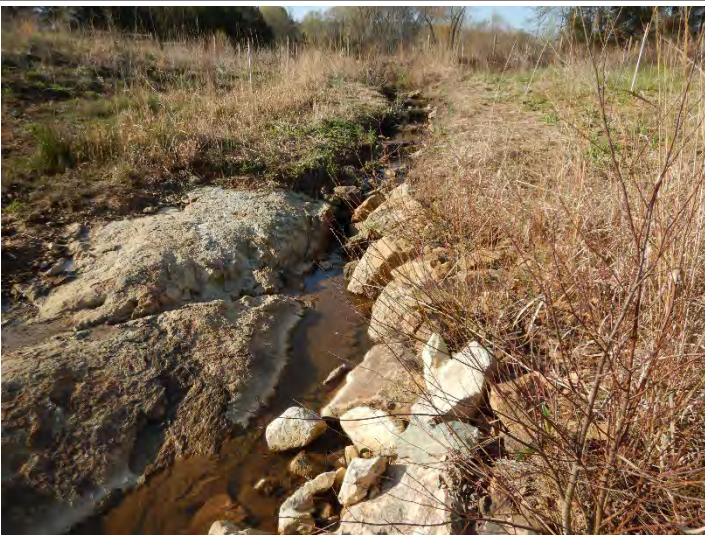
PHOTO POINT 15 UT1 R3 – upstream (04/05/2022)

The repairs around cross-section 7 on UT1 Reach 3 seem to be stable and holding up well. Cross-section 7 has deepened slightly, which is to be expected in a step pool system, but no significant changes have occurred. Wildlands will continue to observe this reach to confirm stability.

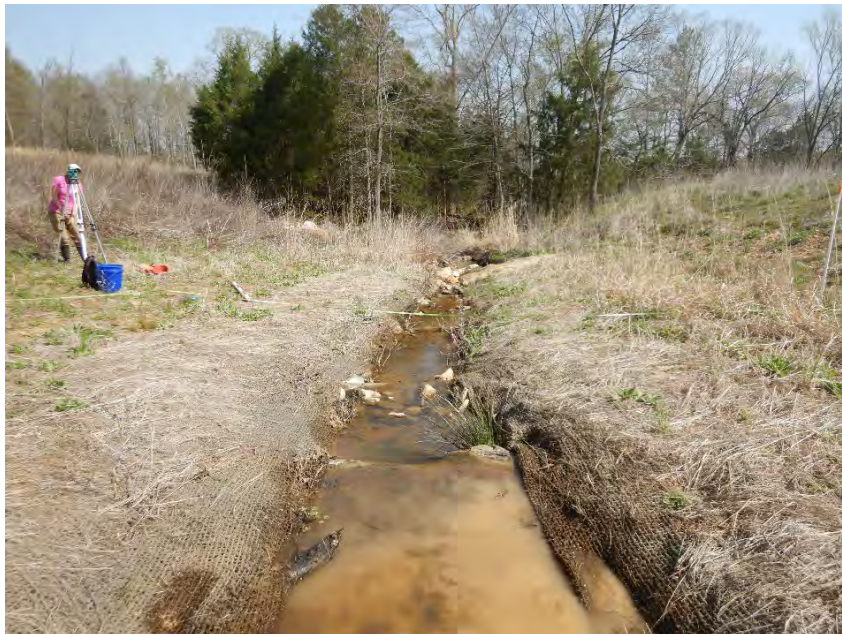
Downstream (4/5/2022)

Cross-section 7 on UT1 Reach 3 is now stable. After repairs, this reach is a step pool system with short riffles and longer glides. This leaves cross-section 7 in a step pool glide, rather than a typical riffle in a C type stream channel. The MY2 and MY3 “Bank Height Ratio – Based on AB-Bankfull Area” in the Cross-Section Plot table and Table 9 (Appendix C) are based on the bankfull area of the channel after repairs were completed in MY2. The repairs changed the channels dimensions, so the low top of bank elevation

and the cross-sectional area are no longer comparable to the MY0 AB-Bankfull Elevation or BHR. When the MY3 cross-section 7 graph is compared to the repaired channel in MY2, it has not changed significantly. The Bank Height Ratio is less than 1.2 and the entrenchment ratio is over 2.2.

MY0	MY1	MY2*	MY3	MY5	MY7
Bankfull Elevation - Based on AB-Bankfull Area	442.36	442.40	442.20	442.06		
Bank Height Ratio - Based on AB-Bankfull Area	1.00	0.97	1.00	1.07		
Thalweg Elevation	440.83	440.87	440.64	440.34		
LTOB Elevation	442.36	442.34	442.20	442.17		
LTOB Max Depth	1.53	1.47	1.56	1.83		
LTOB Cross-Sectional Area	5.39	5.07	7.06	8.02

*Repairs during MY2 changed channel dimensions along this reach. MY2-7 calculations and the graph above are based off the MY2 repaired channel because they are no longer comparable to MY0-1.
