UT to Clark Creek at Cato Farms Stream Restoration Annual Monitoring Report

Monitoring Year: 2005

NCEEP Project Number: 072

UT CLARK CREEK at CATO FARMS STREAM RESTORATION 2005 MONITORING REPORT

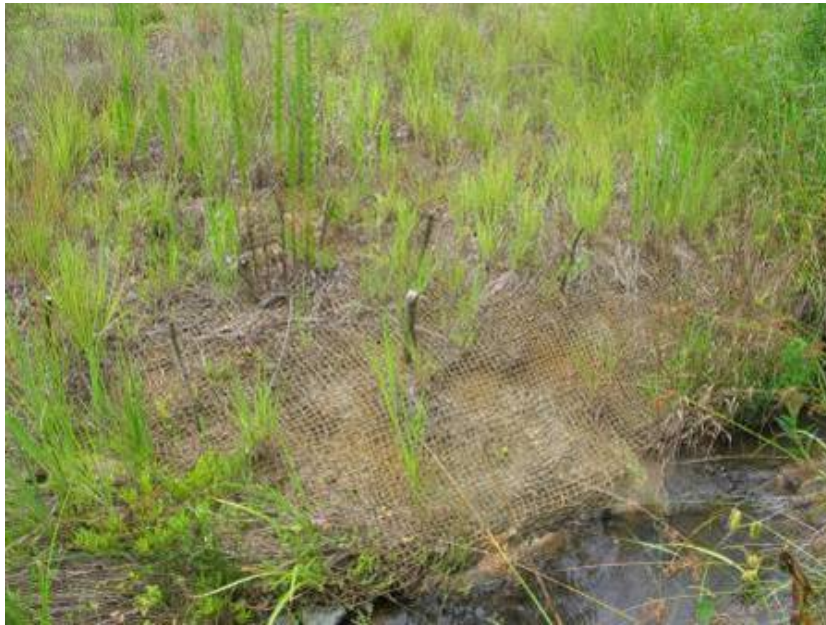
VPA 2a. Bare Bank

Table VII. Vegetative Problem Areas			
Project Number and Name: 072 (UT to Clark Creek at Cato Farms)			
Feature/Issue	Station # / Range	Probable Cause	Photo #
Bare Bank	18+50 to 18+80 - VPA 2	Compacted soils	VPA 2a and b, VPA 3a and b
	21+90 to 22+30 - VPA 3	Poor soil preparation	
Bare Floodplain	16+40 to 16+60 - VPA 1	Compacted soils	VPA 1 and VPA 3c
	21+90 to 22+30 - VPA 3	Poor soil preparation	
Invasive/Exotic Populations	Minimal locations not field identified	Existing or upland seed source	No photo taken

In four areas where vegetation is a concern, steps can be taken to revegetate and stabilize the ground. Where herbaceous vegetation has not become established, soil rehabilitation and the addition of temporary and permanent seeding are recommended. On the banks, replacement of missing and dead live stakes will help to provide long-term stability.

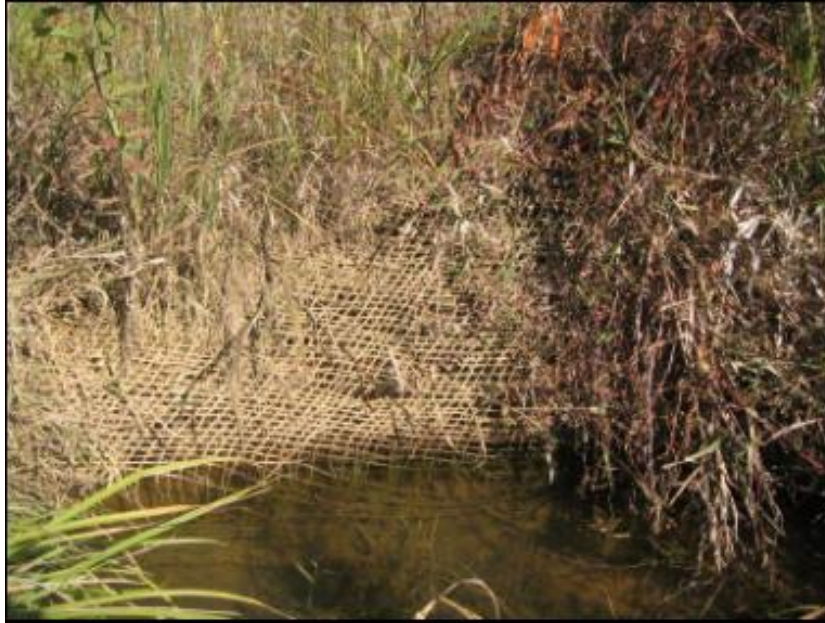
PA1

Problem Number	Feature Issue	Station numbers	Suspected Cause	Photo number
PA 1	Erosion and scour behind matting	2+50 to 2+60	Lack of deep rooting vegetation	PA 1
PA 2	Minor bank slump	3+10 to 3+20	Lack of deep rooting vegetation Overland flow being directed by upstream point bar	PA 2
PA 3	Rills forming along channel bank/slope Note: repair efforts failed in this area	4+00 to 4+60	Lack of deep rooting vegetation Poor soil preparation Compacted soil Sub-soil conditions (lack of nutrients)	PA 3
PA 4	Erosion and scour behind matting	5+00 to 5+10	Lack of deep rooting vegetation	PA 4
PA 5	Scour and slump along outside bank	9+25 to 9+30	Lack of deep rooting vegetation	PA 5
PA 6	Scour and slump along outside bank Note: repair efforts failed in this area due to soil washing out around facines and facines out of water	9+95 to 10+05	Lack of deep rooting vegetation Matting on repair area not adequately secured	PA 6

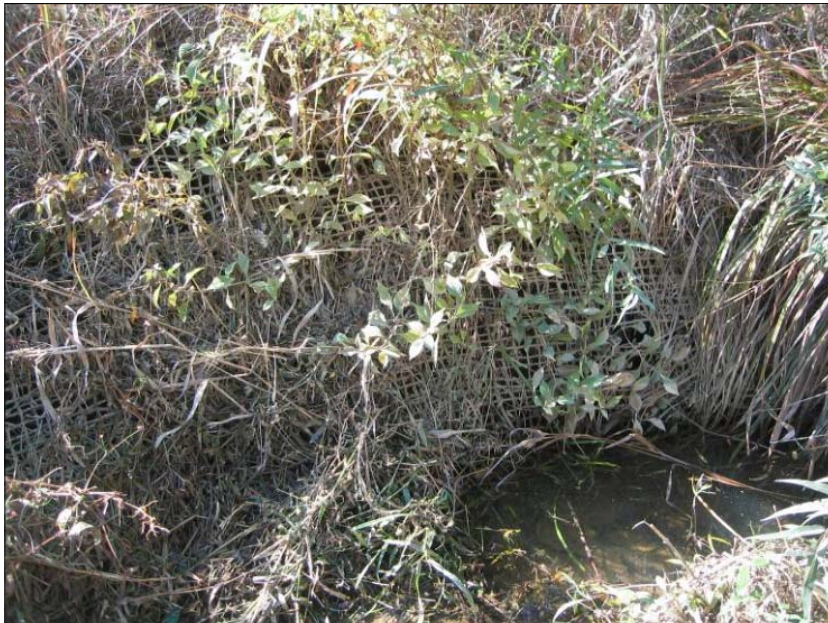
PA4

PA-4	35.41100	80.82205 6'x3' scour behind matting, no veg, not repaired
PA-5	35.41029	80.82191 2'x4' scour and slump on outside bank
PA-6	35.41026	80.82181 Scour and slump along outside bank
PA-7	35.41014	80.82183 Scour and slump along outside bank
PA-8	35.41004	80.82181 Scour and slump along outside bank
PA-9	35.40934	80.82147 Minor Bank Slump
PA-10	35.40918	80.82152 Rills forming along channel bank/slope
PA-11	35.40910	80.82120 Scour and slump along outside bank
PA-12	35.40891	80.82122 Scour and slump along outside bank
PA-13	35.40812	80.82061 Rills forming along channel bank/slope
PA-14	35.40859	80.82107 Scour and slump along outside bank
PA-15	35.40812	80.82061 Bank scour upstream of xvane

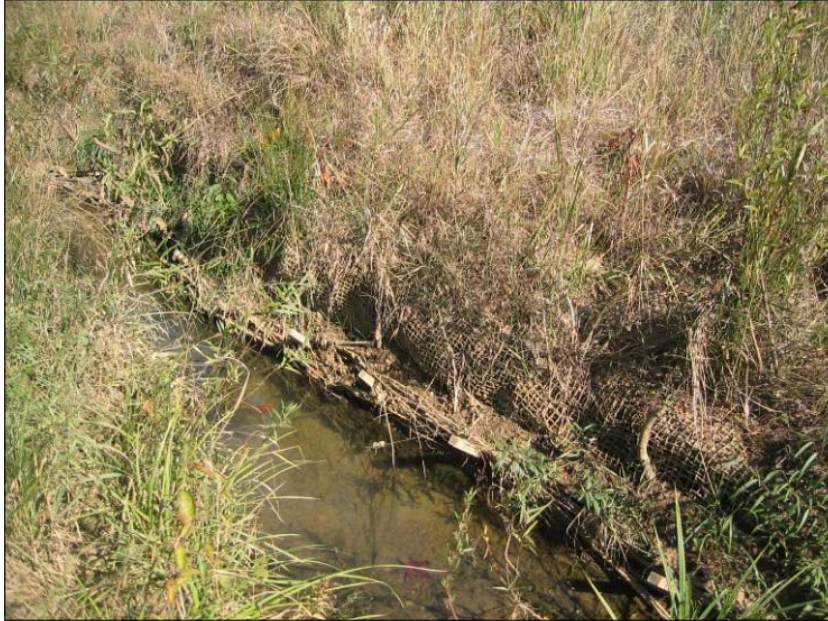
PA7

PA 7	Scour and slump along outside bank Note: repair efforts failed in this area due to soil washing out around facines and facines out of water	10+20 to 10+65	Lack of deep rooting vegetation Matting on repair area not adequately secured	PA 7
PA 8	Scour and slump along outside bank Note: repair efforts failed in this area due to soil washing out around facines and facines out of water	10+95 to 11+00	Lack of deep rooting vegetation Matting on repair area not adequately secured	PA 8
PA 9	Minor Bank Slump	15+40 to 15+50	High bank along outside bend Lack of deep rooting vegetation	PA 9
PA 10	Rills forming along channel bank/slope	15+75 to 16+25	Lack of deep rooting vegetation Poor soil preparation Compacted soil Sub-soil conditions (lack of nutrients)	PA 10
PA 11	Scour and slump along outside bank Note: repair efforts failed in this area due to soil washing out around facines and facines out of water	16+75 to 16+90	Lack of deep rooting vegetation Matting on repair area not adequately secured	PA 11

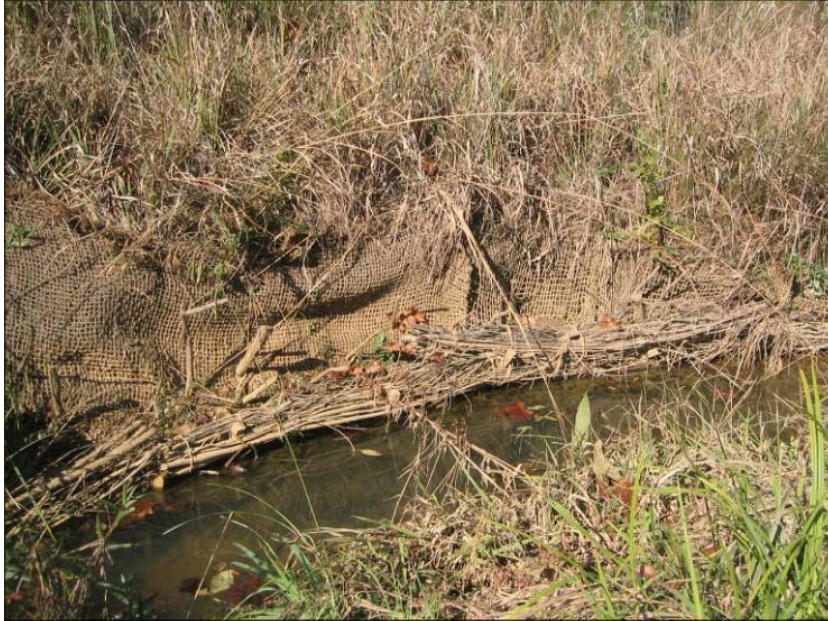
PA12

PA 12	Scour and slump along outside bank Note: repair efforts failed in this area due to soil washing out around facines and facines out of water	17+50 to 17+65	Lack of deep rooting vegetation Matting on repair area not adequately secured	PA 12
PA 13	Rills forming along channel bank/slope	18+35 to 18+85	Lack of deep rooting vegetation Poor soil preparation Compacted soil Sub-soil conditions (lack of nutrients)	PA 13
PA 14	Scour and slump along outside bank	19+20 to 19+30	Lack of deep rooting vegetation	PA 14
PA 15	Bank scour upstream of xvane Note: repaired but vegetation has not recovered	21+75 to 21+95	Lack of deep rooting vegetation	PA 15

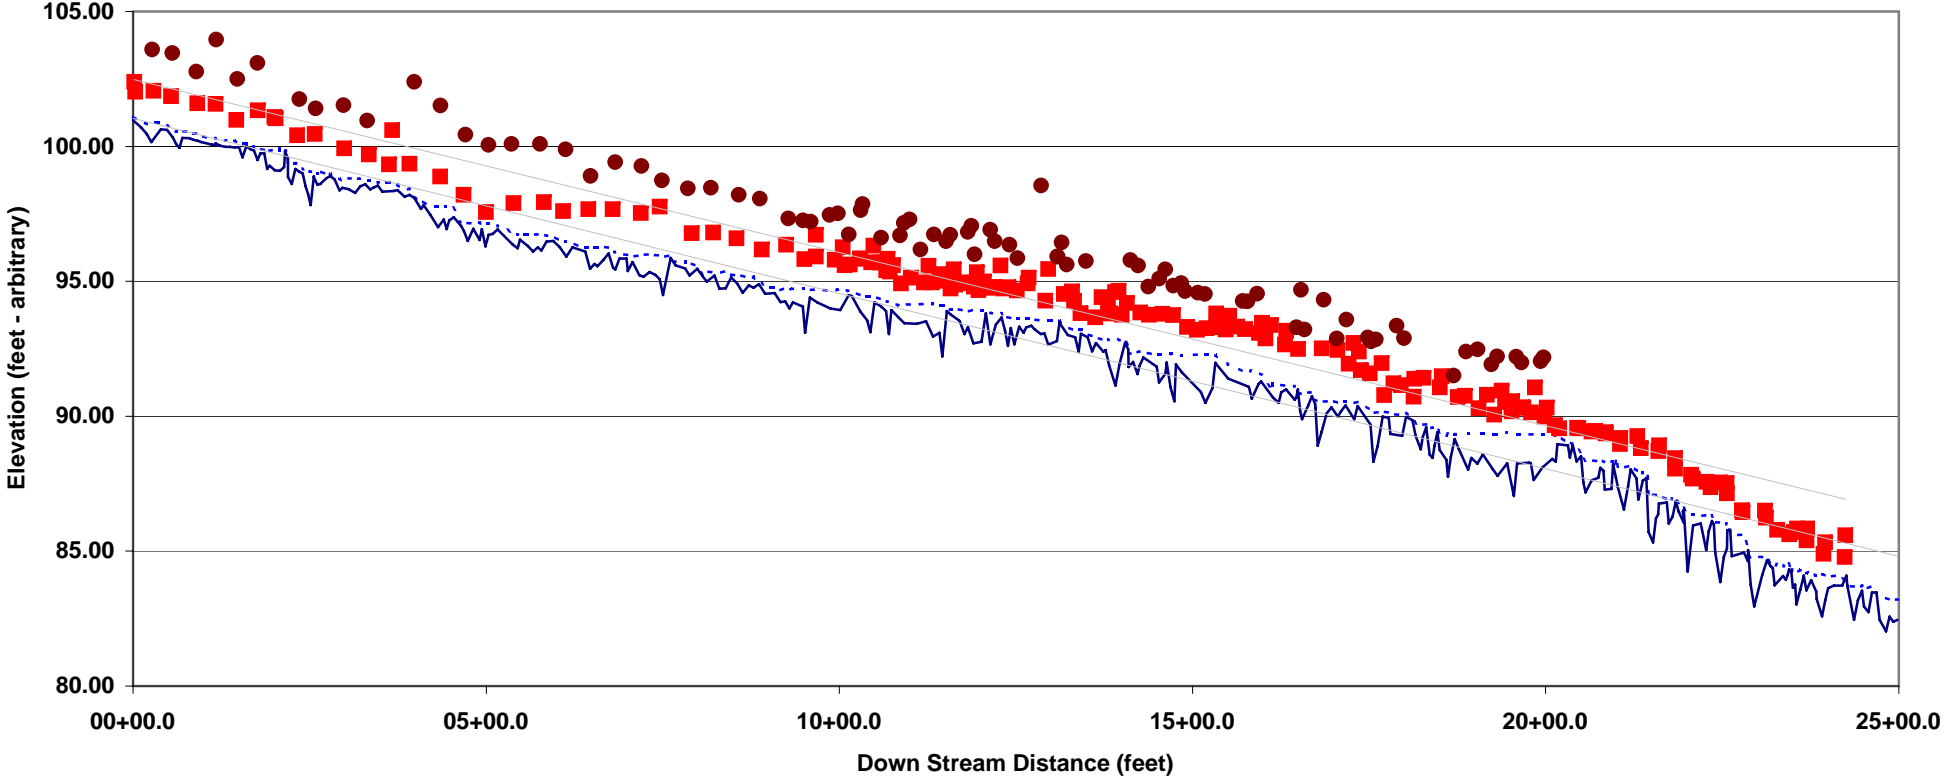
CATO FARMS
 UT Clark Creek
 Longitudinal Profile 2005

BKF Regression	$y = -0.0064x + 102.48$
WS Regression	$y = -0.0065x + 101.04$
