# Cato Farms Stream Restoration

## Project No. 72

### 2006 Monitoring Report: Year 2 of 5

**March 2007**

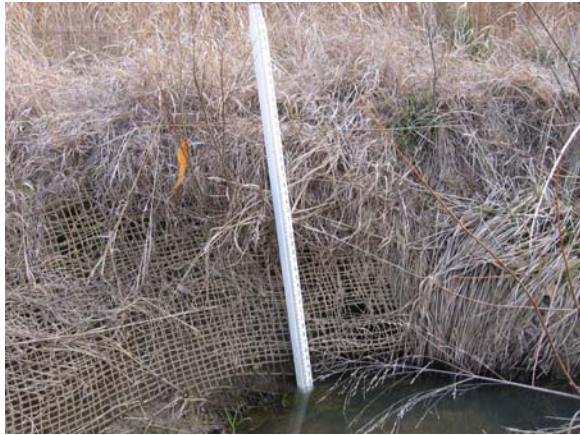
1. Bank Erosion: Moderate – 3/30/06

In the limited areas where vegetation has not established, addition of temporary and permanent seeding is recommended. On the banks with high live stake mortality, replacement of live stakes will provide long-term stability.

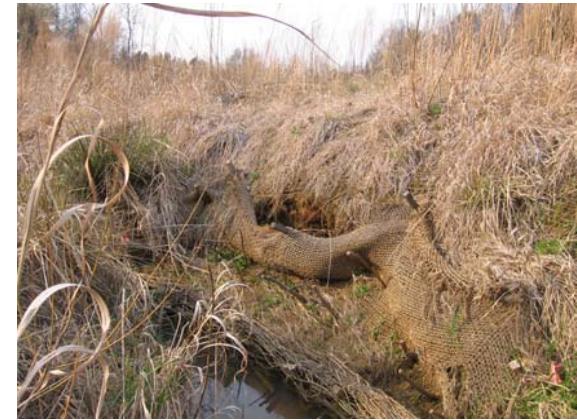
2. Bank Erosion: Severe – 3/30/06

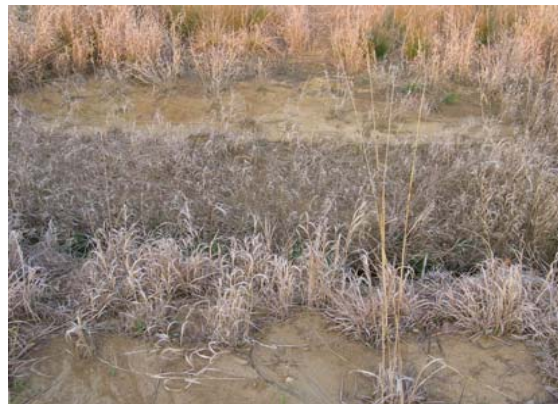
3. Poor Vegetative Cover: Soil compaction or nutrient poor soil – 3/30/06

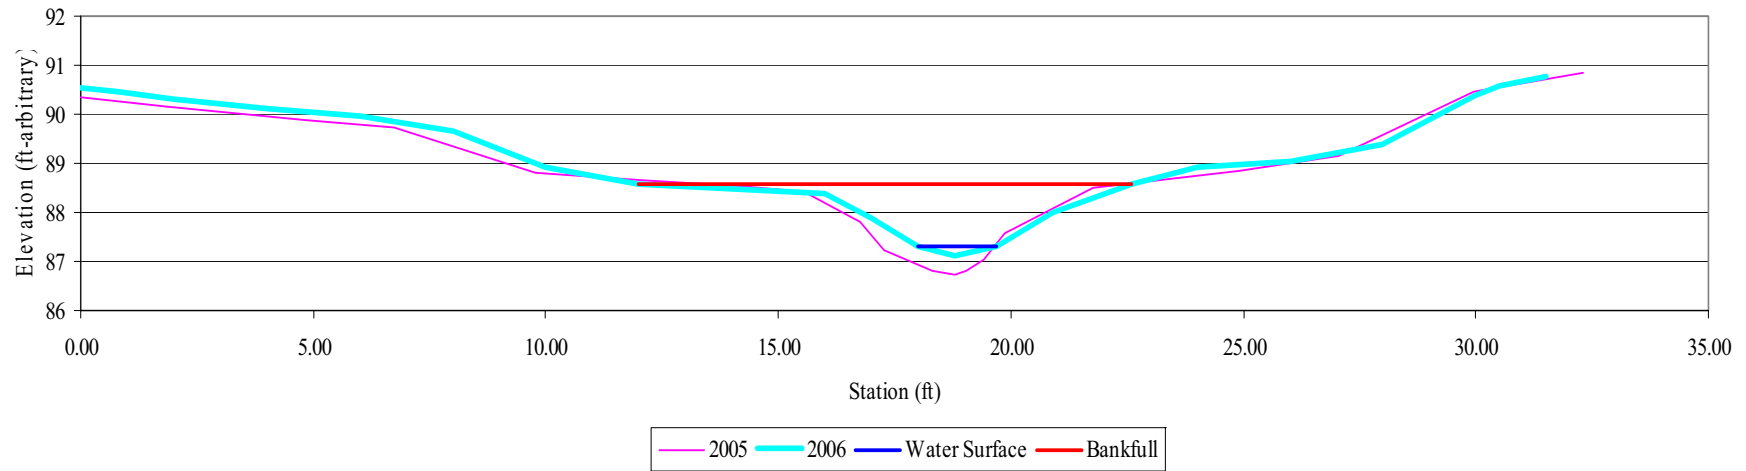
Cross-Section #1 Riffle  
Cato Farms

2006 Summary Data	
Bankfull Cross-Sectional Area	4.09
Bankfull Width	10.60
Bankfull Mean Depth	0.69
Bankfull Max Depth	1.48
Width/Depth Ratio	8.64
Entrenchment Ratio	>2.2

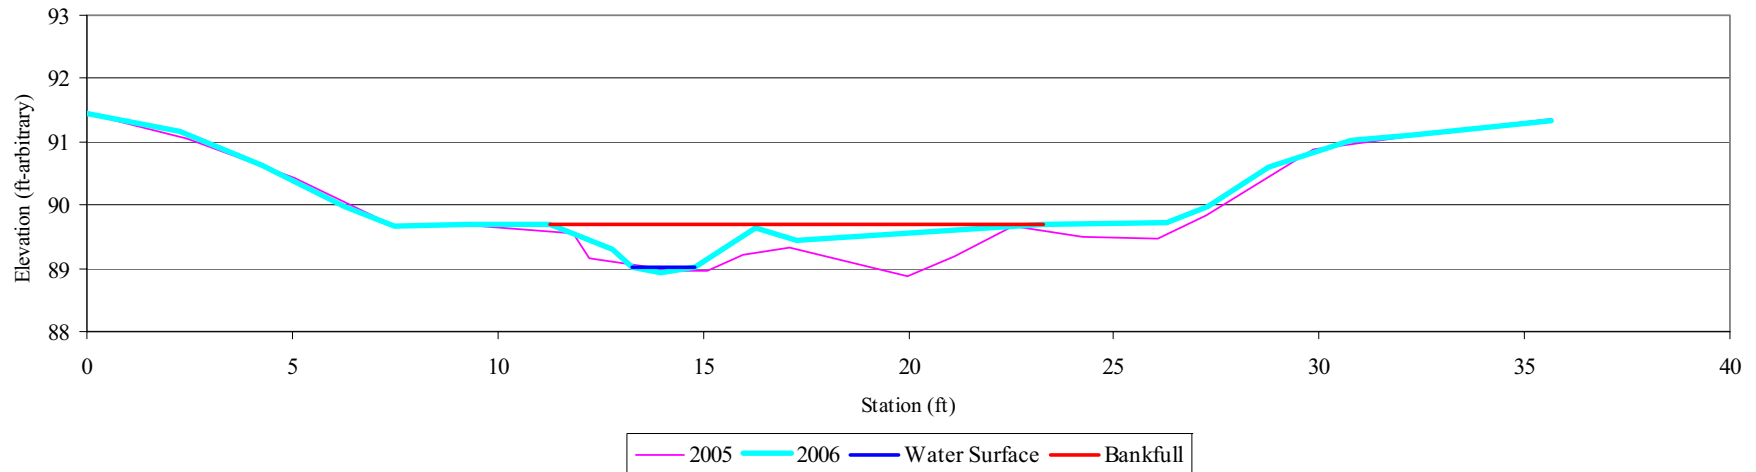
Cross-Section #2-Riffle  
Cato Farms

2006 Summary Data	
Bankfull Cross-Sectional Area	3.14
Bankfull Width	12.00
Bankfull Mean Depth	0.26
Bankfull Max Depth	0.77
Width/Depth Ratio	46.15
Entrenchment Ratio	>2.2

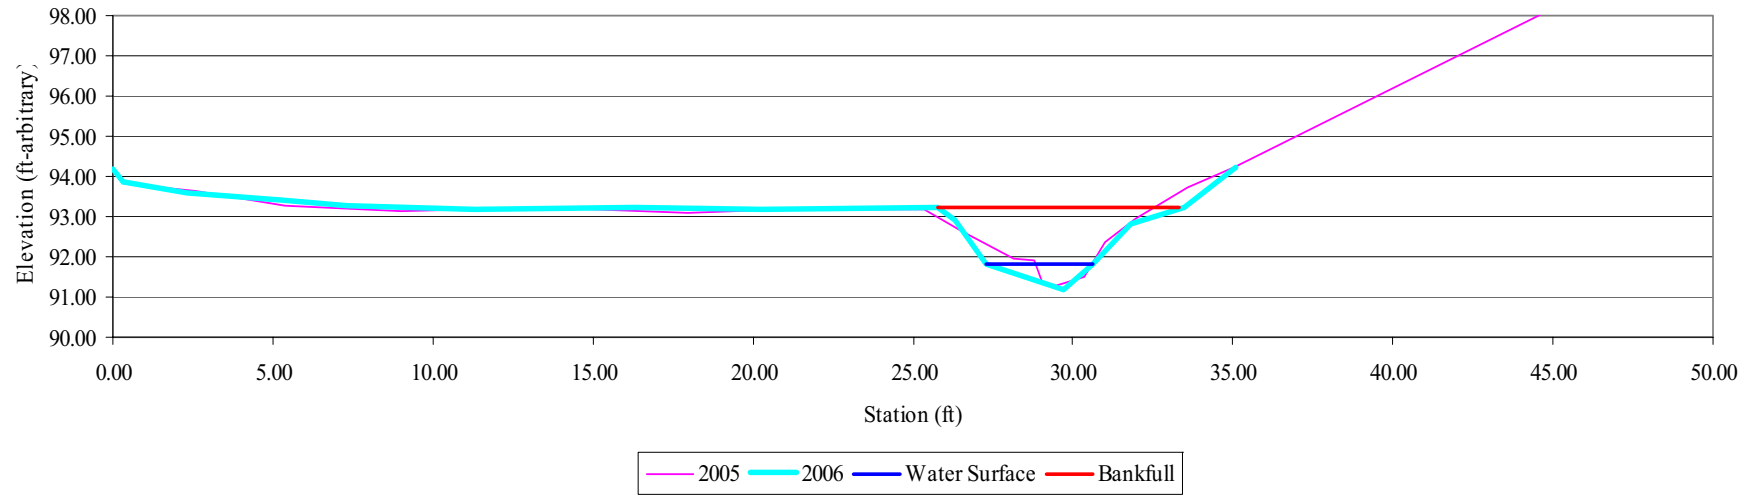
Cross-Section #3-Pool  
Cato Farms

2006 Summary Data	
Bankfull Cross-Sectional Area	7.65
Bankfull Width	7.70
Bankfull Mean Depth	0.99
Bankfull Max Depth	2.04
Width/Depth Ratio	7.78
Entrenchment Ratio	N/A

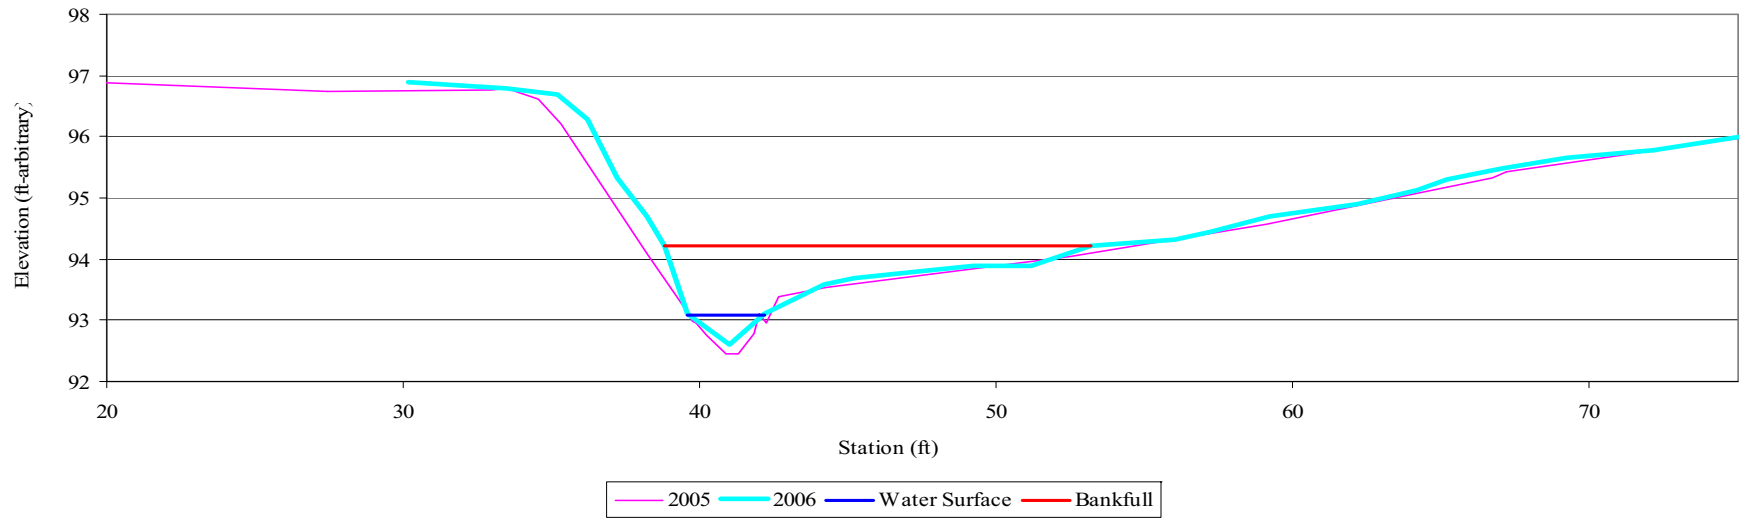
Cross-Section #4-Pool  
Cato Farms

2006 Summary Data	
Bankfull Cross-Sectional Area	9.07
Bankfull Width	14.40
Bankfull Mean Depth	0.63
Bankfull Max Depth	1.63
Width/Depth Ratio	22.86
Entrenchment Ratio	N/A

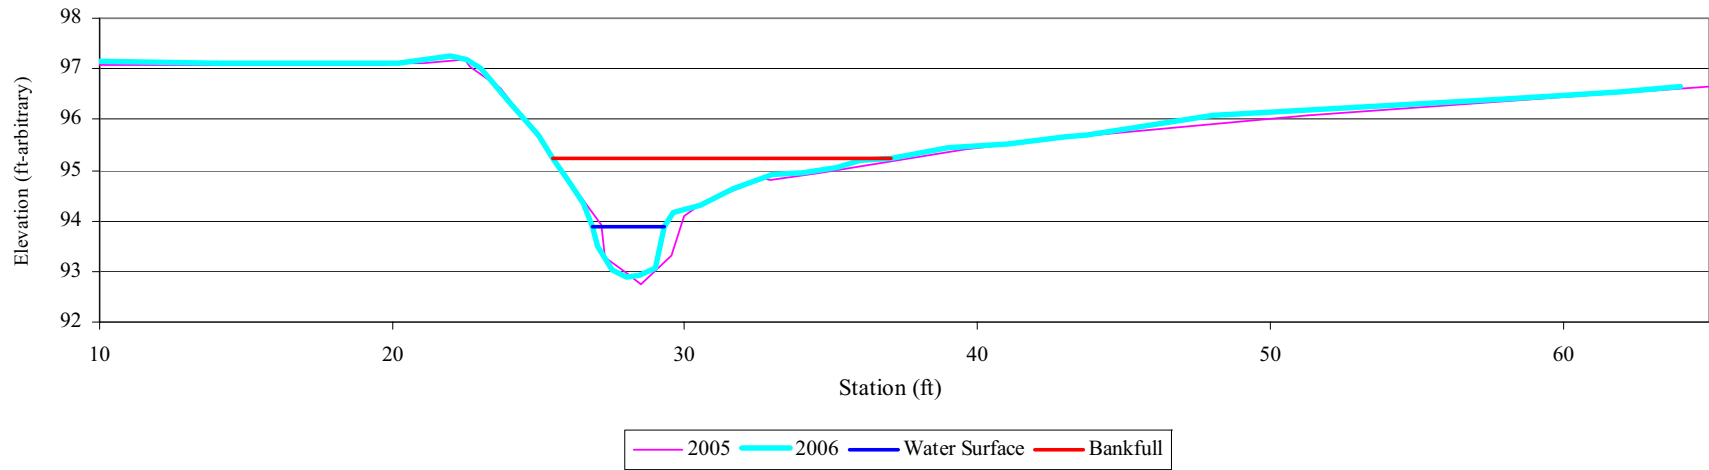
Cross-Section #5-Pool  
Cato Farms

2006 Summary Data	
Bankfull Cross-Sectional Area	9.1
Bankfull Width	11.5
Bankfull Mean Depth	0.8
Bankfull Max Depth	2.4
Width/Depth Ratio	14.6
Entrenchment Ratio	N/A

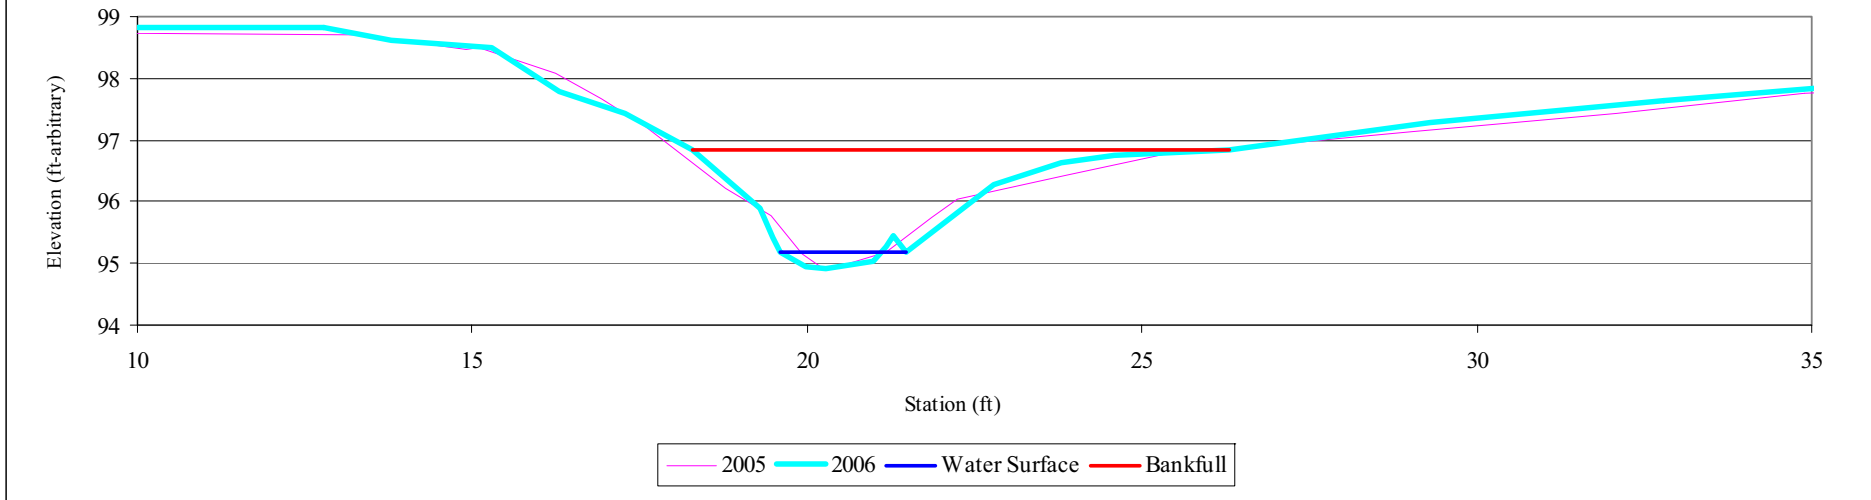
Cross-Section #6-Pool  
Cato Farms

2006 Summary Data	
Bankfull Cross-Sectional Area	5.7
Bankfull Width	8.0
Bankfull Mean Depth	0.7
Bankfull Max Depth	1.8
Width/Depth Ratio	11.3
Entrenchment Ratio	N/A

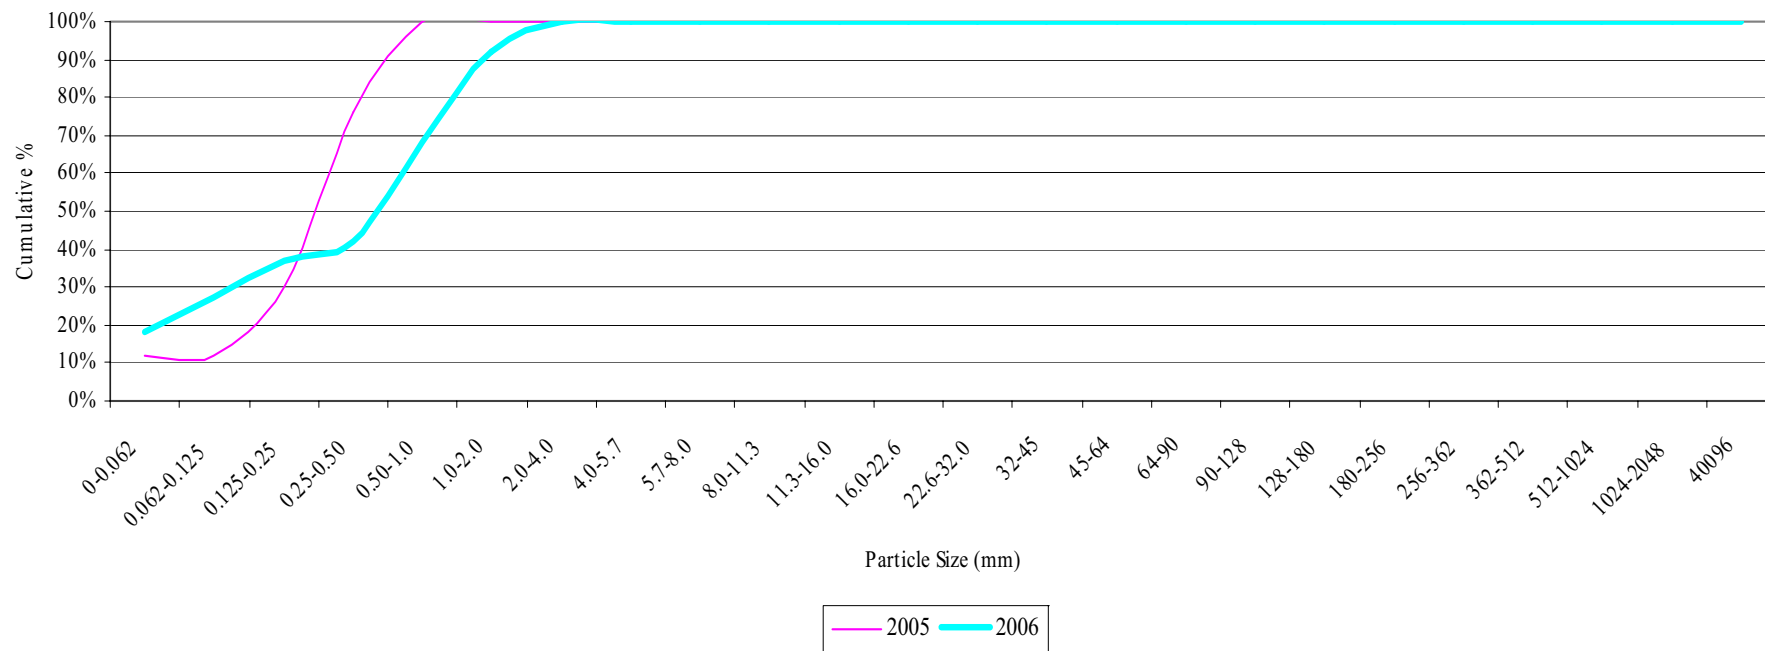
Cross-Section #1 Riffle  
Cato Farms

<b>d16</b>	<b>d35</b>	<b>d50</b>	<b>d84</b>	<b>d95</b>
<b>2005</b>	0.11	0.21	0.27	0.50	0.67
<b>2006</b>	0.05	0.23	0.71	1.51	1.89

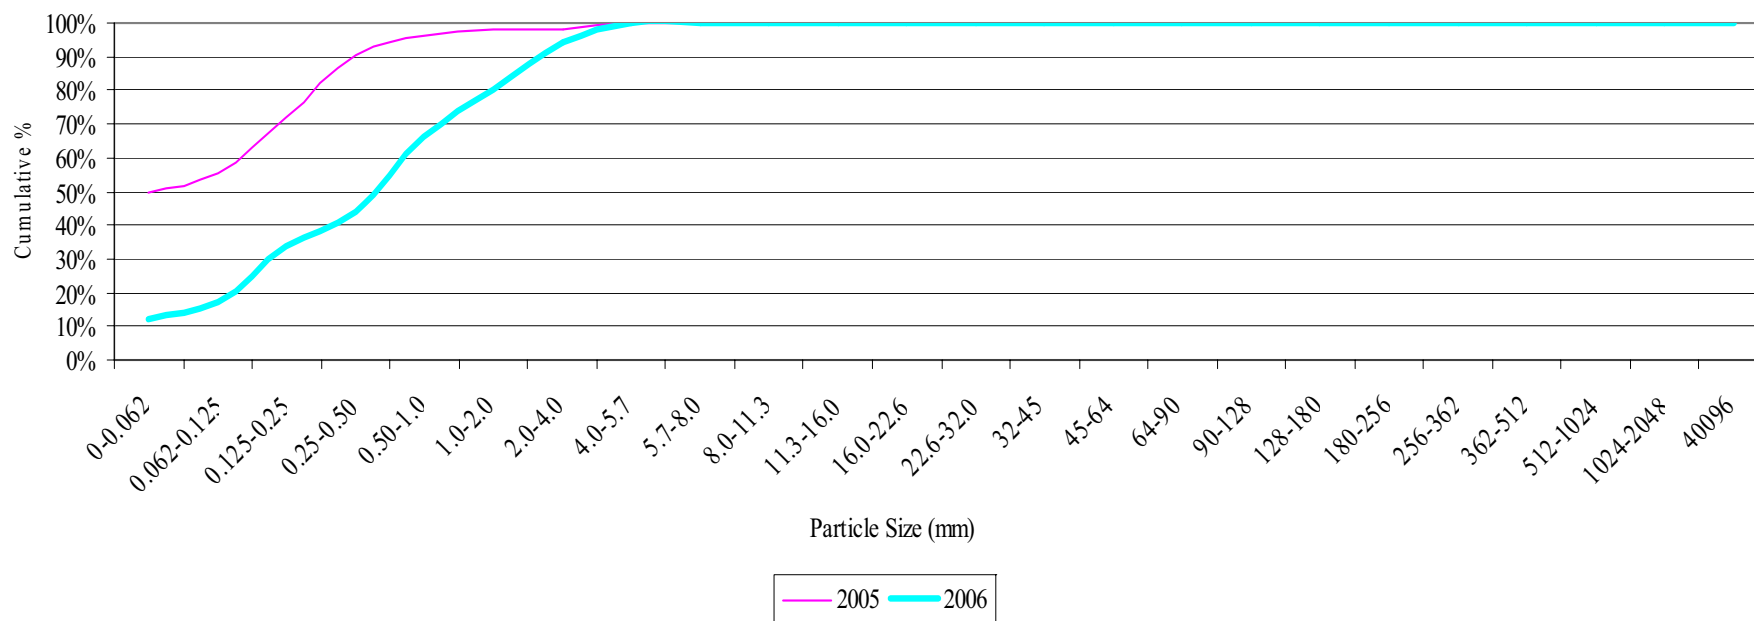
Cross-Section #2-Riffle  
Cato Farms

<b>d16</b>	<b>d35</b>	<b>d50</b>	<b>d84</b>	<b>d95</b>
<b>2005</b>	0.00	0.00	0.06	0.31	0.66
<b>2006</b>	0.14	0.33	0.66	2.02	3.52

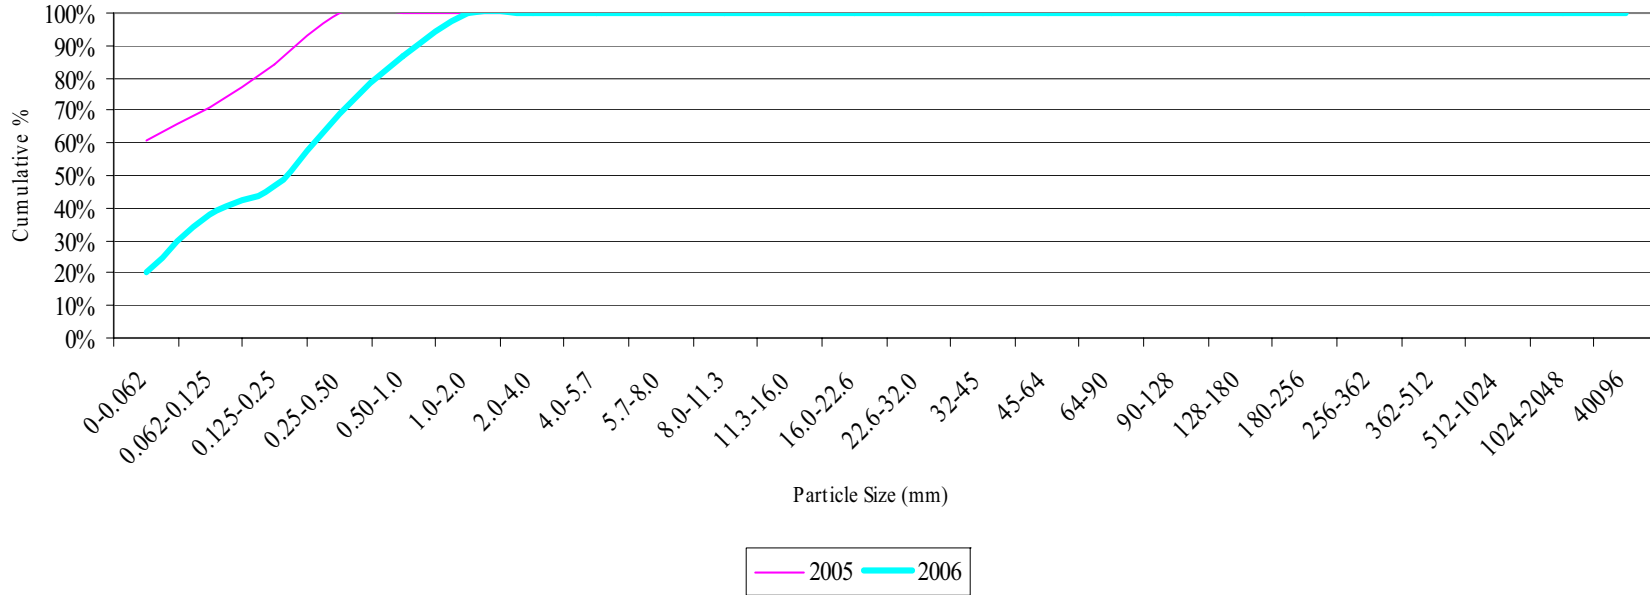
Cross-Section #3-Pool  
Cato Farms

<b>d16</b>	<b>d35</b>	<b>d50</b>	<b>d84</b>	<b>d95</b>
<b>2005</b>	0.00	0.00	0.00	0.19	0.32
<b>2006</b>	0.05	0.12	0.35	1.04	1.70

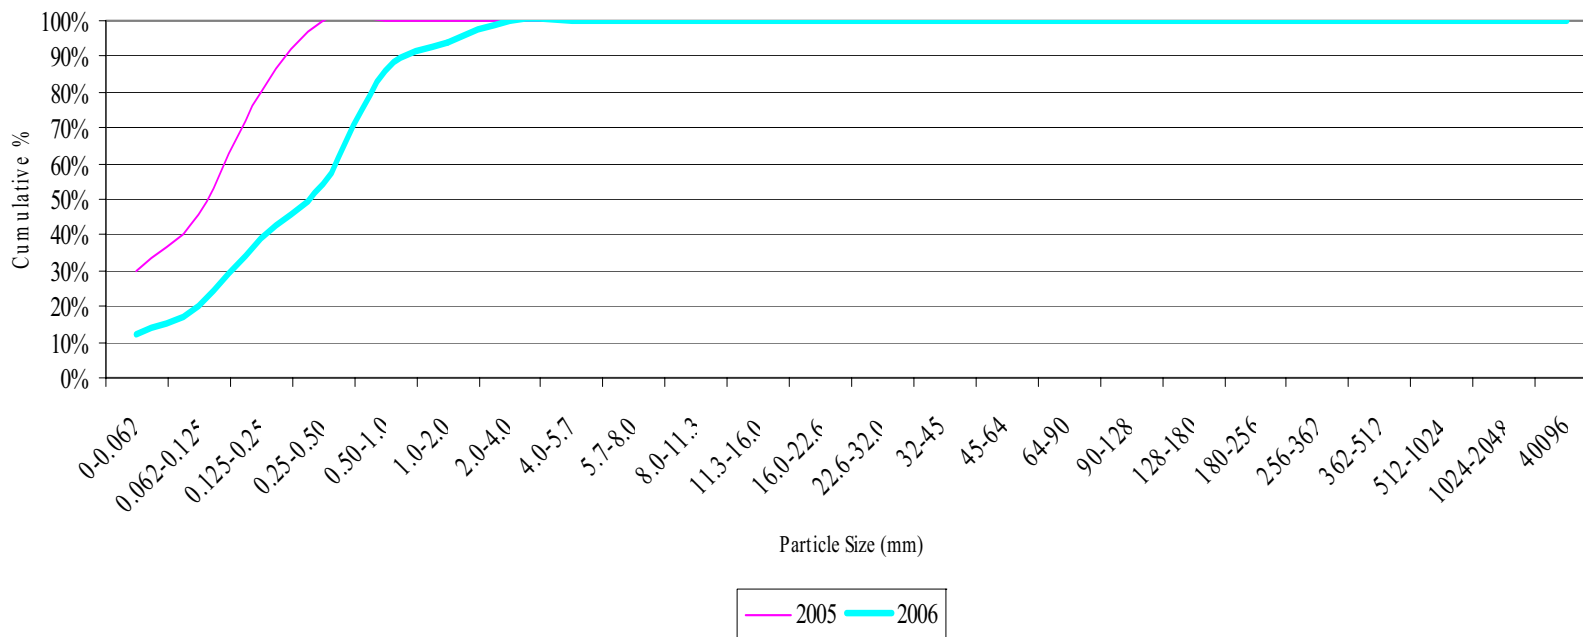
Cross-Section #4-Pool  
Cato Farms

<b>d16</b>	<b>d35</b>	<b>d50</b>	<b>d84</b>	<b>d95</b>
<b>2005</b>	0.00	0.07	0.10	0.23	0.33
<b>2006</b>	0.12	0.23	0.44	0.87	1.00

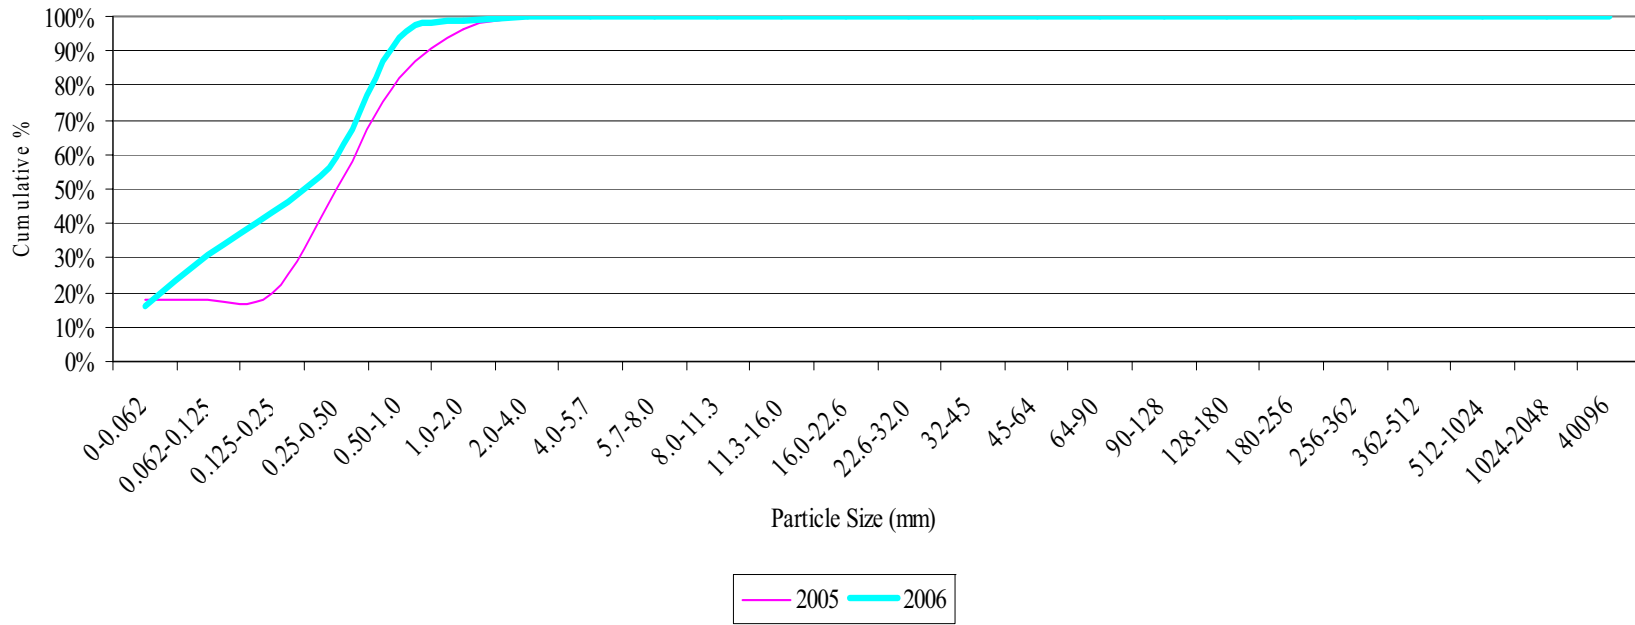
Cross-Section #5-Pool  
Cato Farms

<b>d16</b>	<b>d35</b>	<b>d50</b>	<b>d84</b>	<b>d95</b>
<b>2005</b>	0.00	0.28	0.38	0.86	1.45
<b>2006</b>	0.06	0.17	0.36	0.84	1.2

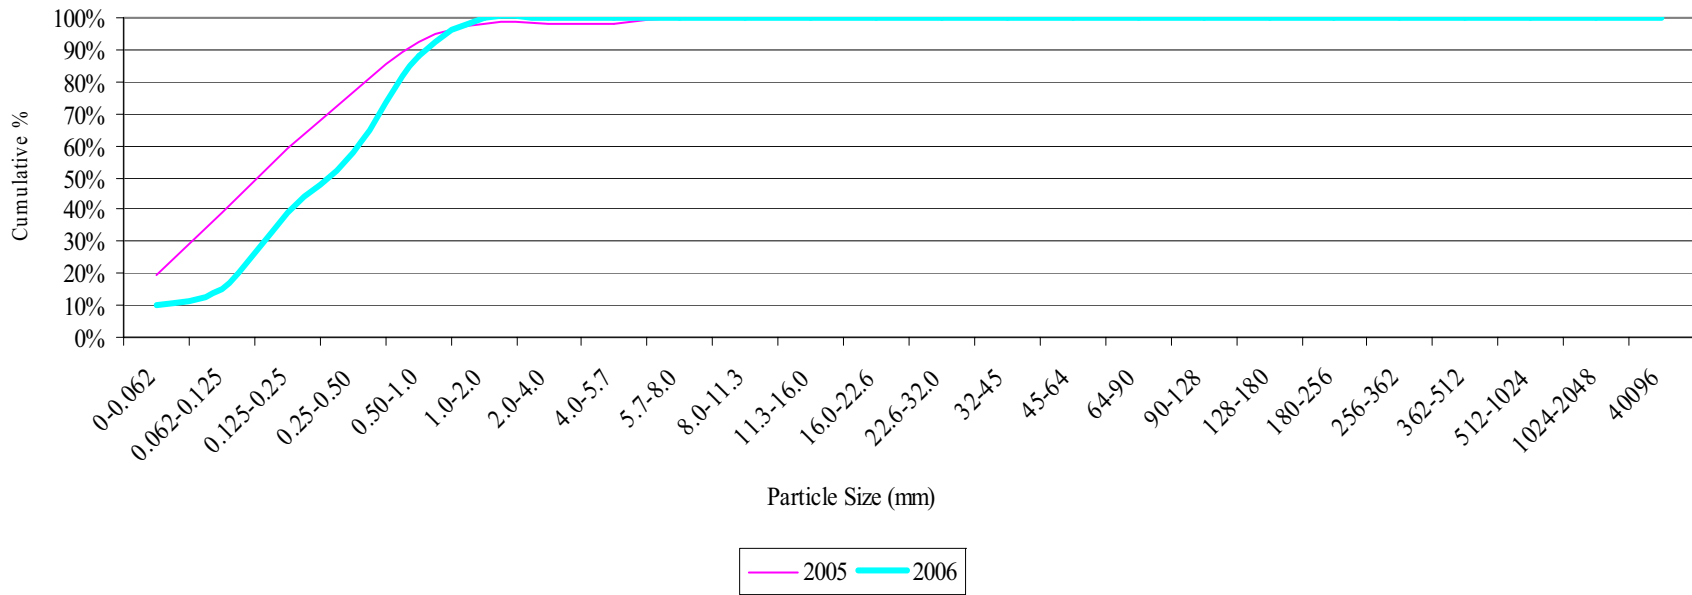
Cross-Section #6-Pool  
Cato Farms

<b>d16</b>	<b>d35</b>	<b>d50</b>	<b>d84</b>	<b>d95</b>
<b>2005</b>	0	0.09	0.15	0.56	1.11
<b>2006</b>	0.13	0.23	0.39	0.93	1.58
