**Cato Farms Stream Restoration**  
**Project No. 72**  
**2007 Monitoring Report (Final): Year 3 of 5**

**March 2008**

Prepared for: NCDENR-EEP  
1652 Mail Service Center  
Raleigh, NC 27699-1652

Prepared by: Jordan, Jones, and Goulding, Inc.  
9101 Southern Pine Blvd., Suite 160  
Charlotte, NC 28273

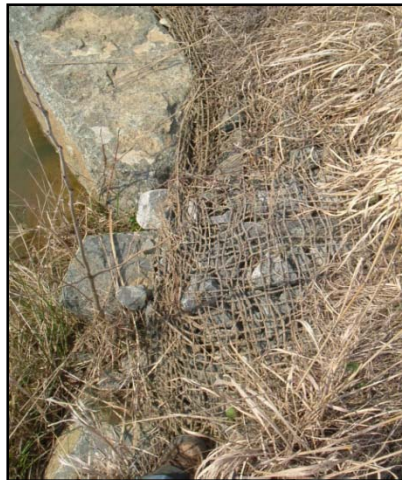
3. Streambank Cover Poor  
3/22/2007

In the limited areas where vegetation has not established, addition of temporary and permanent seeding is recommended. On the banks with high live stake mortality, replacement of live stakes is recommended to provide long-term stability.
