# Cato Farms Stream Restoration

## Project No. 72

### 2009 Monitoring Report: Year 5 of 5

**November 2009 (Revised April 2010)**

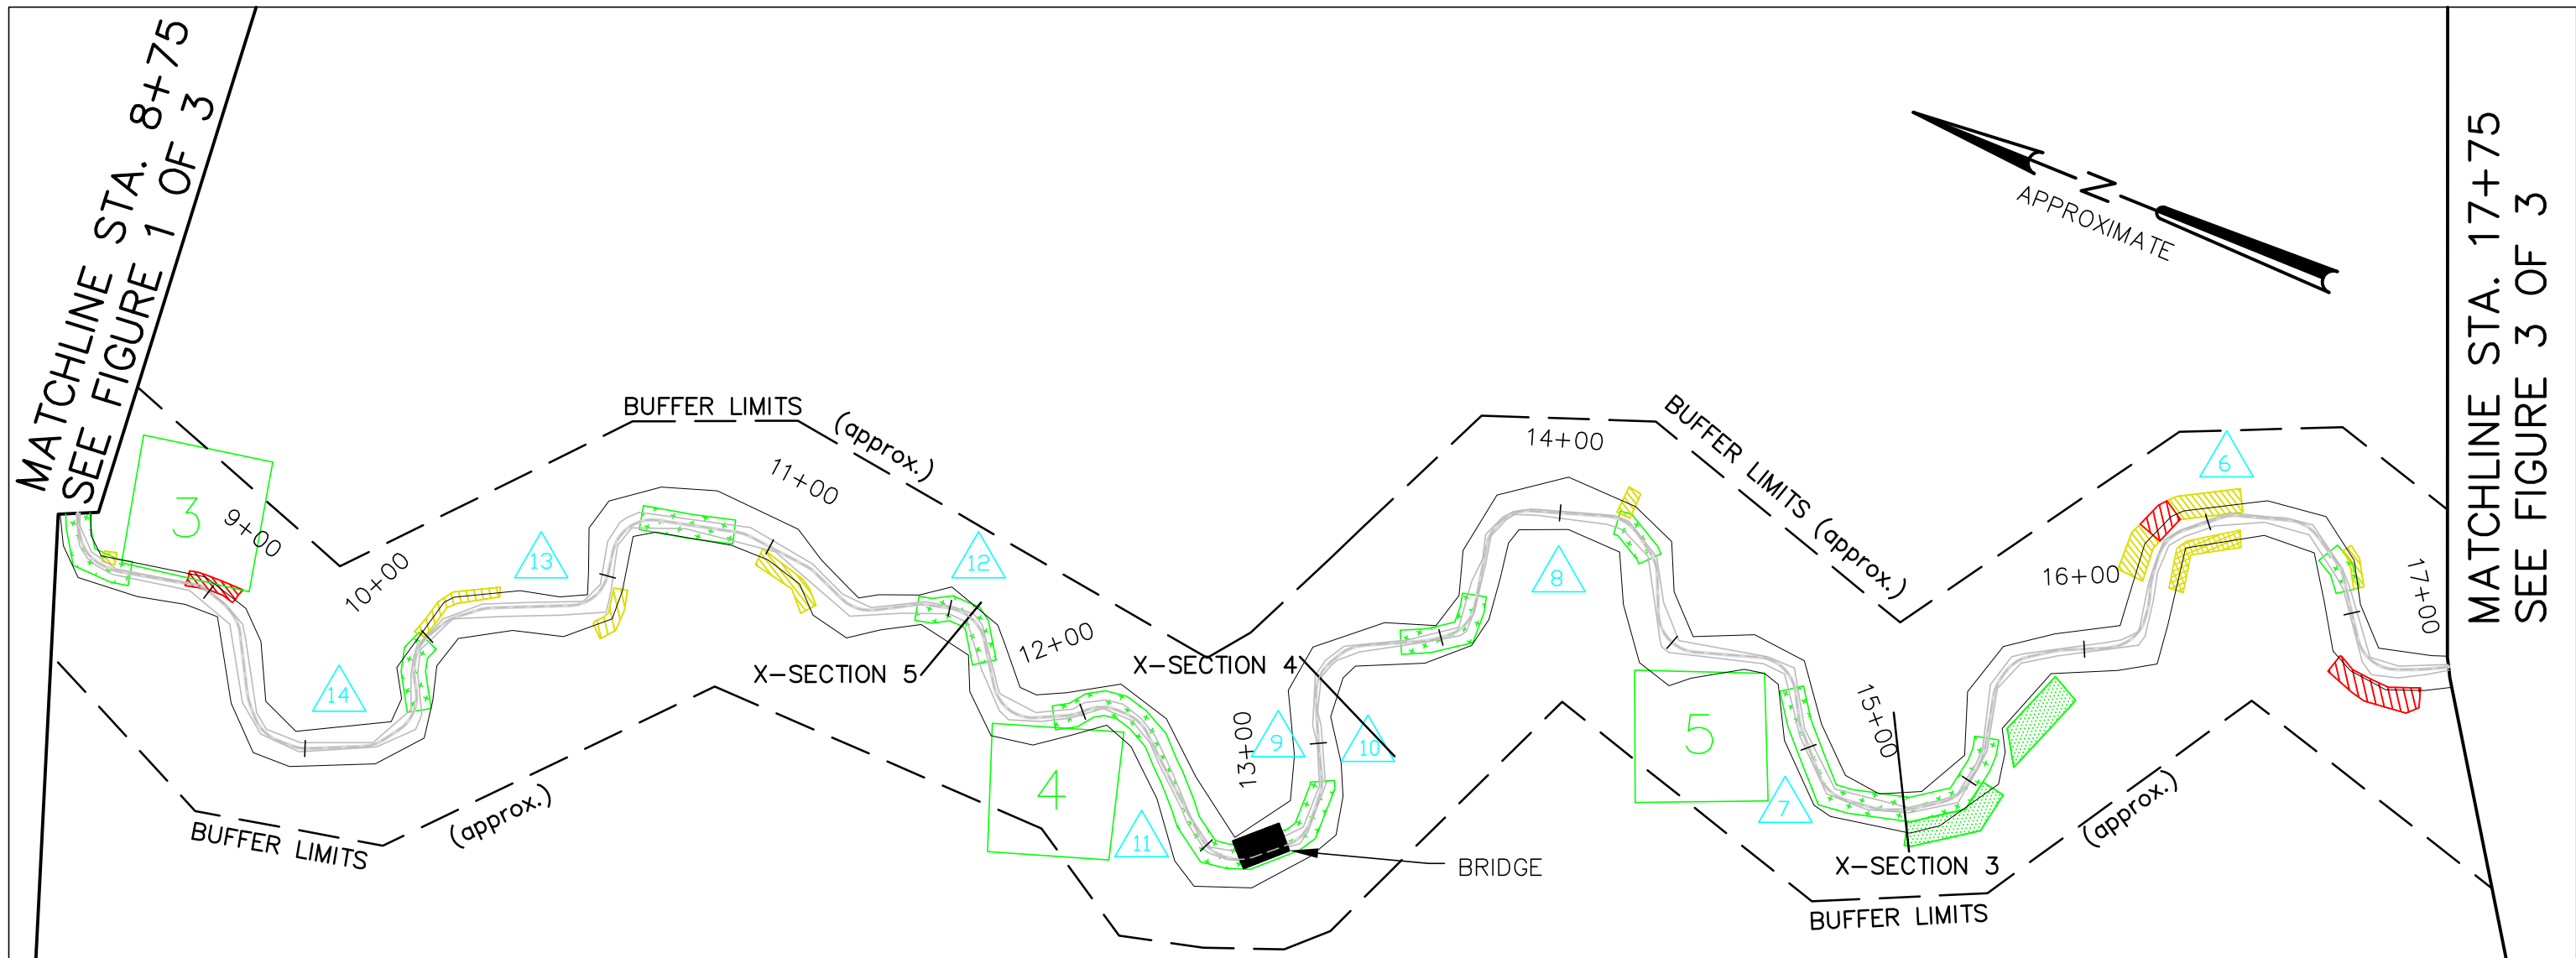
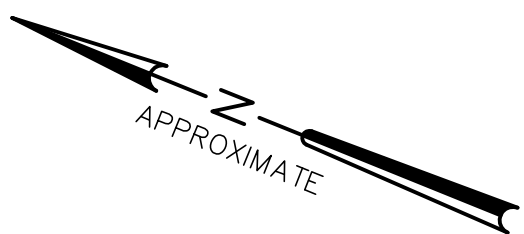
FIGURE 1 OF 3

- In a few outer bends, there are areas of moderate to severe bank erosion under the matting due to the lack of vegetative cover. (approximate stationing 9+15, 16+85, and 17+50).
- Overall, the structures appear to be in good condition; however, the outer arm of some structures are lacking in vegetative cover; therefore, moderate scouring has occurred over the years (stationing 22+50, 22+90 and 24+30).
- Throughout the entire stream restoration project, in-stream vegetation (soft rush (*Juncus effuses*) and various grasses) are growing in the middle of the channel, creating abnormal flow conditions.
- Approximately at station 4+00, the channel water is now spread across the point bar rather than entirely in the pool area due to in-stream vegetation growth.

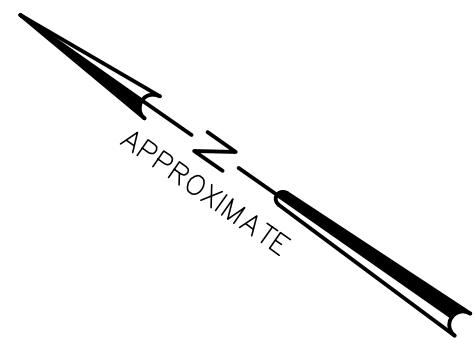
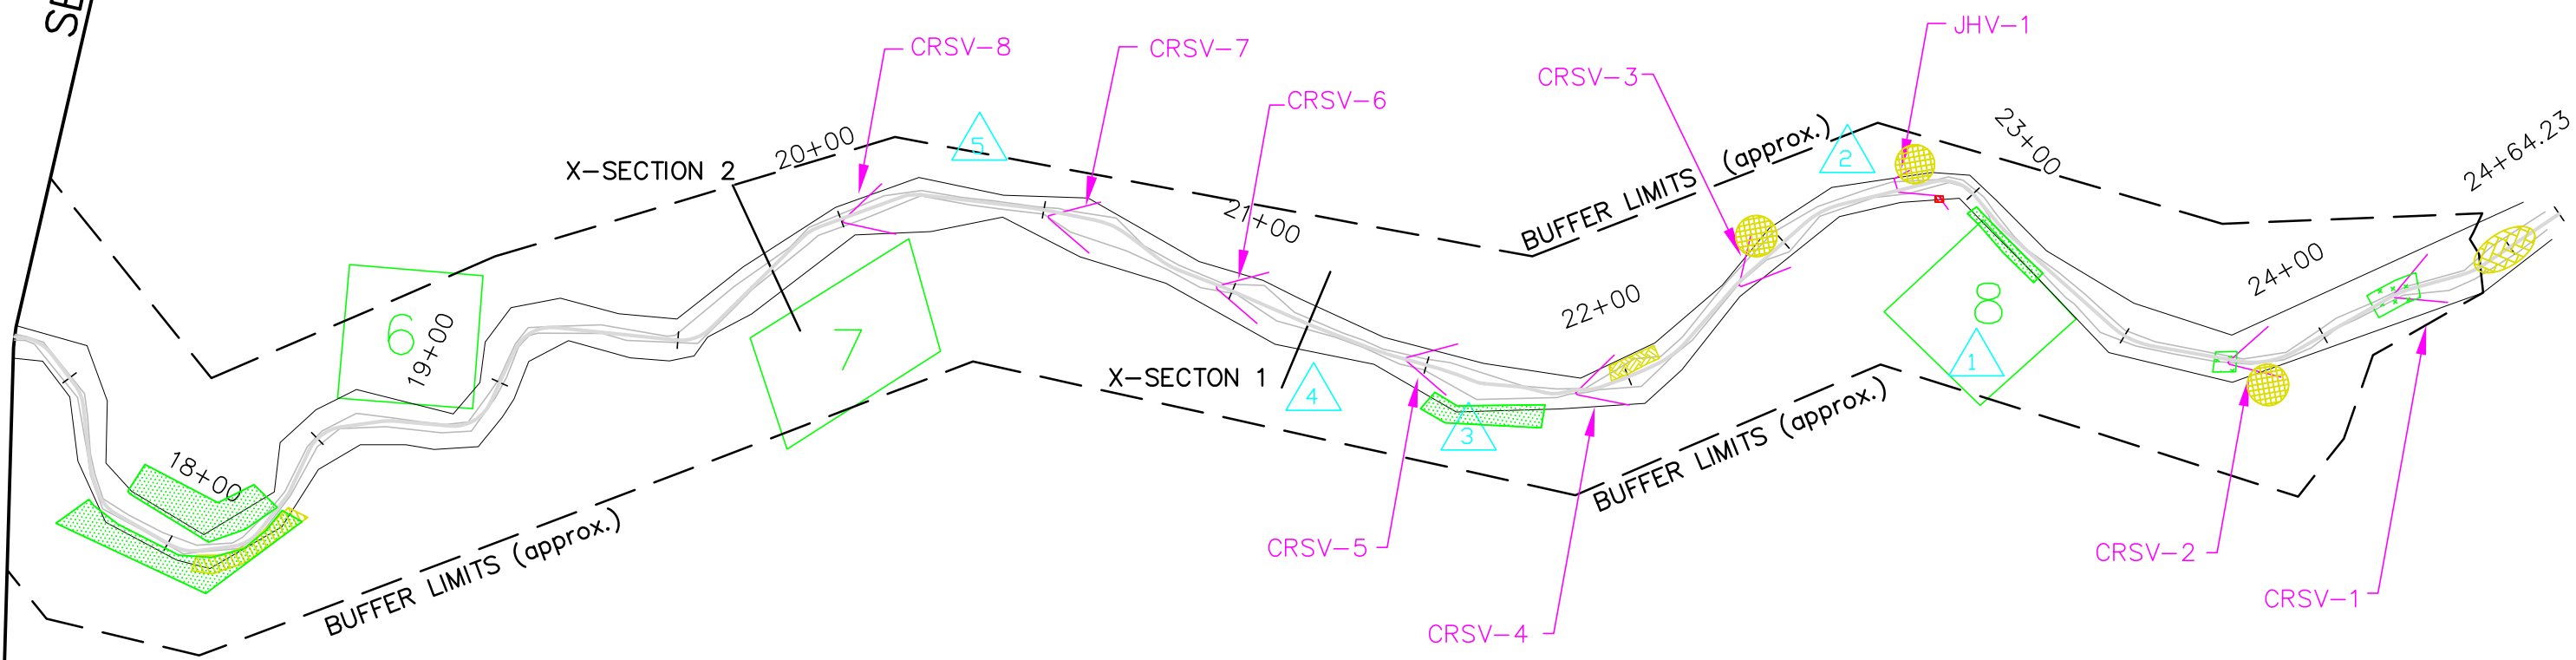
DATE : NOVEMBER 2009  
 SCALE : 1"=40'  
 JOB NO.: 03060004  
 FIGURE 2 OF 3

Overall, the structures within the transition zone appear to be in good condition; however, the outer arm of some structures are lacking vegetative cover; therefore, moderate to severe scouring has occurred over the monitoring years (Stationing 21+00, 21+50, 22+50, 22+90, 23+90, 23+25, and 24+30).
