Caviness Farm (Tibbs Run) Stream Restoration

NCDENR-EEP Project Number 73

**Annual Monitoring Report
Performance Year: 2005
Monitoring Year: 2 of 5**

**CAVINESS FARM (TIBBS RUN) STREAM RESTORATION
2005 MONITORING REPORT**

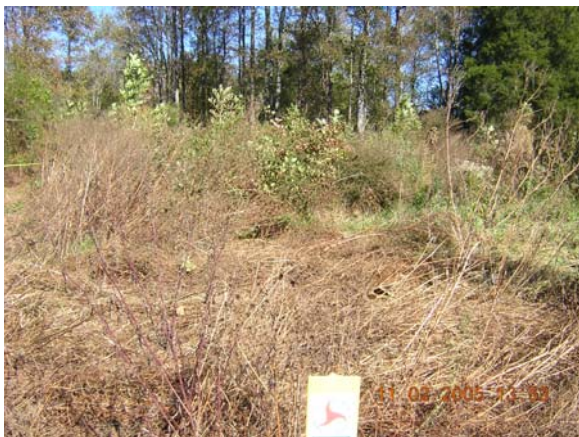
VPP3a

It was observed that mowing within the right-of-way has recently occurred in and around Plot 3. The mowing removed much of the herbaceous cover in the plot and damaged some of the planted seedlings. This occurred as a result of a misunderstanding between the landowner and the mower operator. The mower operator apparently deliberately removed fencing in the vicinity of the crossing at Station 18+60-18+80 in order to obtain access for mowing. The landowner noticed the error and redirected the mower operator before the entire easement was disturbed.
