**Caviness Farm Stream Restoration Site
Randolph County, North Carolina
EEP Project No. 73**

**2008 Annual Monitoring Report
Monitoring Year 5**

March 2009

WK Dickson and Co., Inc.
720 Corporate Center Drive
Raleigh, NC 27607
(919) 782-0495

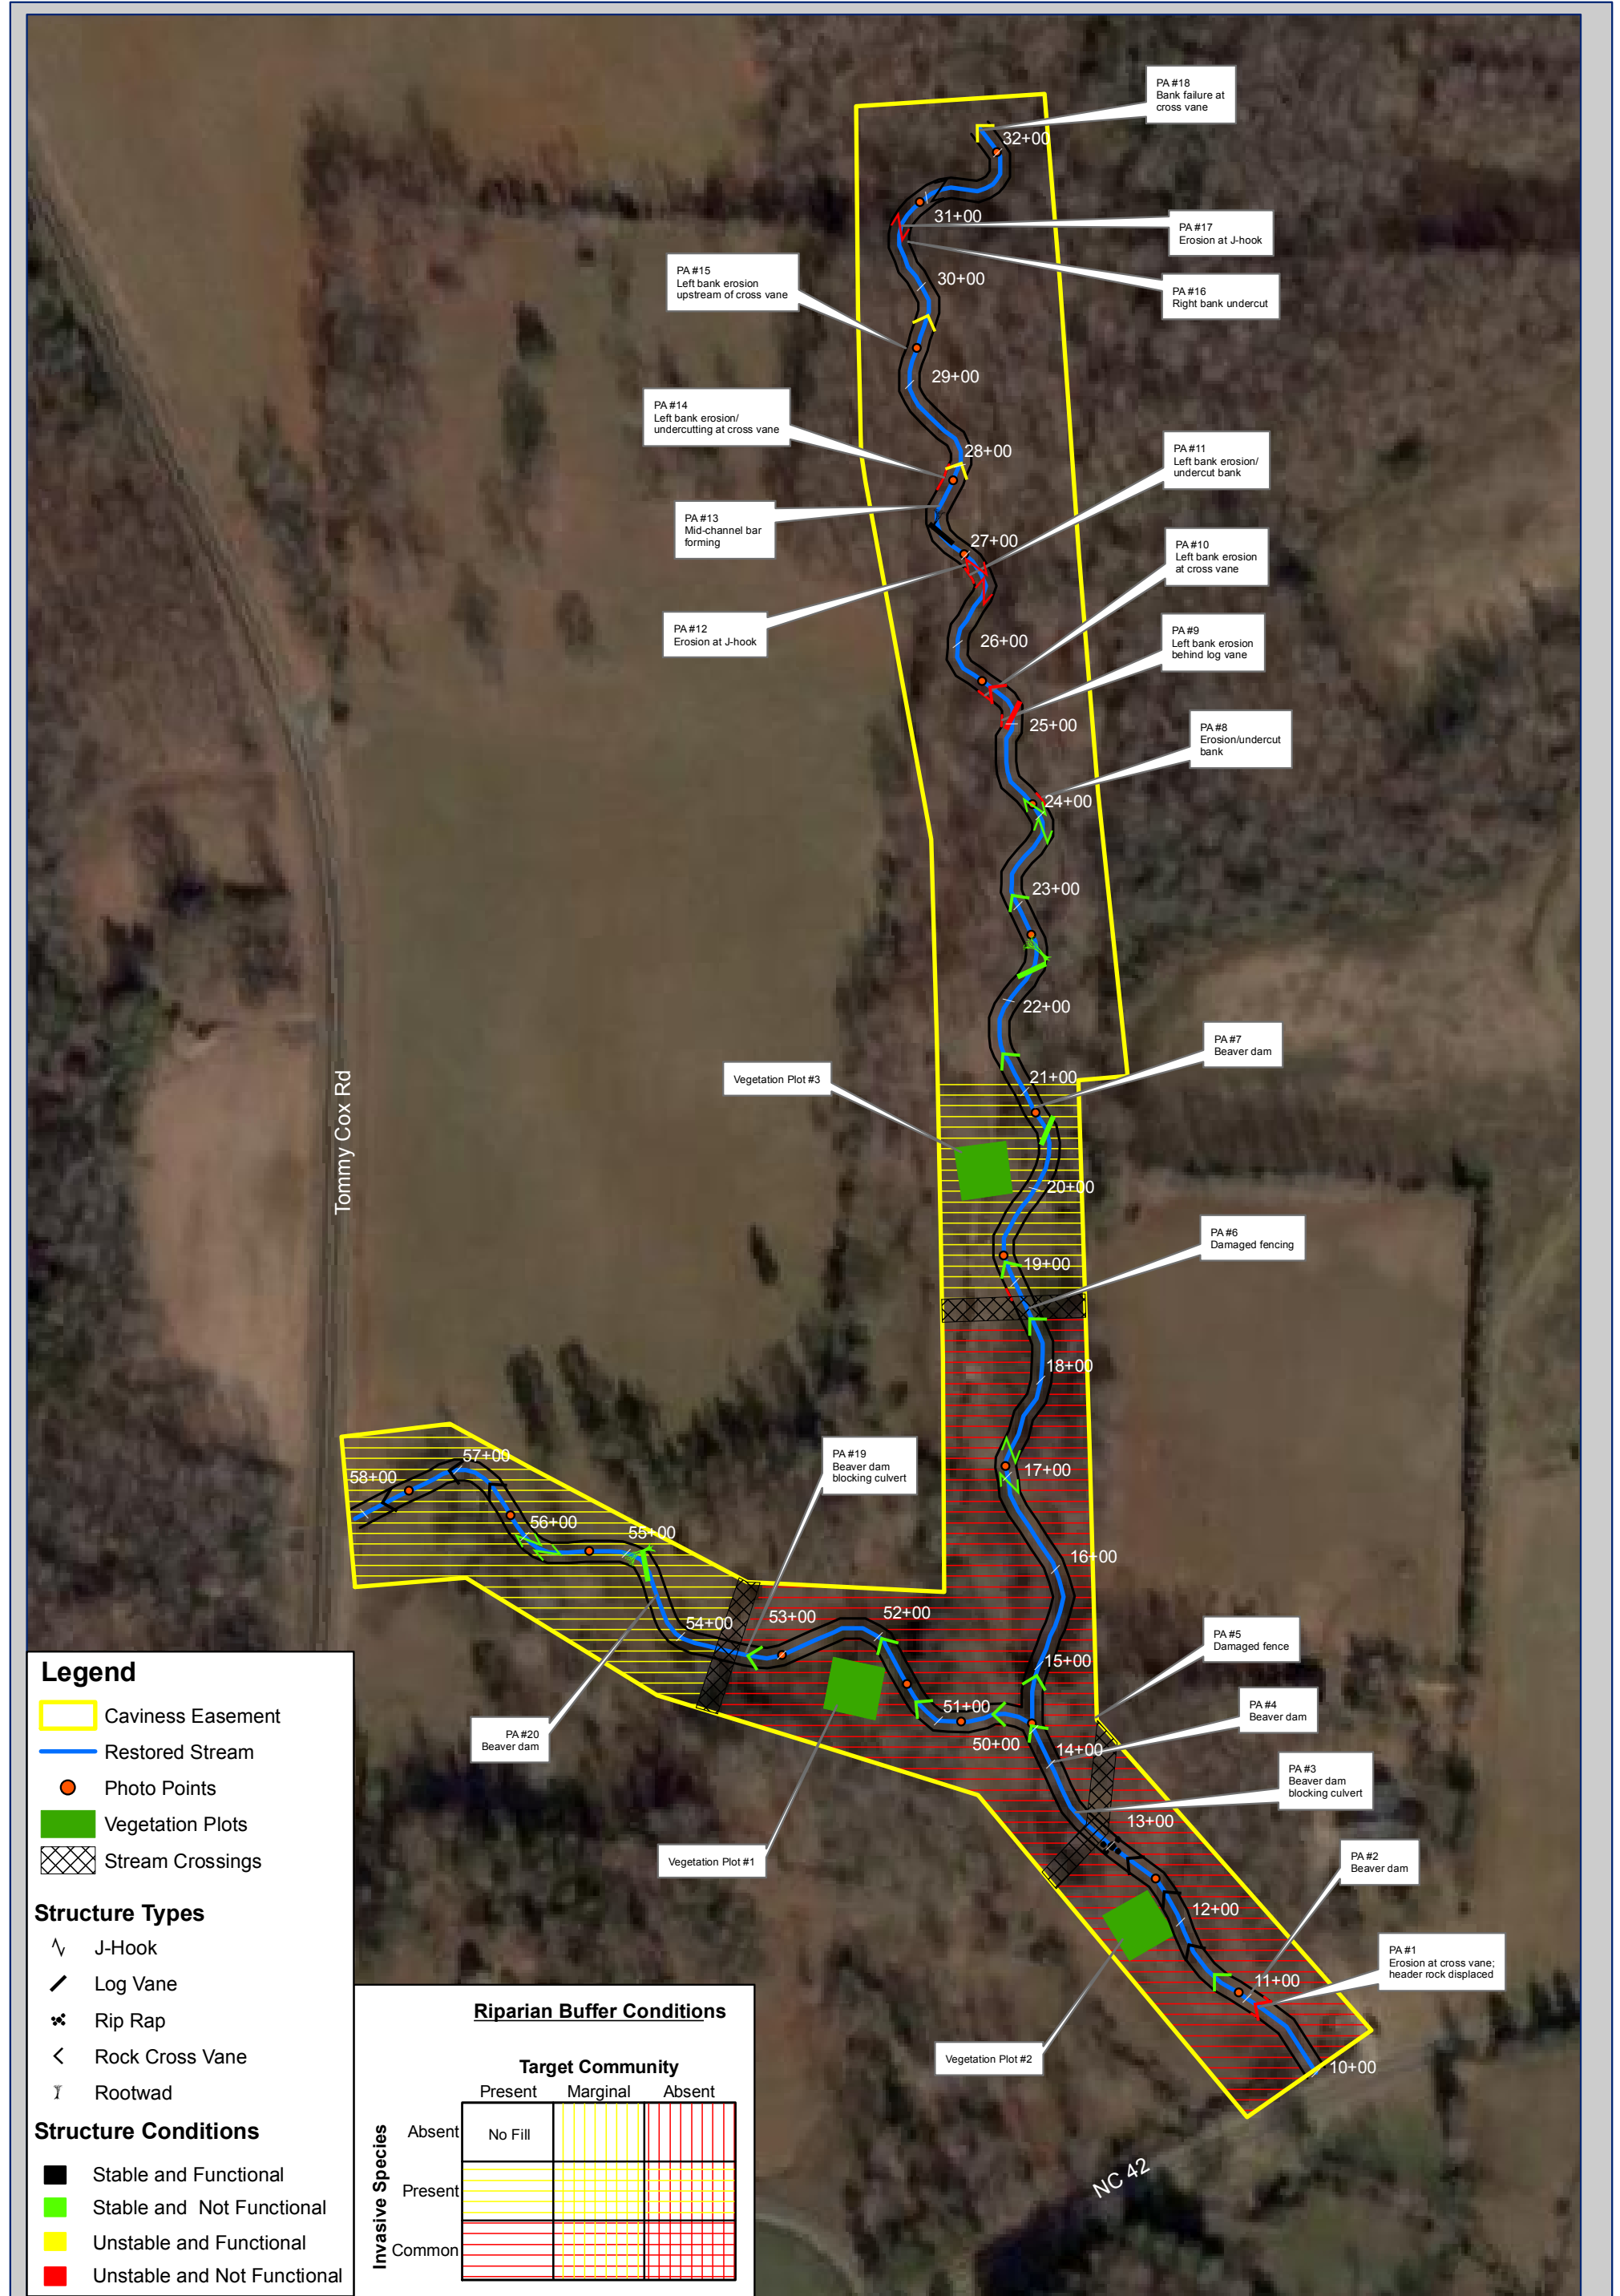
Figure 2
Caviness Current Conditions Plan View
Year 4 Monitoring
October 2008

In the course of 2008 monitoring activities, 20 problem areas were identified. These areas are discussed below in **Table VII** and can be located on the Caviness Farm Current Conditions Plan View figure in **Appendix B** along with photos of each problem.

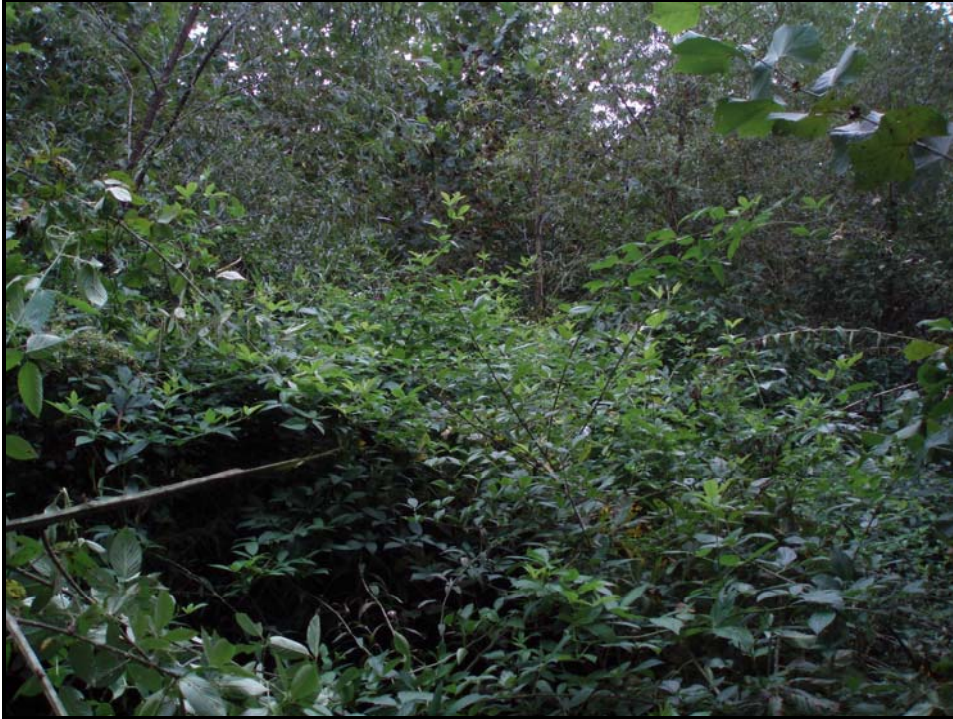
Photo 5. Vegetation Plot 3

The area in Plot 3 that had been mowed appears to have recovered. Fencing at the crossing downstream from this plot has not been repaired and has suffered additional damage from flooding. This fencing needs to be repaired. Fencing in a number of areas throughout the easement boundary appears degraded and needs repair and maintenance. These areas were deemed minor and pose no immediate threat to vegetation success or project goals. Specific areas of bare banks, failures, and damaged fencing are marked on the Current Conditions Plan View in **Appendix B**. All vegetative problem areas and the vegetative plan view are provided in **Appendix A**.
