Monitoring Report MY01

**Cedar Branch Restoration Site
Monitoring Year 01
DMS Contract 6598
DMS Project Number 97009**

**DWR #: 20150904
USACE Action ID: 2003-21395
Randolph County, North Carolina**

**Monitoring Data Collected: November 2018
Date Submitted: January 2019**

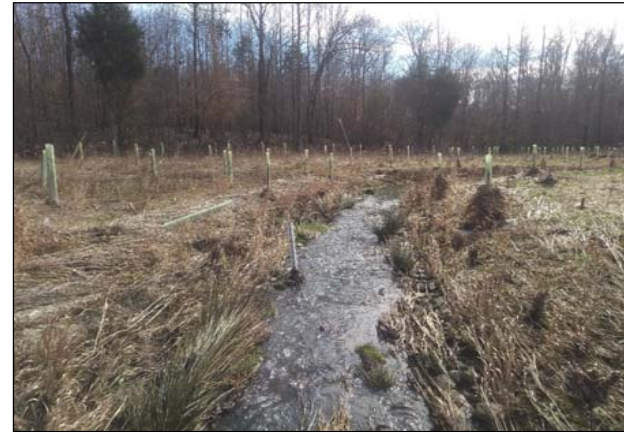
River Basin:	Yadkin River
Site:	Cedar Branch
XS ID	XS14
Drainage Area (sq mi):	0.41
Date:	1/14/2019
Field Crew:	T. Seelinger, J. Sullivan

SUMMARY DATA	
Current Bankfull Elevation:	637.95
Bankfull Cross-Sectional Area:	12.8
Total Cross-Sectional Area:	12.6
Bankfull Width:	13.9
Flood Prone Area Elevation:	639.6
Flood Prone Width:	43.5
Max Depth at Bankfull:	1.7
Mean Depth at Bankfull:	0.9
W / D Ratio:	15.1
Entrenchment Ratio:	3.1
Bank Height Ratio:	1.1

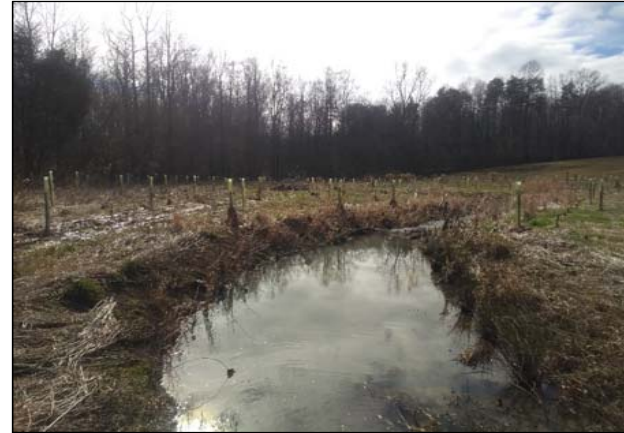
River Basin:	Yadkin River
Site:	Cedar Branch
XS ID	XS15
Drainage Area (sq mi):	0.41
Date:	1/14/2019
Field Crew:	T. Seelinger, J. Sullivan

SUMMARY DATA	
Current Bankfull Elevation:	637.57
Bankfull Cross-Sectional Area:	35.8
Total Cross-Sectional Area:	32.8
Bankfull Width:	20.7
Flood Prone Area Elevation:	---
Flood Prone Width:	---
Max Depth at Bankfull:	3.3
Mean Depth at Bankfull:	1.7
W / D Ratio:	---
Entrenchment Ratio:	---
Bank Height Ratio:	---

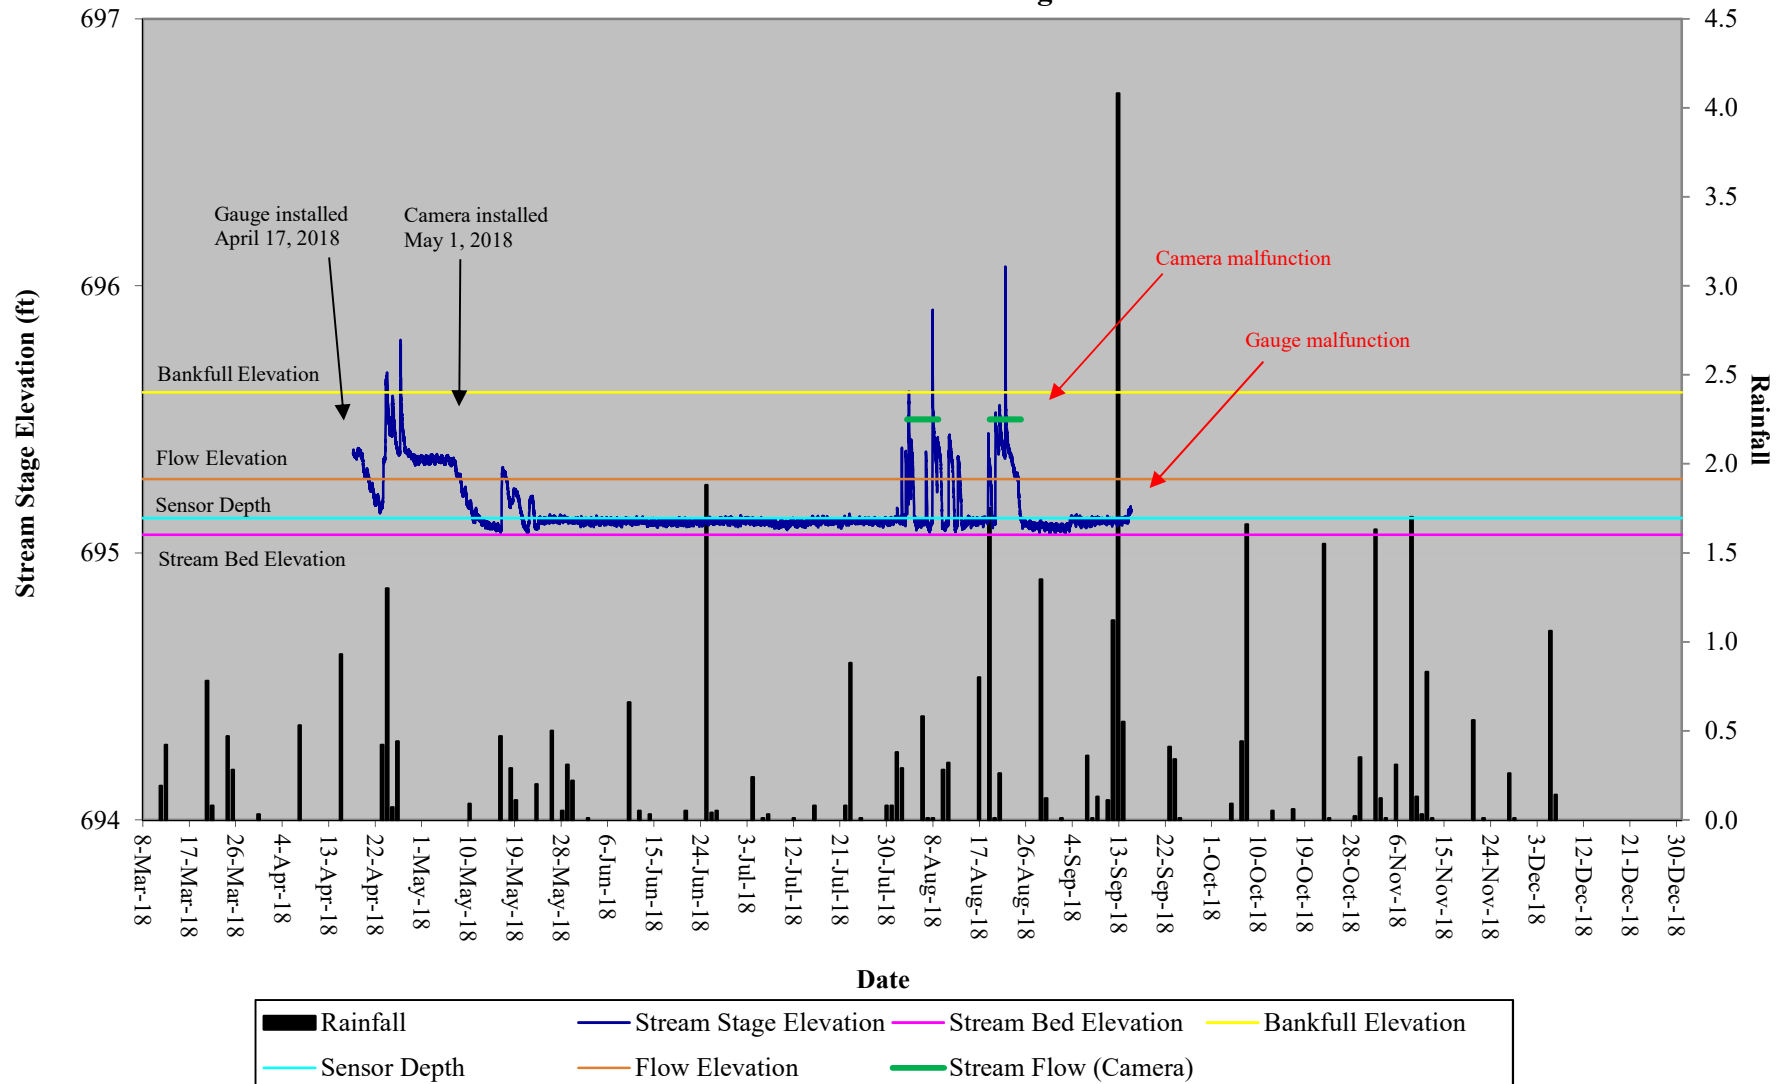
Cedar Branch Restoration Site Hydrograph T1-1 Stream Flow Gauge

Table 12. Stream Flow Criteria Attainment Cedar Branch Restoration Site, DMS Project #97009							
	Greater than 30 Days of Flow/Max Consecutive Days						
Reach	MY-01 2018	MY-02 2019	MY-03 2020	MY-04 2021	MY-05 2022	MY-06 2023	MY-07 2024
T1 (Gauge)	Yes/60						
T1 (Camera)	Yes/102						
T1-1 (Gauge)	No/16						
T1-1 (Camera)	No/7*						
T3 (Gauge)	Yes/83						
T3 (Camera)	Yes/93

* camera malfunction
