Monitoring Report MY02

**Cedar Branch Restoration Site
Monitoring Year 02
DMS Contract 6598
DMS Project Number 97009**

**DWR #: 20150904
USACE Action ID: 2003-21395
Randolph County, North Carolina**

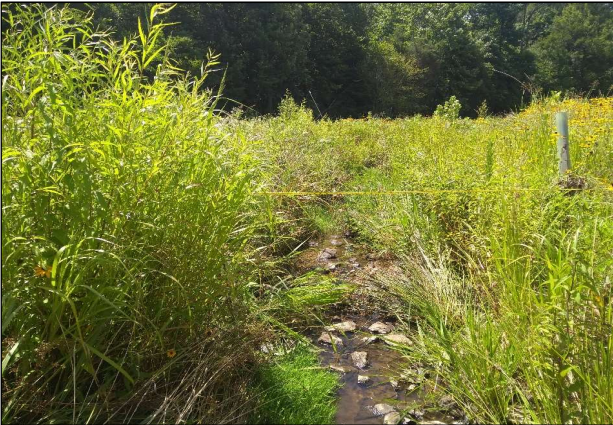
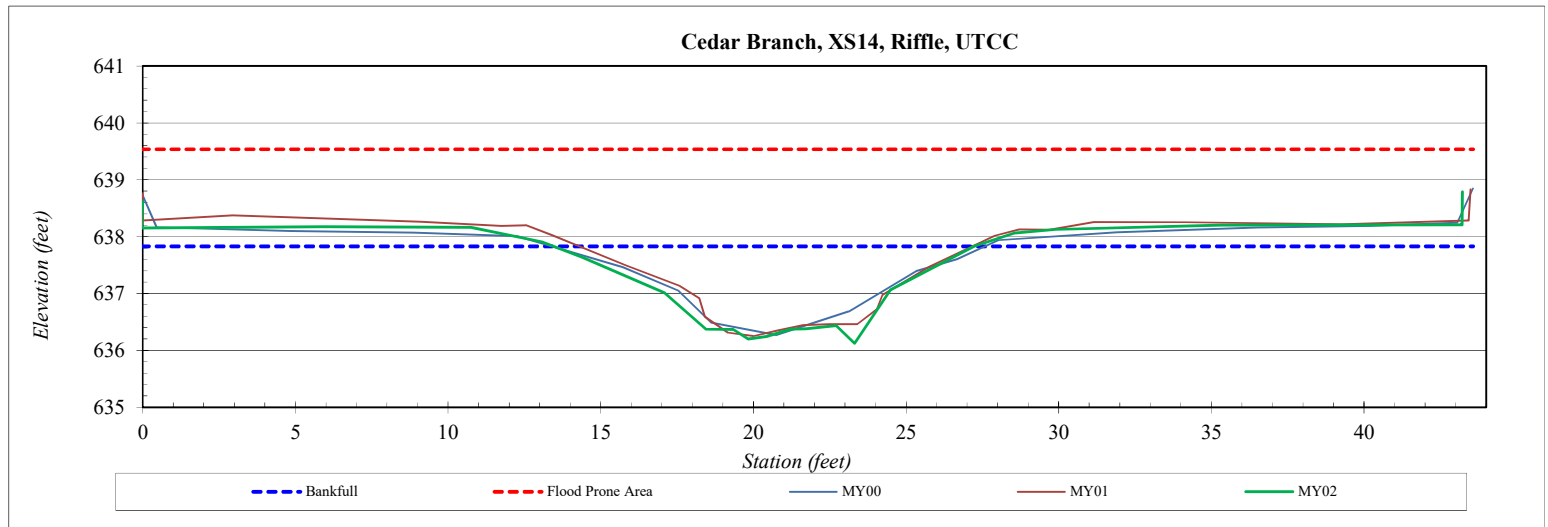
River Basin:	Yadkin River
Site:	Cedar Branch
XS ID	XS14
Drainage Area (sq mi):	0.41
Date:	6/26/2019
Field Crew:	T. Seelinger, A. Gutierrez

SUMMARY DATA	
Current Bankfull Elevation:	637.83
Bankfull Cross-Sectional Area:	12.8
Total Cross-Sectional Area:	14.3
Bankfull Width:	13.8
Flood Prone Area Elevation:	639.5
Flood Prone Width:	43.2
Max Depth at Bankfull:	1.7
Mean Depth at Bankfull:	0.9
W / D Ratio:	14.8
Entrenchment Ratio:	3.1
Bank Height Ratio:	1.0

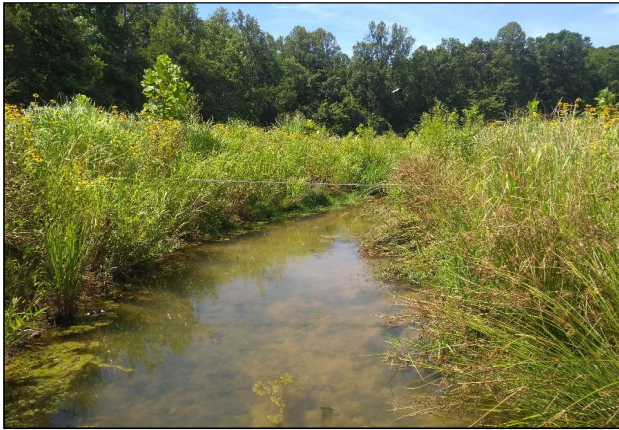
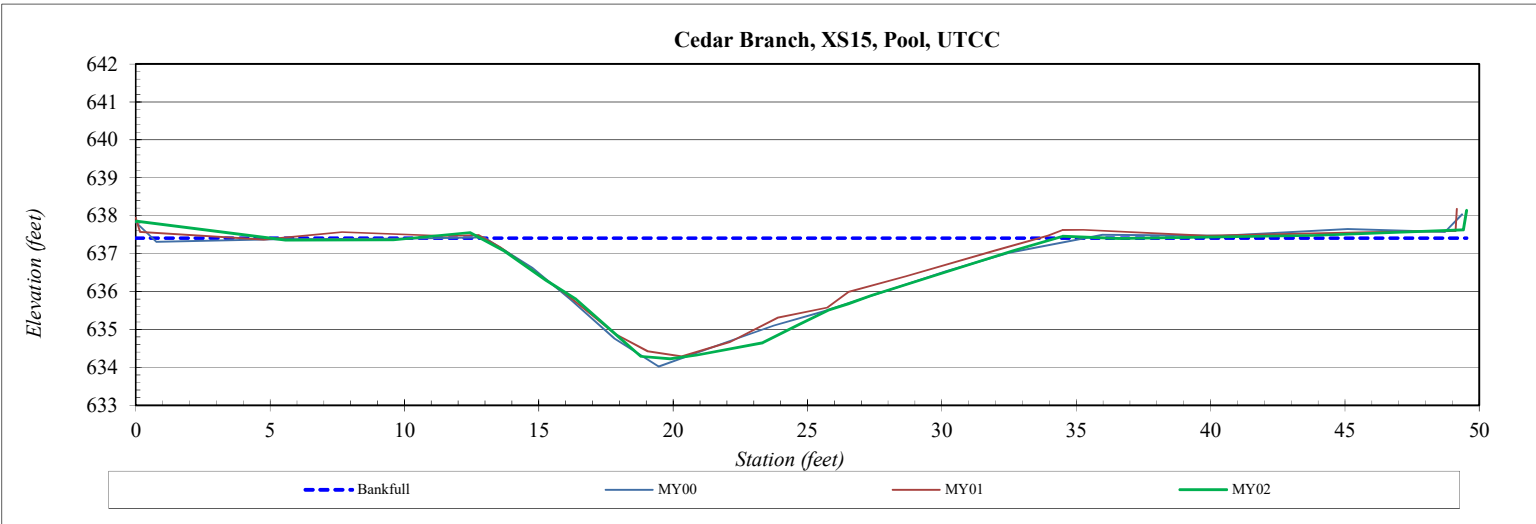
River Basin:	Yadkin River
Site:	Cedar Branch
XS ID	XS15
Drainage Area (sq mi):	0.41
Date:	6/26/2019
Field Crew:	T. Seelinger, A. Gutierrez

SUMMARY DATA	
Current Bankfull Elevation:	637.41
Bankfull Cross-Sectional Area:	35.8
Total Cross-Sectional Area:	36.2
Bankfull Width:	21.4
Flood Prone Area Elevation:	---
Flood Prone Width:	---
Max Depth at Bankfull:	3.2
Mean Depth at Bankfull:	1.7
W / D Ratio:	---
Entrenchment Ratio:	---
Bank Height Ratio:	---
