**CEDAR CREEK STREAM AND WETLAND RESTORATION
PROJECT
MONITORING REPORT
MONITORING YEAR 1**

SAMPSON COUNTY, NORTH CAROLINA
CONTRACT NO. 005011 - PROJECT NO. 95718

March 2016

**Resource Environmental Solutions, LLC
302 Jefferson Street, Suite 110
Raleigh, NC 27605
919-209-1061**

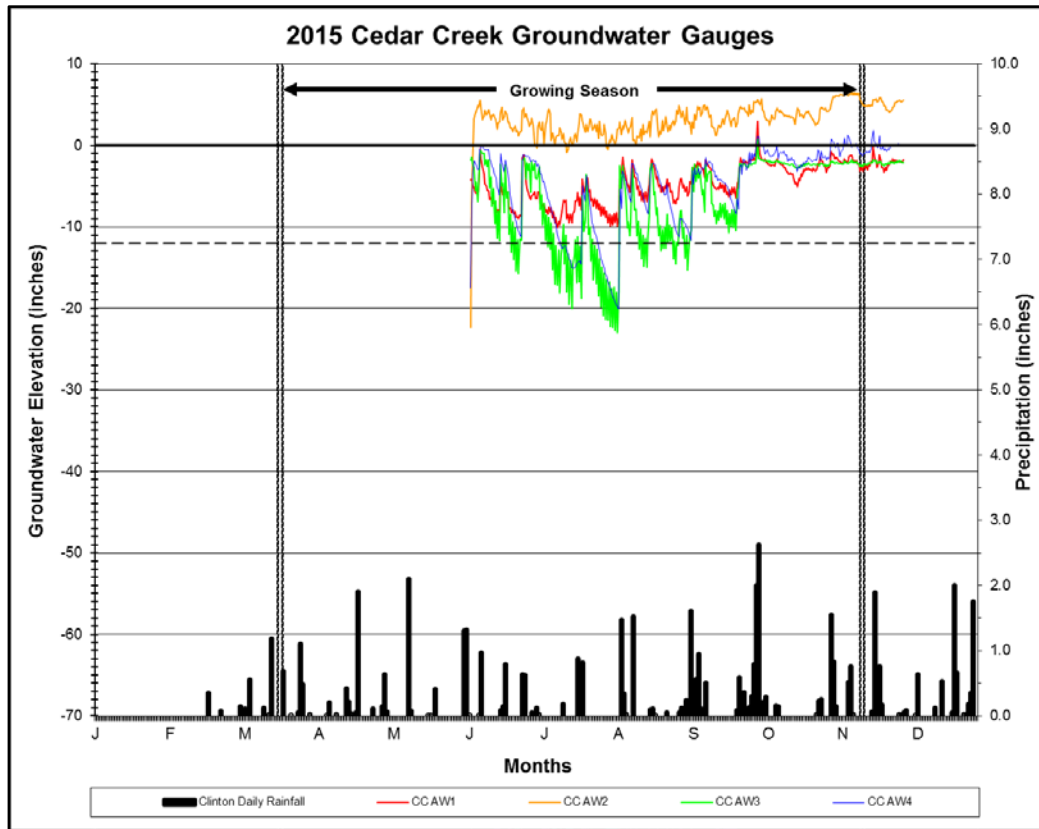
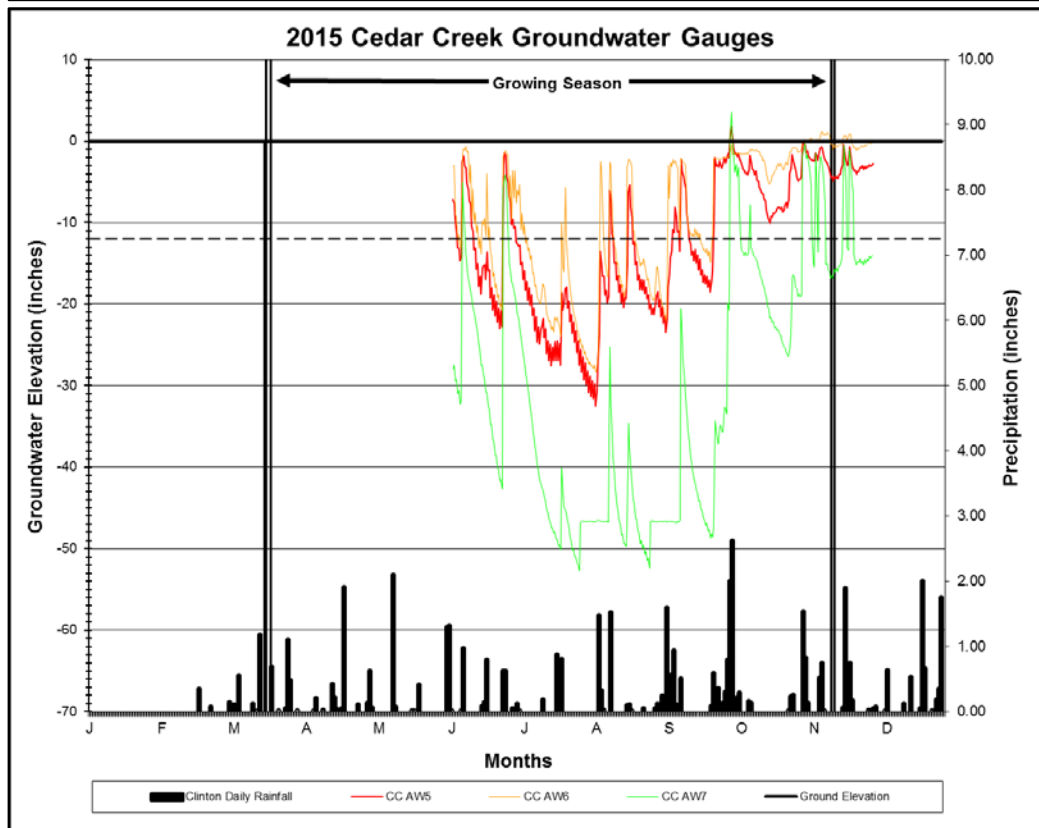
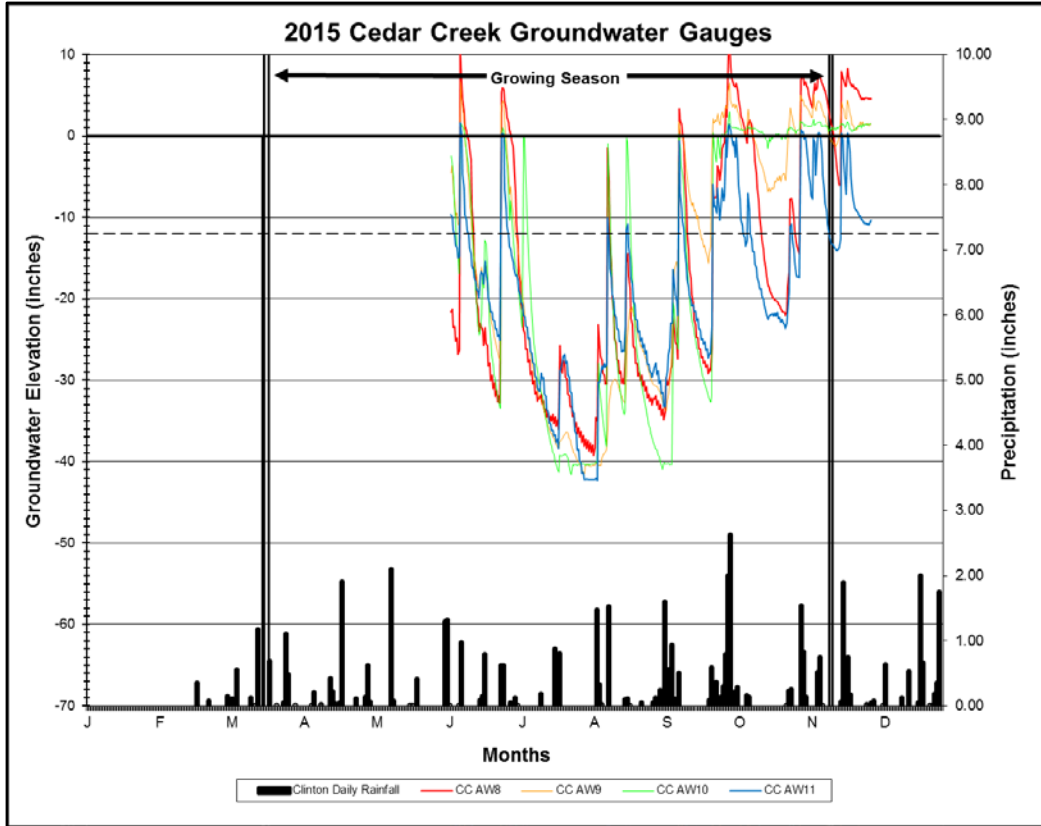
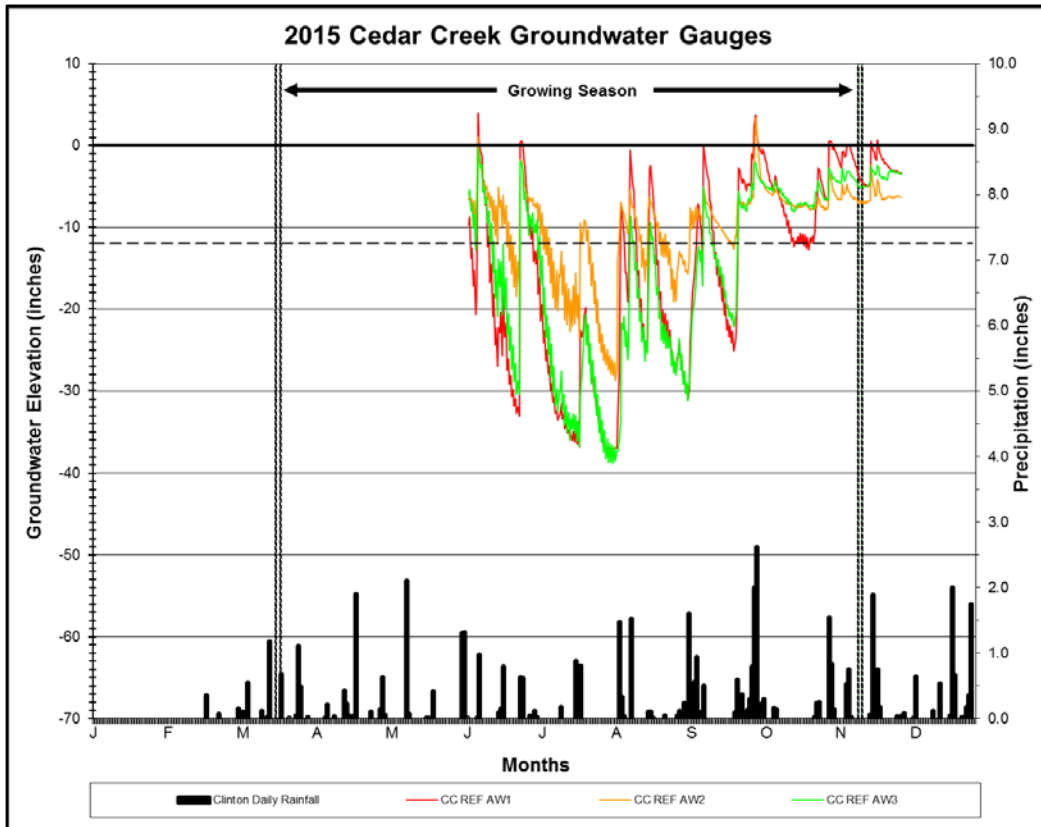
Chart 2. 2015 Cedar Creek Site Groundwater Monitoring Gauge Hydrographs

Eleven wetland hydrology gauges were installed in early June 2015 and documented hydrology conditions for approximately 67 percent of the total growing season. Ten of the eleven wetland gauges (only AW7 did not) achieved the success criteria by remaining continuously within 12 inches of the soil surface for at least nine percent of the growing season. Since wetland hydrology was only monitored for the last portion of the growing season, it is difficult to determine if the remaining gauge was successful. Groundwater gauge data indicate the hydroperiods being responsive to rainfall events. All three reference gauges met the nine percent success criteria, with RAW2 and RAW3 having hydroperiods of 21 percent and RAW1 having a hydroperiod of ten percent. Year 2 wetland hydrology monitoring data will represent the first full growing season. Wetland gauge and rainfall data is presented in Appendix E.
