**CEDAR CREEK STREAM AND WETLAND RESTORATION  
PROJECT  
MONITORING REPORT  
MONITORING YEAR 3  
FINAL**

SAMPSON COUNTY, NORTH CAROLINA  
CONTRACT No. 005011 - PROJECT No. 95718  
USACE ACTION ID No. 2012-00389 – NCDWR PROJECT No. 2013-0186

RE: Cedar Creek Stream and Wetland Restoration Site: MY3 Monitoring Report  
(NCDMS ID 95718)

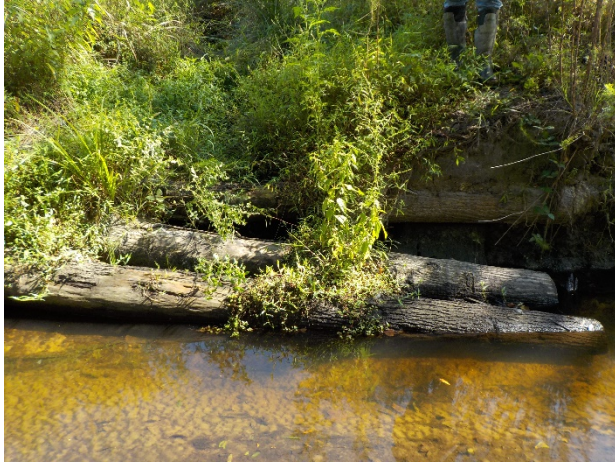
<b>Table 7. Stream Problem Areas</b> <b>Cedar Creek Stream and Wetland Restoration Project - Project # 95718</b>			
<b>Feature Issue</b>	<b>Station # / Range</b>	<b>Suspected Cause; Repair</b>	<b>Photo Number</b>
<b>Unstable Log Outlet Structure</b>	UT2 @ 9+28	Log outlet structure is dislodged and is unfunctional. Structure repair is recommended.	SPA1
<b>Bank Erosion</b>	UT1 @ 25+75 and 27+50 to 28+75	Localized bank erosion on left and right banks. Recommended minimal earthwork, re-matting and livestocking.	SPA2
<b>Undercut Log Sills</b>	UT3 @ 20+10 to 20+00	Water is undercutting two log sills. Continue to monitor to determine if channel is affected upstream of structure.	SPA3

SPA1-Non-functioning Log Outlet Structure –  
Confluence of UT1 and UT2

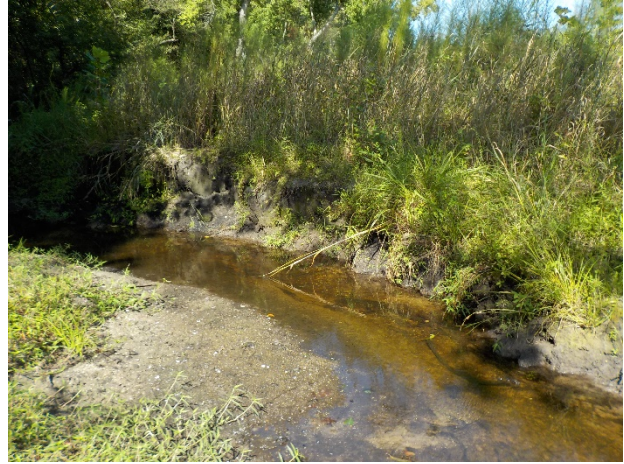
SPA2- Bank Erosion on right bank - UT1  
@ Sta. 25+75

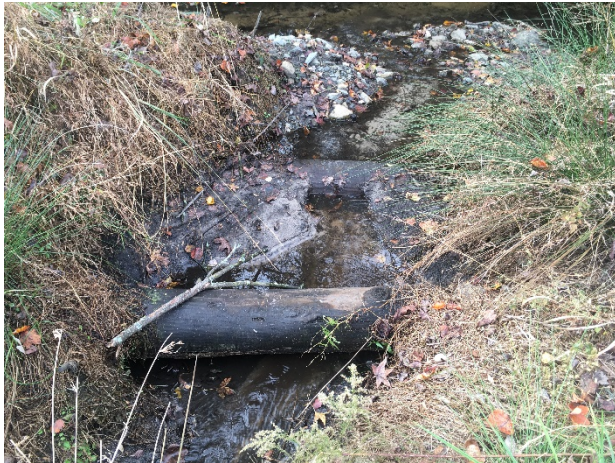
SPA3 – Undercut Log Sills – UT3 @ Sta. 20+10 to  
20+00
