**CEDAR CREEK STREAM AND WETLAND RESTORATION
PROJECT
MONITORING REPORT
MONITORING YEAR 4
FINAL**

SAMPSON COUNTY, NORTH CAROLINA
CONTRACT No. 005011 - PROJECT No. 95718
USACE ACTION ID No. 2012-00389 – NCDWR PROJECT No. 2013-0186

**Cedar Creek
Sampson County, North Carolina
DMS Project ID 95718**

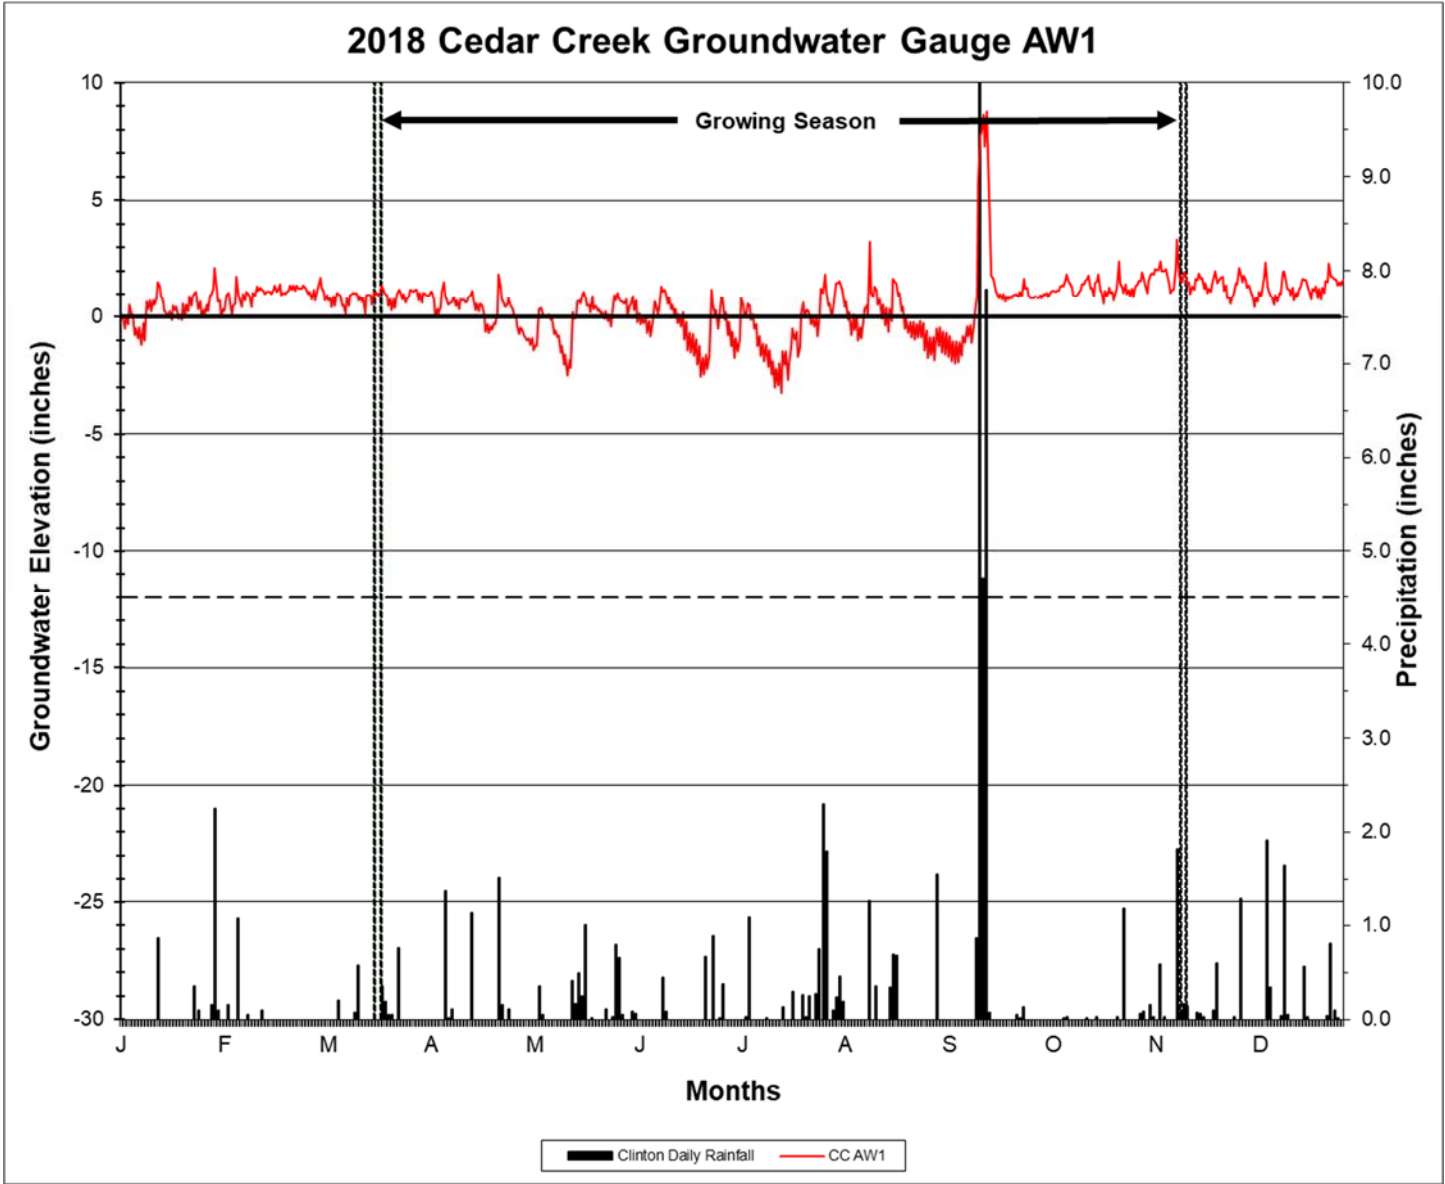
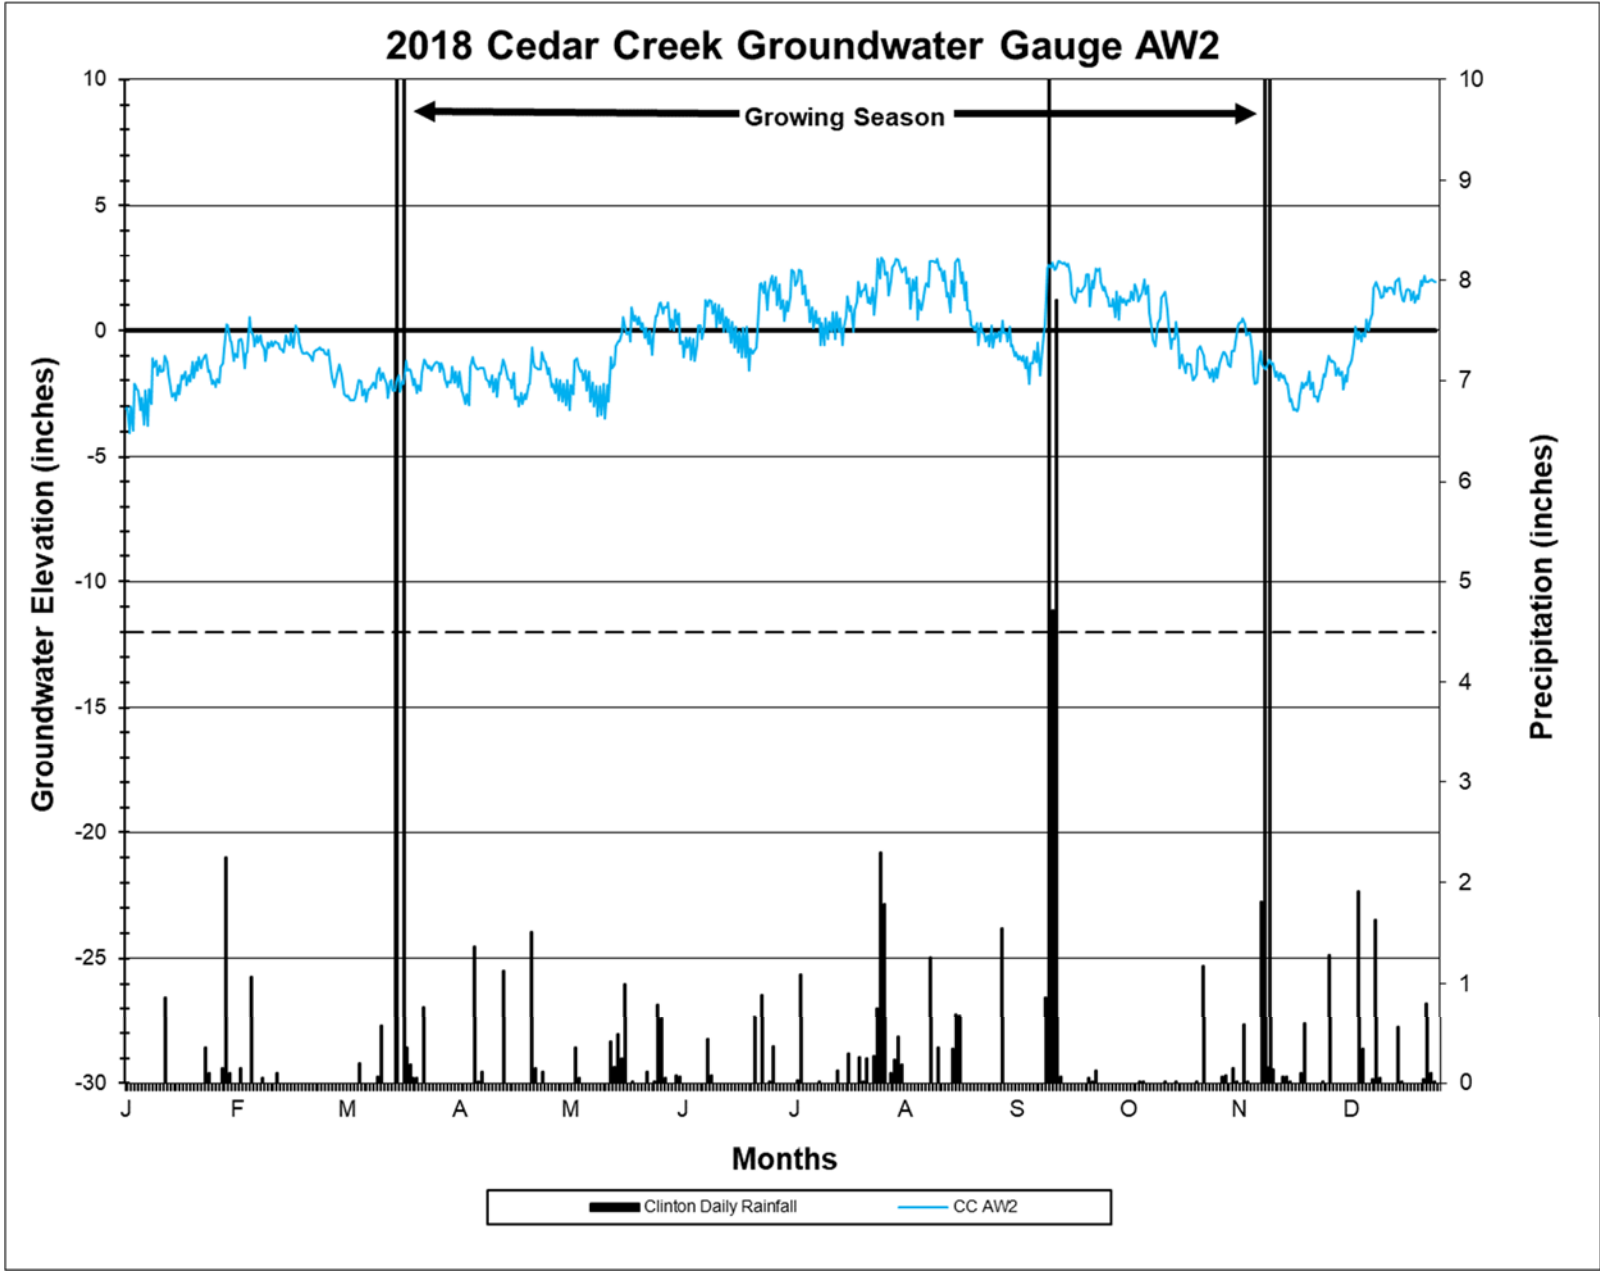
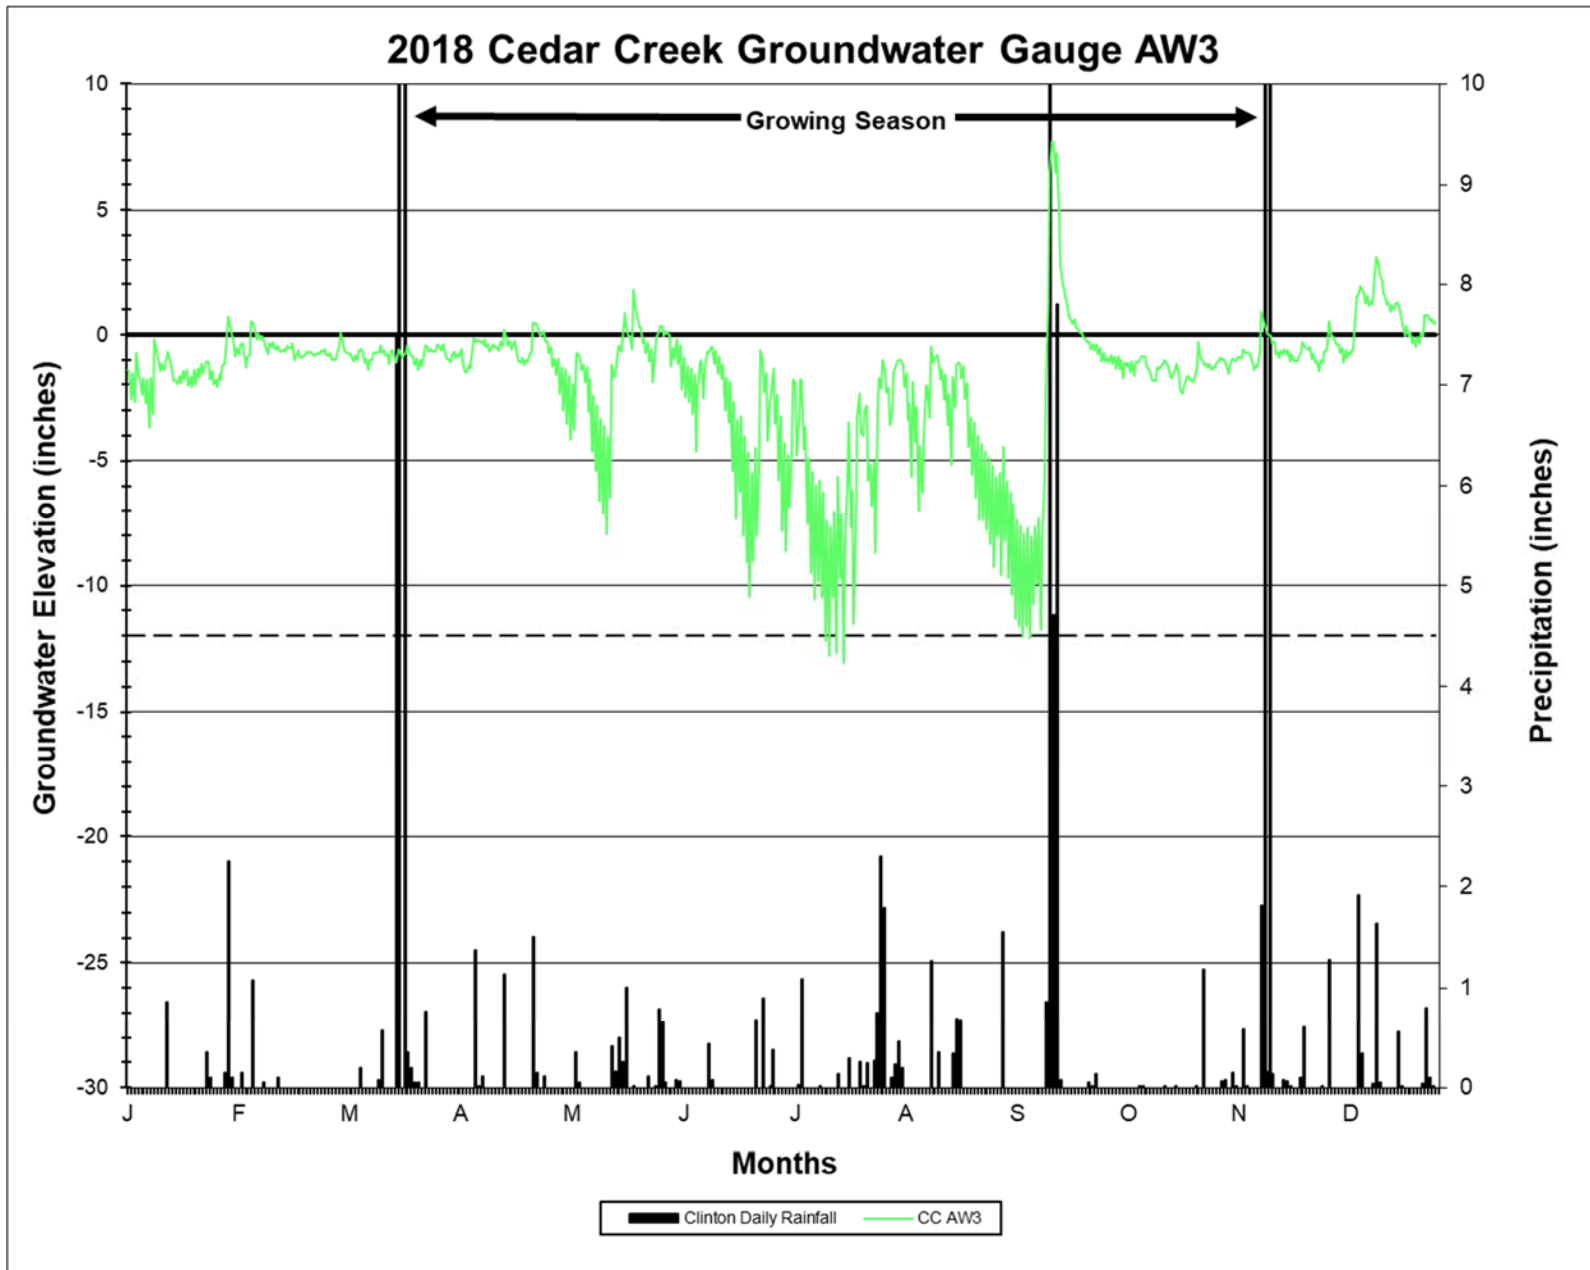
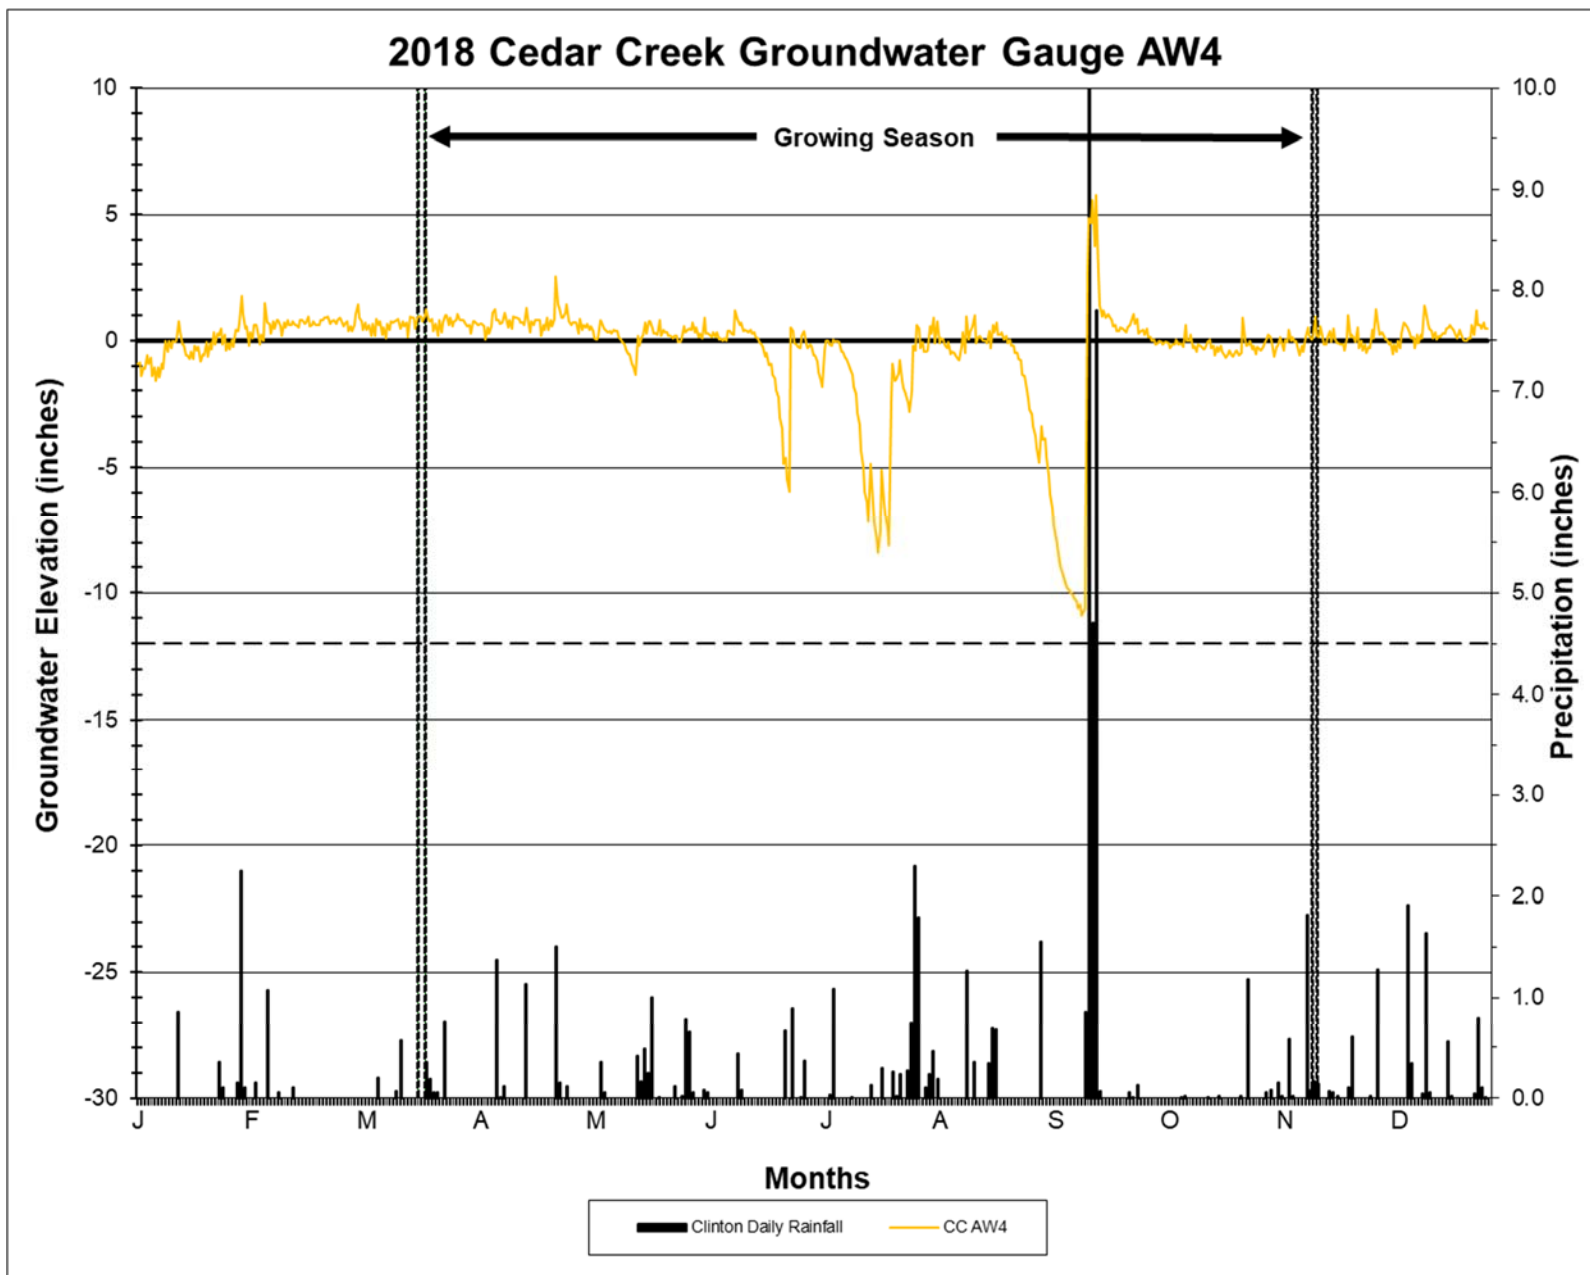
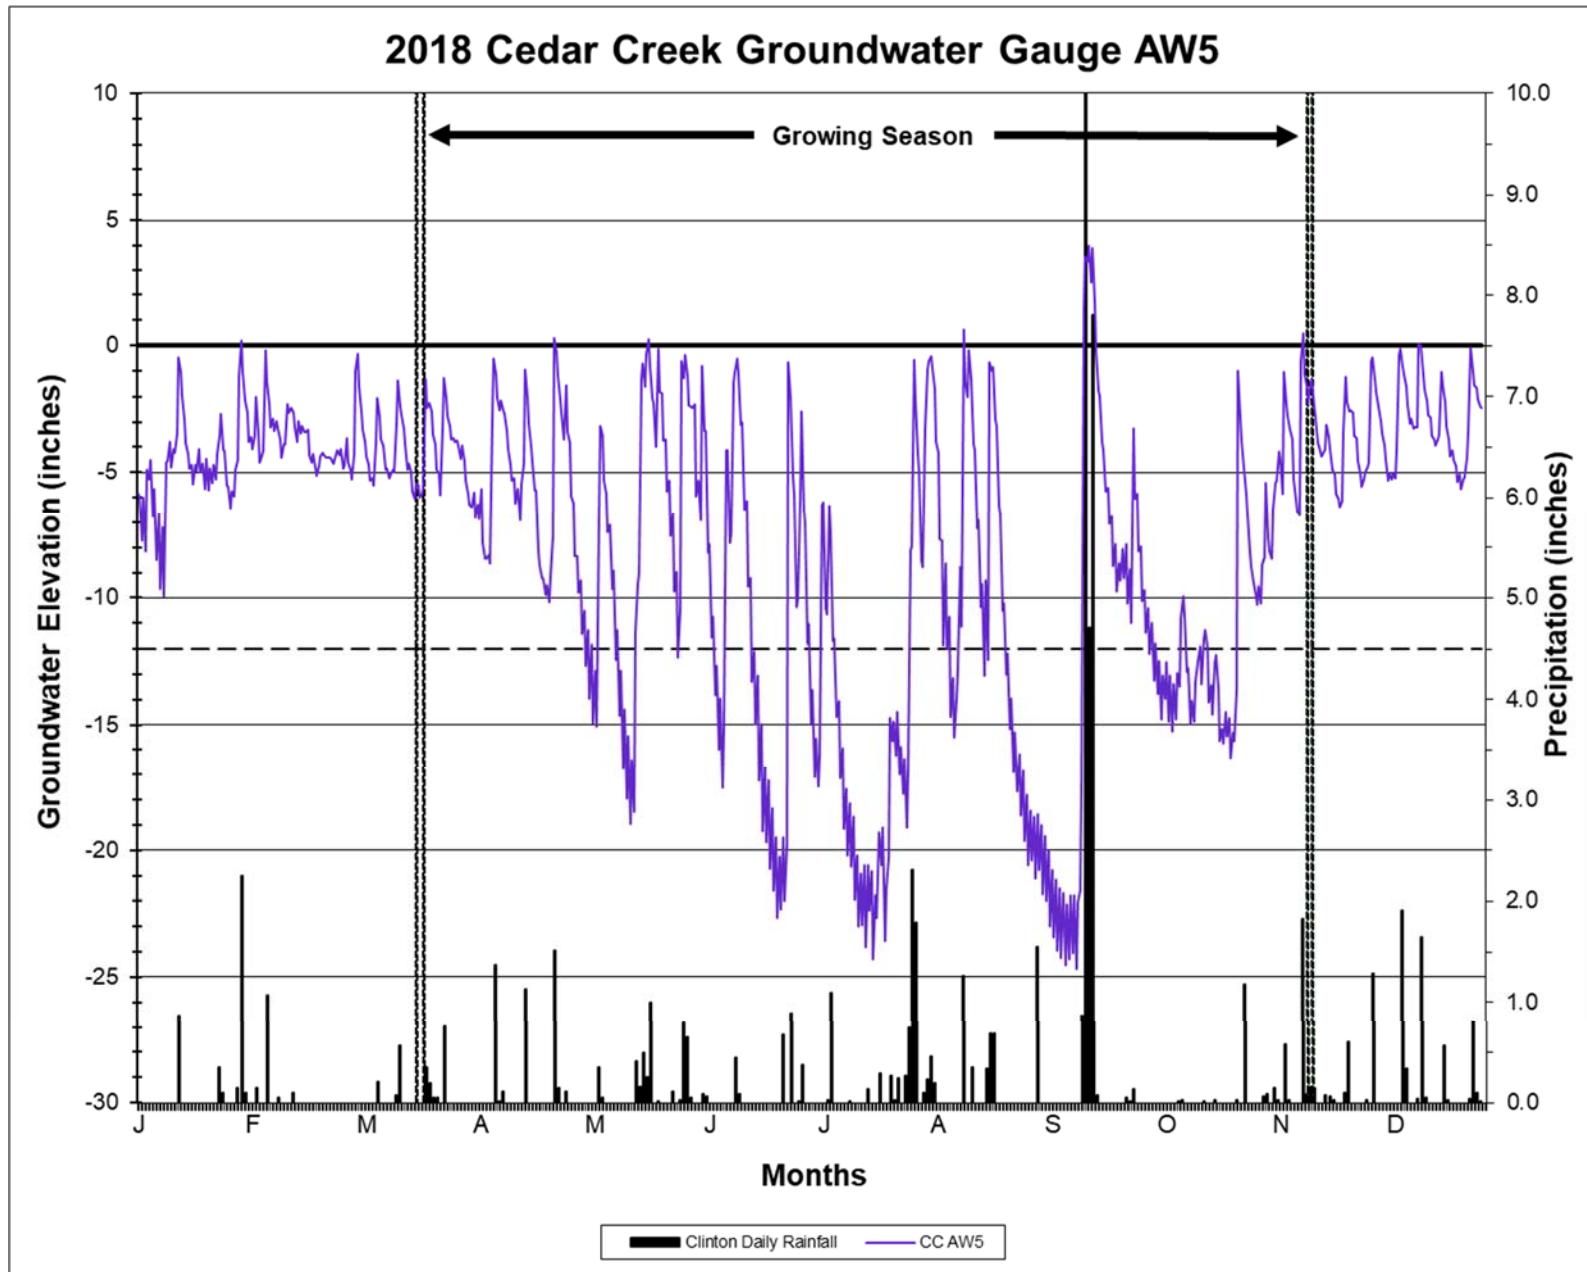
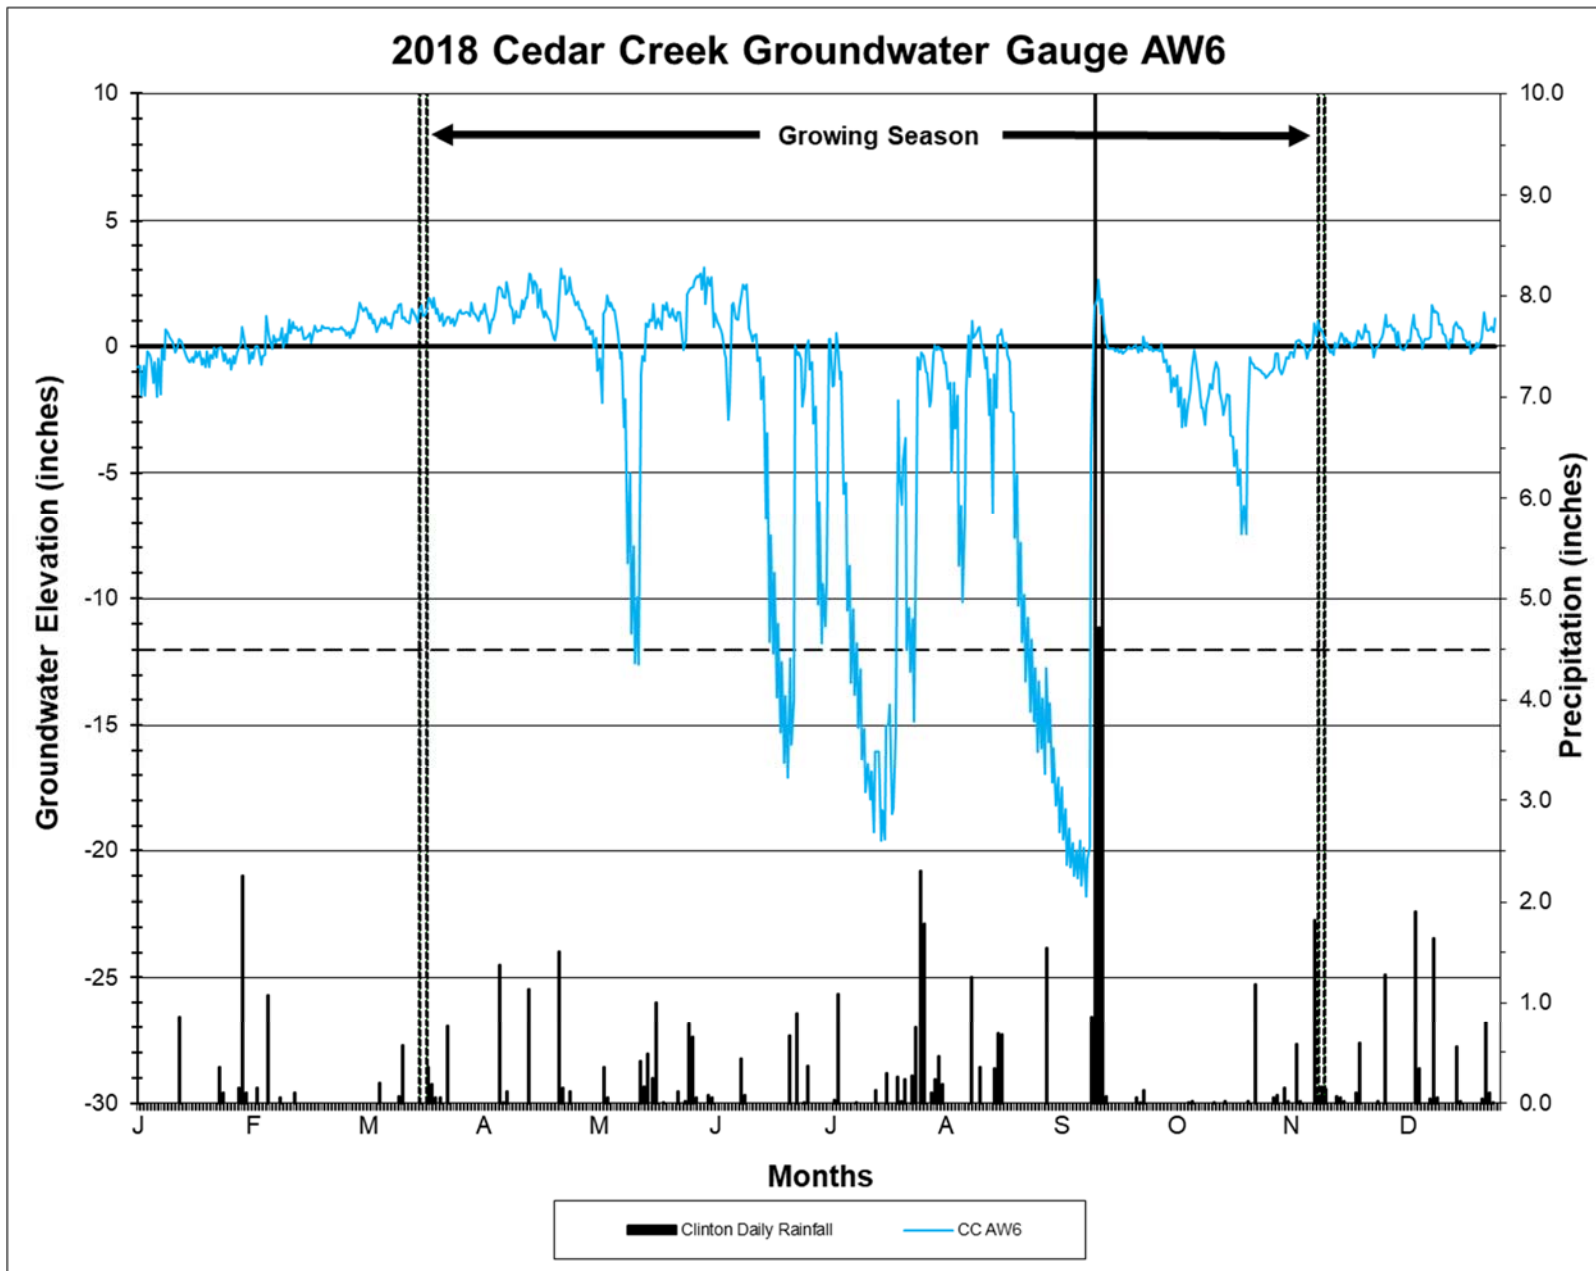
Figure 8. 2018 Cedar Creek Groundwater Monitoring Gauge Hydrographs

8. **Appendix E:**
 - a. 2018 Groundwater Monitoring Gauge Hydrographs: In reviewing these hydrographs, it appears that the entire growing season was not observed for the wetland assessment/gauge data collection. Please explain why not.
RES collected additional groundwater monitoring on January 10, 2019. The report now includes data from the entire growing season.

Eight of the eleven wetland gauges achieved the success criteria by remaining continuously within 12 inches of the soil surface for at least nine percent of the growing season. Groundwater gauge data indicate the hydroperiods being very responsive to rainfall events. Wetland hydrology gauge AW7 fell short of the nine percent success criteria. AW7 documented 7 days consecutively (3%) throughout the growing season. RES plugged the ditch adjacent to AW7 to make sure wetland hydrology is met in this area in future years. AW8 and AW11 fell short of the success as well but stayed above the five percent hydroperiod for jurisdictional wetlands with eight percent. All three reference gauges documented hydroperiods well above the nine percent success criteria ranging from 15 to 23 percent of the growing season. Wetland gauge and rainfall data is presented in **Table 15** and **Figure 8**.
