**Chapel Creek Stream Restoration Project
Orange County, North Carolina
EEP Project #77**

MY-02 Monitoring Report - Final

Data Collected: October 6, 2010

**Ward Consulting Engineers, P.C.
Firm License Number C-2619
Project Manager: Becky Ward, P.E.
8368 Six Forks Road, Suite 104
Raleigh, NC 27615-5083
Ph: 919-870-0526
Fax: 919-870-5359**

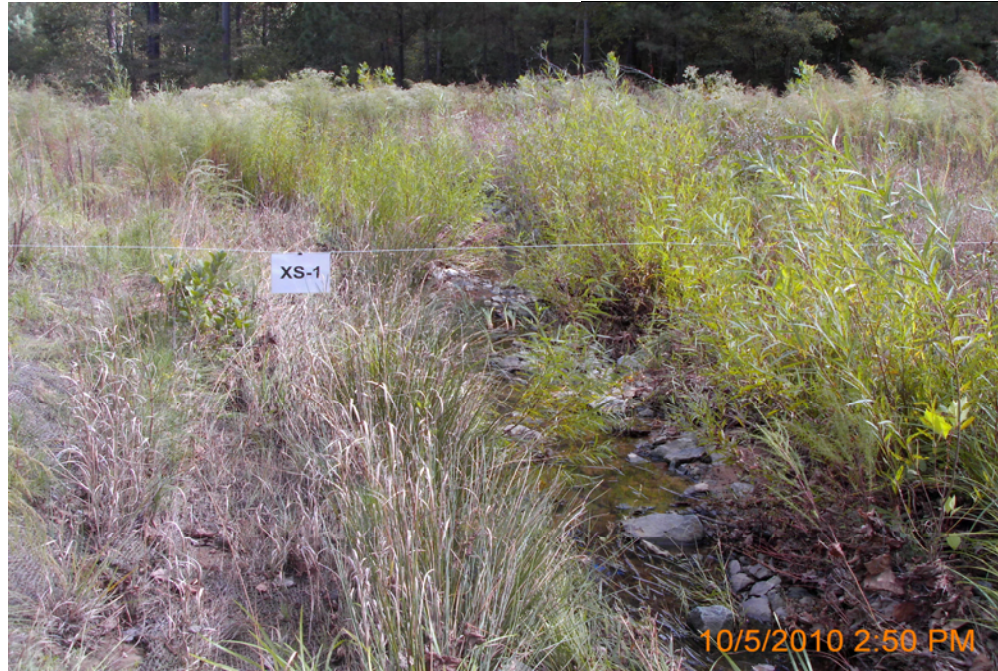
Cross Section 1

Photo of XS-1, looking in the downstream direction

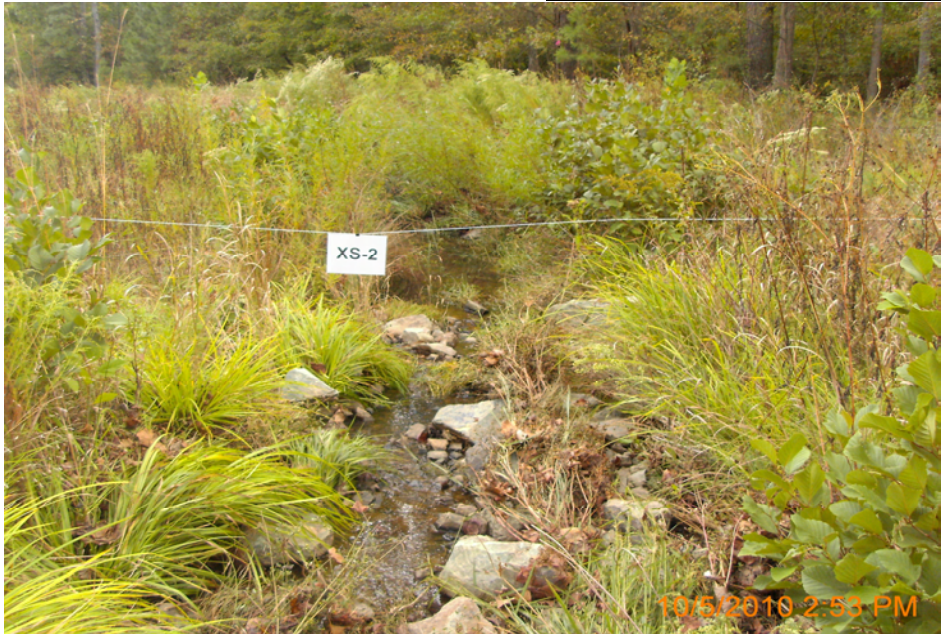
Project:	Chapel Creek	Summary (bankfull)			
Cross Section:	Cross Section 2	MY0	MY1	MY2	
Feature:	Riffle	A (BKF)	29.9	25.0	36.9
Station:	5+40	W (BKF)	23.0	19.1	31.0
Date:	10/5/10	Max d	2.4	2.0	2.9
Crew:	ZP, SV	Mean d	1.3	1.3	1.2
		W/D	17.6	14.6	26.1

Photo of XS-2, looking in the downstream direction

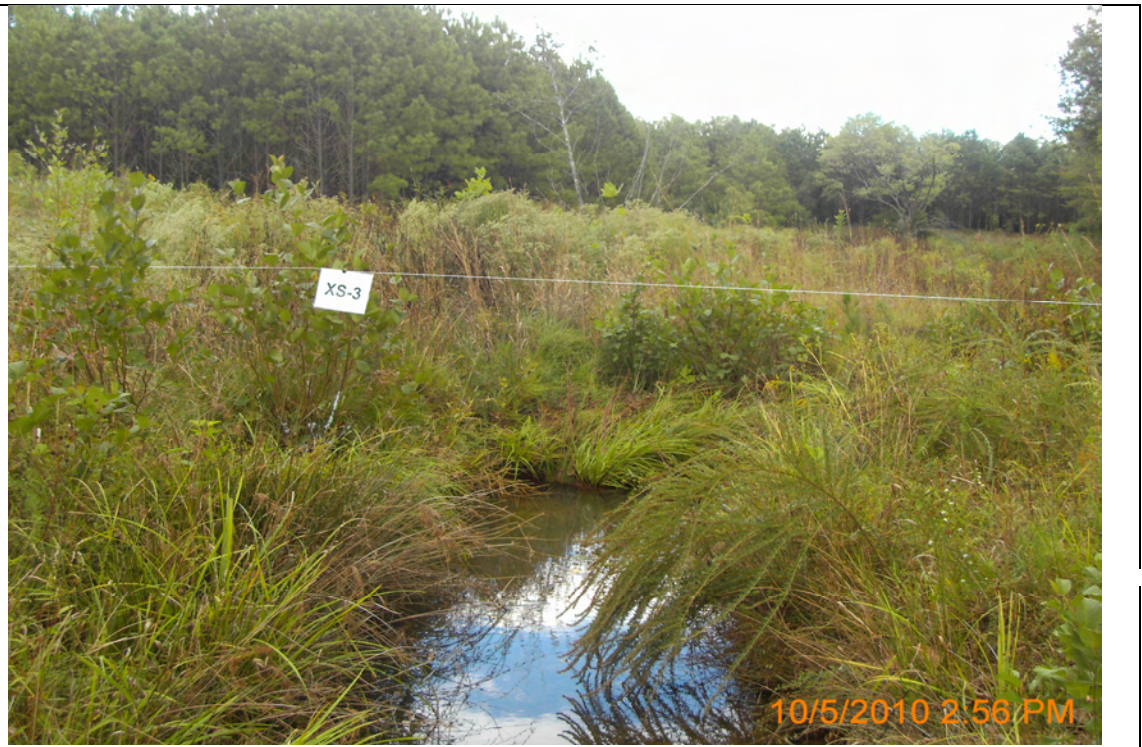
Project:	Chapel Creek	Summary (bankfull)			
Cross Section:	Cross Section 3	MY0	MY1	MY2	
Feature:	Pool	A (BKF)	31.7	31.1	30.7
Station:	6+28	W (BKF)	24.8	27.1	22.9
Date:	10/5/10	Max d	3.3	3.2	3.1
Crew:	ZP, SV	Mean d	1.3	1.1	1.3
		W/D	19.4	23.6	17.0

Photo of XS-3 looking in the downstream direction

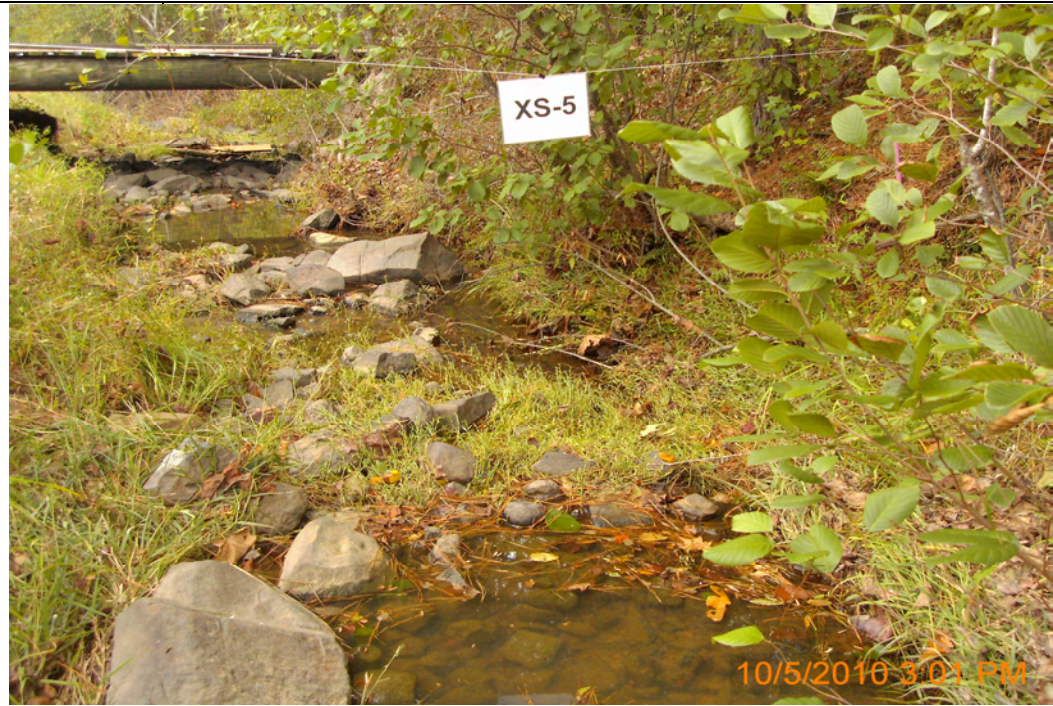
Project:	Chapel Creek	Summary (bankfull)			
Cross Section:	Cross Section 5	MY0	MY1	MY2	
Feature:	Riffle	A (BKF)	28.9	29.8	32.5
Station:	11+23	W (BKF)	15.4	16.3	17.5
Date:	10/5/10	Max d	2.9	2.7	2.8
Crew:	ZP, SV	Mean d	1.9	1.8	1.9
		W/D	8.2	8.9	9.4

Photo of XS-5, looking in the downstream direction

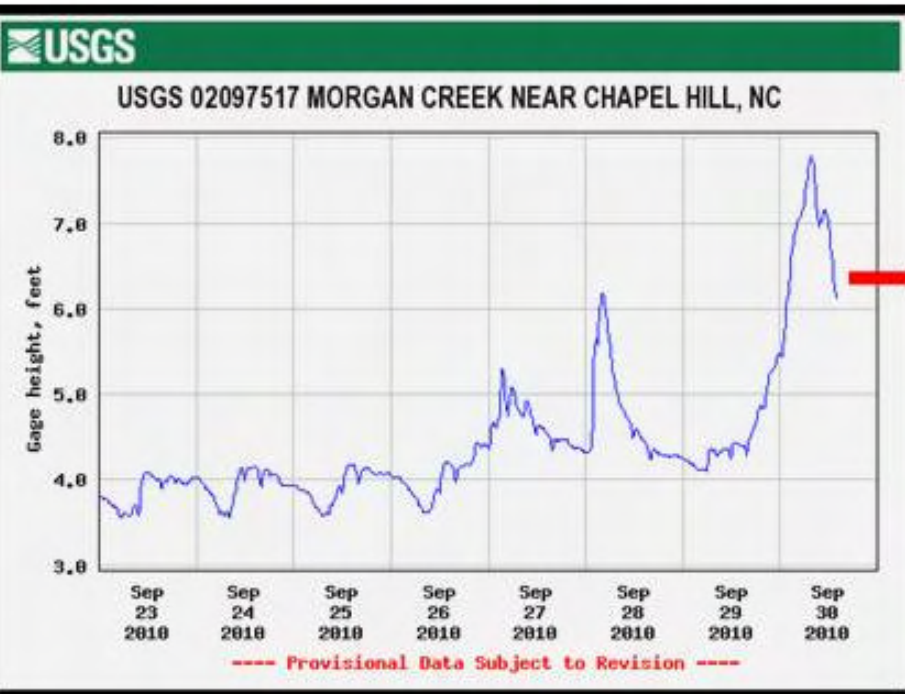
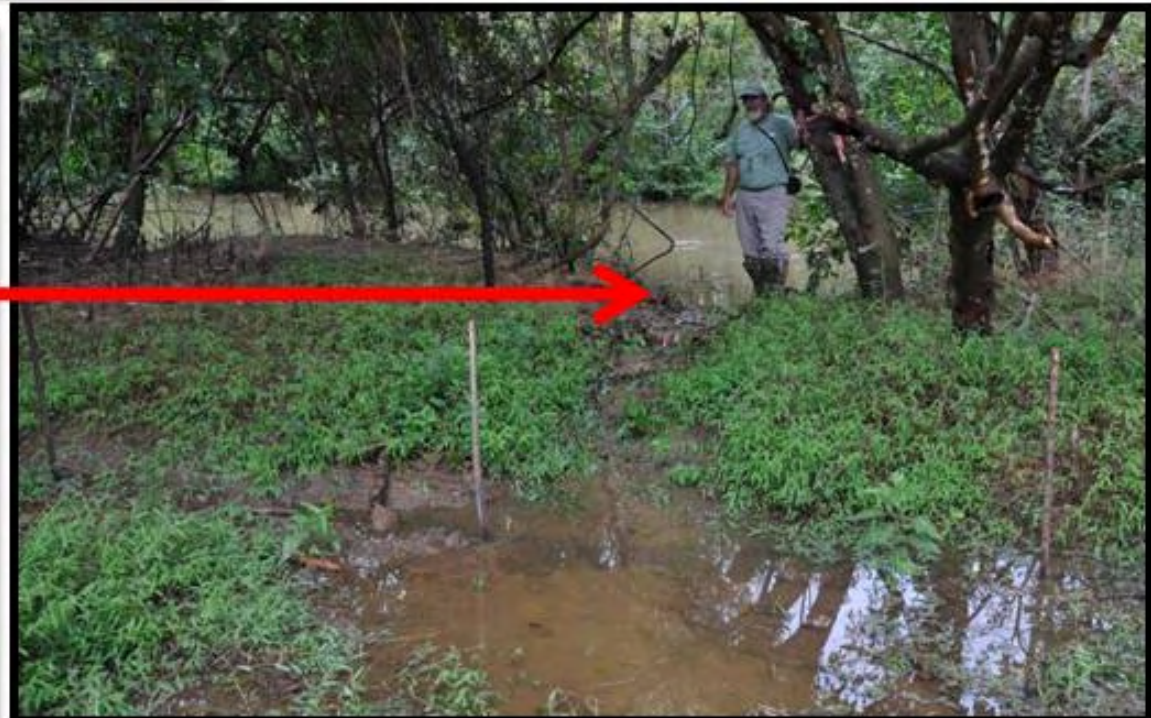
Morgan Creek berm openings 30 September, 2010. Arrow shows creek at ca. 6 feet. The maximum creek level (at ca. 7.8 feet) did not cause flow through the berm openings.
