**ANNUAL REPORT FOR 2003**

**South Fork Big Pine Creek Stream Mitigation Site  
(Charles/McGinnis Site)  
Madison County  
WBS Element 32573.4.1  
TIP No. A-10WM**

Prepared By:  
Office of Natural Environment & Roadside Environmental Unit  
North Carolina Department of Transportation  
December 2003

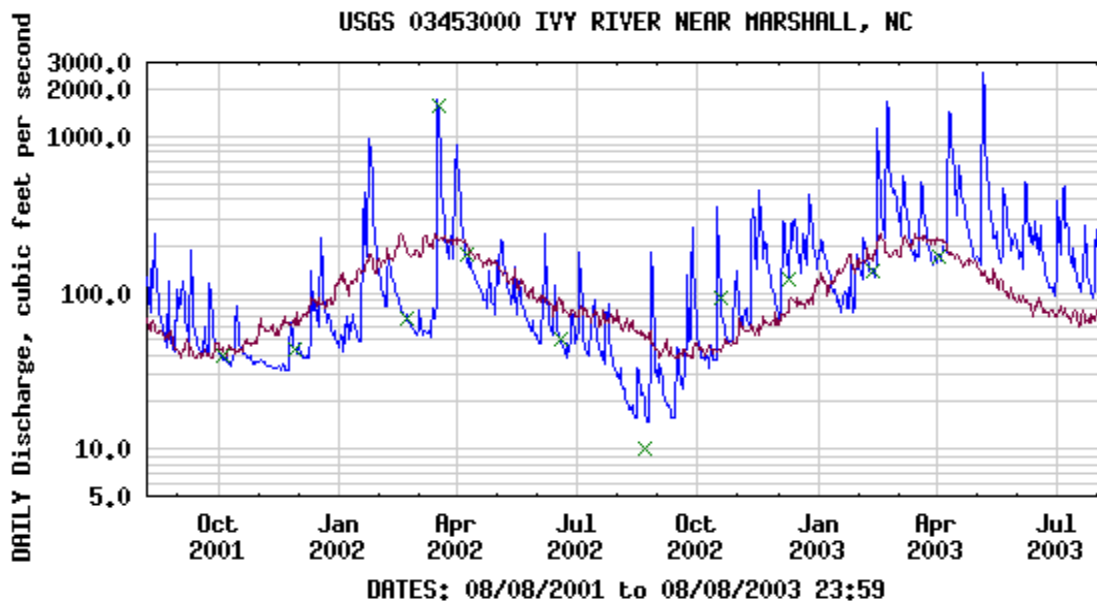
The Ivy River gage was utilized for this report since it is the smaller of the two gages (158 square-mile drainage area as compared to the 1,332 square-mile drainage area associated with the French Broad) and more accurately reflects hydrology and precipitation in the area. The Ivy River gage is situated in USGS Hydrologic Unit 06010105. Datum of the gage is 1,700.41 feet above sea level NGVD29. Based on the drainage area associated with the gage, the correlated bankfull discharge according to the NC Rural Mountain Regional Curves (USACE, 2003) is between 450 and 500 cubic feet per second (cfs). A review of peak flows was conducted for the period between August 2001 and August 2003. According to the graph, there were 14 bankfull events occurring during this period, with seven of the events happening in 2003. Approximately five of these events over the two year period exceeded 1,000 cfs, well above the bankfull discharge. The USGS graph depicting these peak flows is presented below.

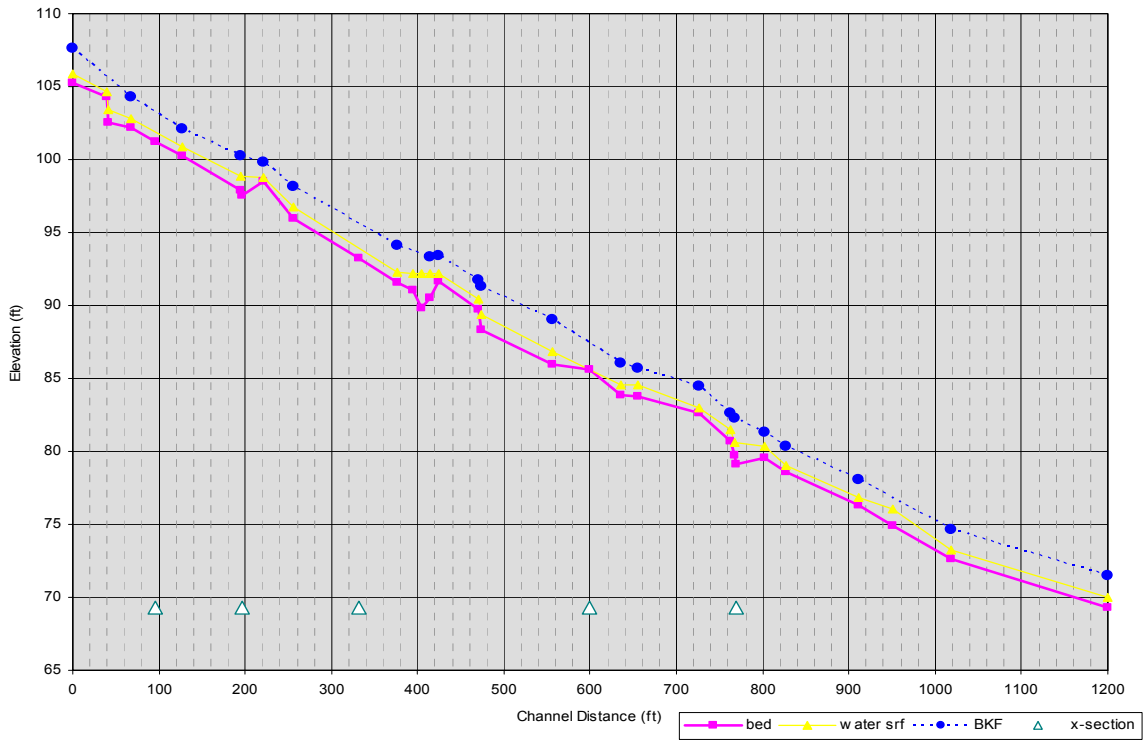
Longitudinal Profile of Big Pine Creek, Charles Site Madison County, NC (July 17, 2003)

Several head cuts were noted during the survey of the longitudinal profile. The first was noted at Station 0+40. This head cut was causing debris to accumulate in the center of the channel which appeared to be exacerbating bank erosion along both sides of the channel. The estimated drop of the thalweg was approximately two feet. The other two head cuts were observed at Stations 4+70 and 7+63. The second head cut exhibited a vertical drop of nearly 1.5 feet while the third dropped approximately one foot. Both the second and third head cuts had resulted in minor bank scouring.
