YEAR 3 MONITORING and CLOSEOUT REPORT
for
CHARLES/McGINNIS MITIGATION SITE
SOUTH FORK BIG PINE CREEK,
MADISON COUNTY, NORTH CAROLINA

EEP PROJECT NUMBER 92701

December 2008

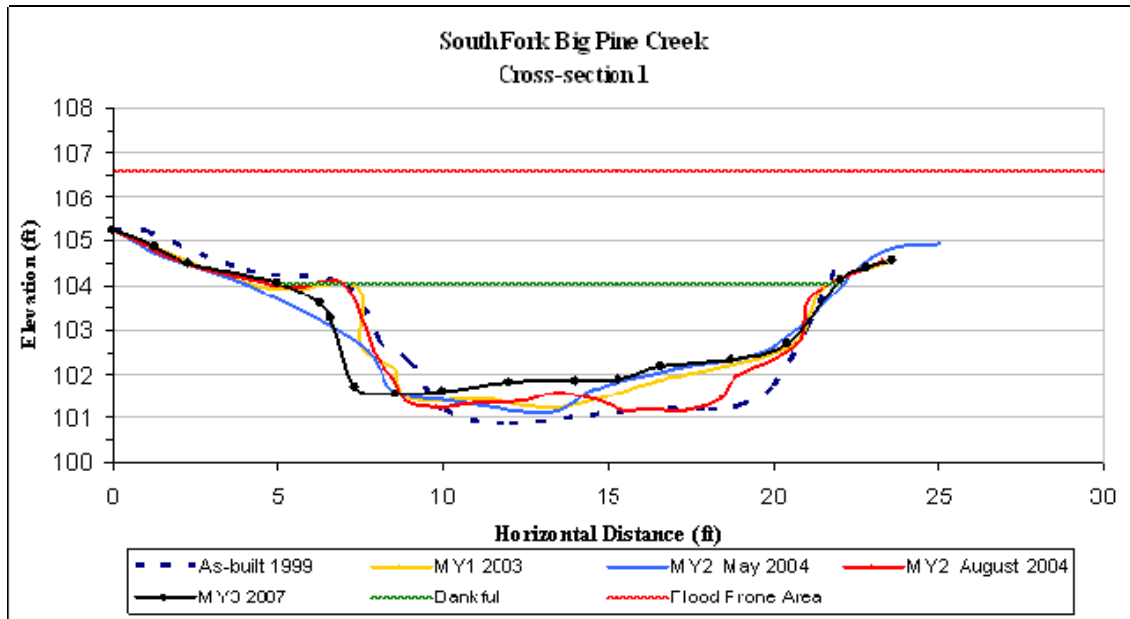
movement (bank erosion) observed along either streambank. The left bank is under cut at the waters edge; however, the bank is stable and well vegetated. The channel bottom has shown some minor aggradation.

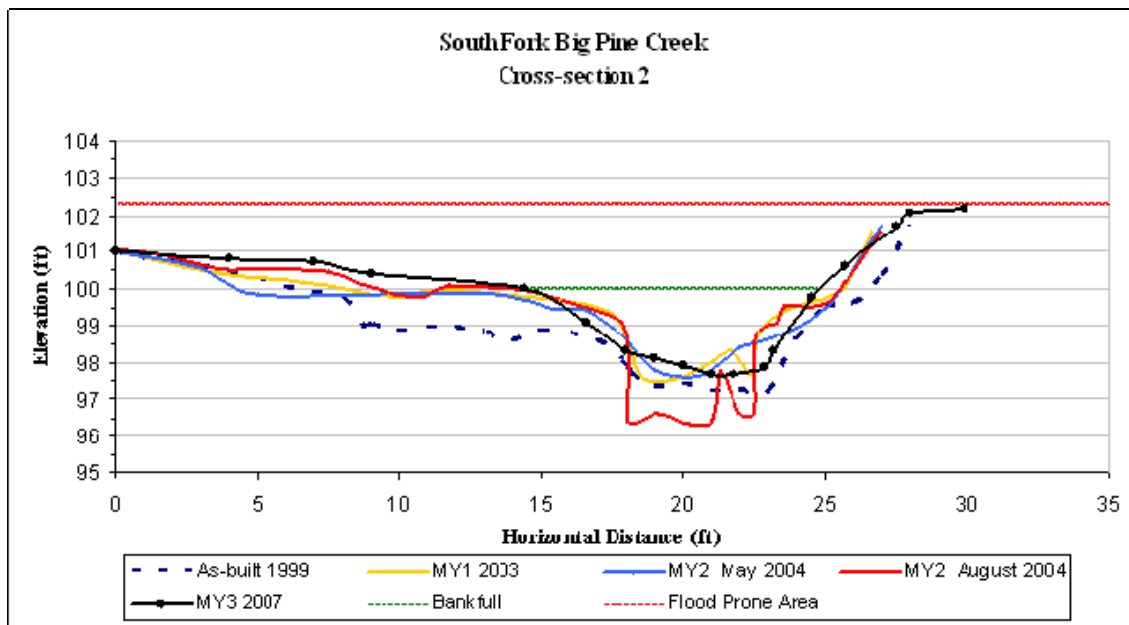
Cross-section 2, Run (Appendix table A.1.2).—The right bank of this cross-section is adjacent to SR 1158 and has been susceptible to erosion during high flow events in the past. The SR 1158 road shoulder between cross-section 2 and 3 has been repaired with large boulders and rip-rap at least twice after flood events. Aggradation on the left bank, from the water's edge up to easement fence line, is likely resulting from the vegetation capturing bed material during flood events. At the time of the MY3 survey, both the right and left banks were stable, and the left bank vegetation was well established.

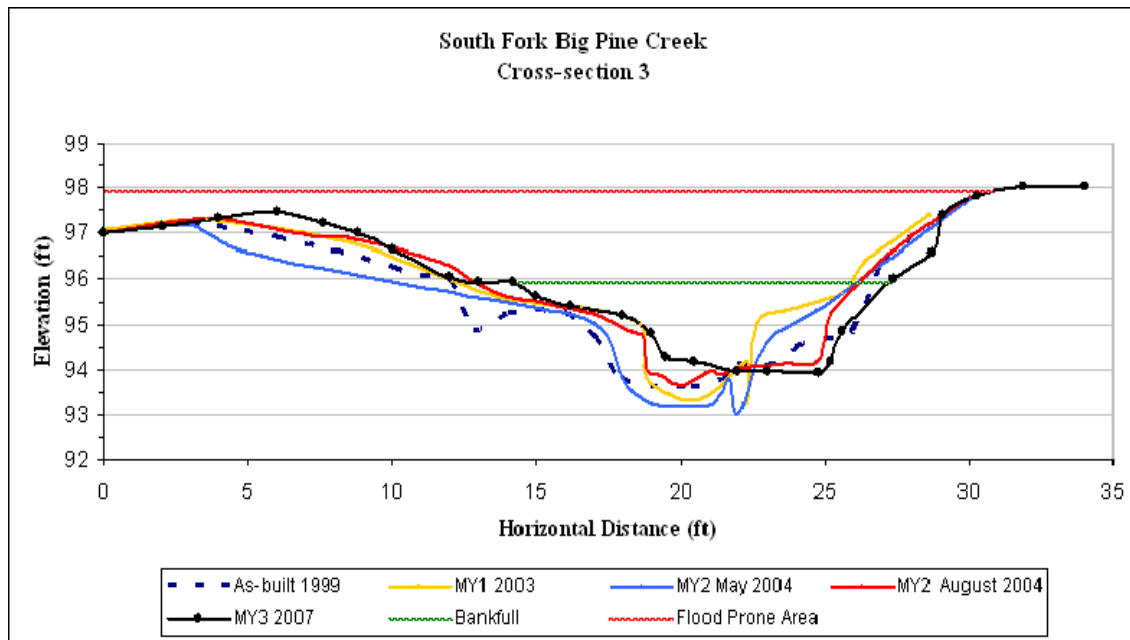
Cross-section 3, Riffle (Appendix Table A.1.3).—The right bank of this cross-section is adjacent to SR 1158. The right bank has been susceptible to erosion during high flow events in the past. The SR 1158 road shoulder between cross-section 2 and 3 has been repaired with large boulders and rip-rap at least twice following flood events. The thalweg has shifted towards the right bank when compared with its location following construction. The left bank is stable and well vegetated.

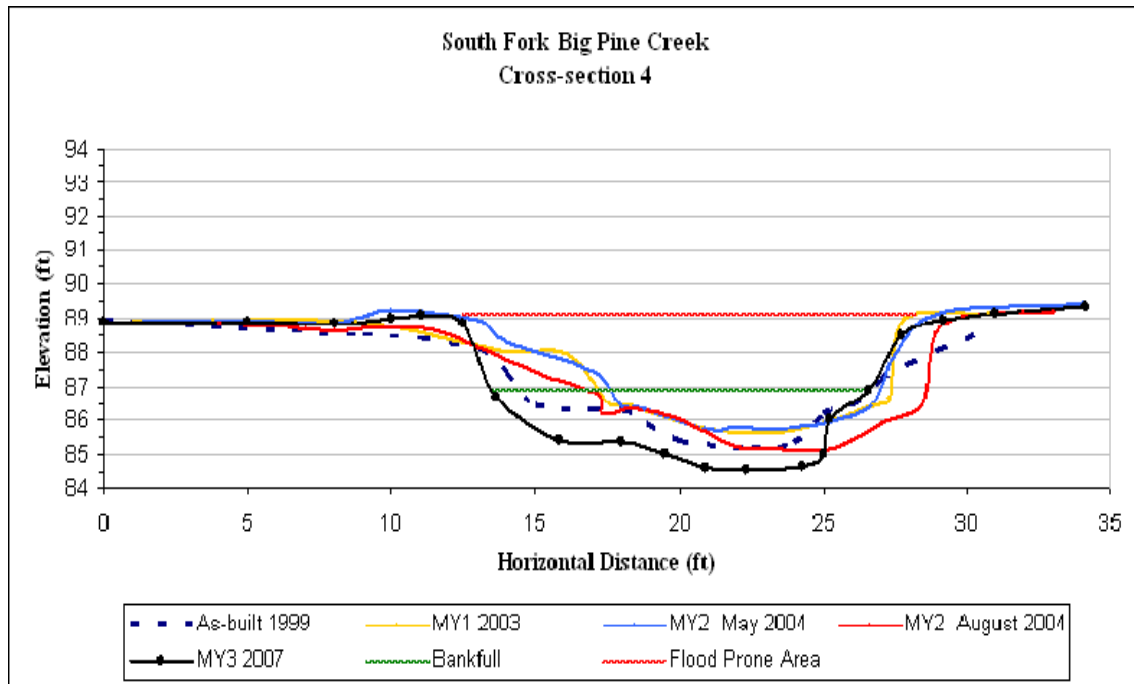
Cross-section 4, Riffle (Appendix Table A.1.4).—The right bank of this cross-section is adjacent to SR 1158 and has been susceptible to erosion during high flow events in the past. The SR 1158 road shoulder has been repaired with large boulders and rip-rap at least twice following flood events. This cross-section is located in a slight meander (to the left) that creates near bank stress against the right bank and road shoulder during high flows. The thalweg has deepened (± 0.8 ft) since the as-built survey; likely resulting from stream energy scouring the stream bed due to the confining of the channel laterally (on the right) by the large boulders used to stabilize the road shoulder. The root mass from an oak tree (present before construction) has protected the left bank from damage during flood events. That root mass combined with the reestablished woody plants should aid in keeping the left bank stable.

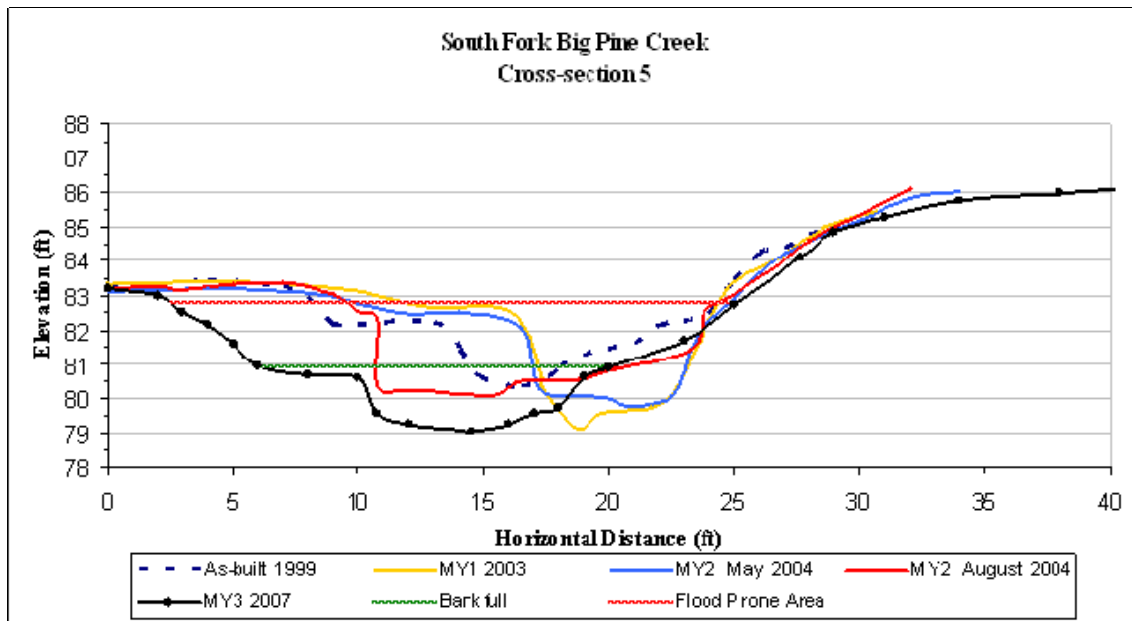
The left end of this cross-section was changed when repairs to the stream channel were made following high flow events caused by the remnants of two hurricanes in the fall of 2004. A short section of the left bank was excavated to the bankfull elevation and a single arm rock vane constructed. This is likely the cause for the noticeable shift (to the left) of the thalweg and the lower elevation of the left bank. This cross-section has stabilized since the repair work was completed; the vegetation on the left bank is now well established.

Additionally, Emergency Watershed Protection (EWP) funds were used to conduct repair work following the 2004 hurricane floods. As part of the EWP work, a single arm rock vane also was installed on the left bank to address a scour problem occurring at station 7+70, cross section 5 (Appendix A.1.5).
