**Chavis Park (Garner Branch)
Stream Restoration Monitoring Report
EEP Project # 87
Monitoring Year – 05
2008**

March 2009

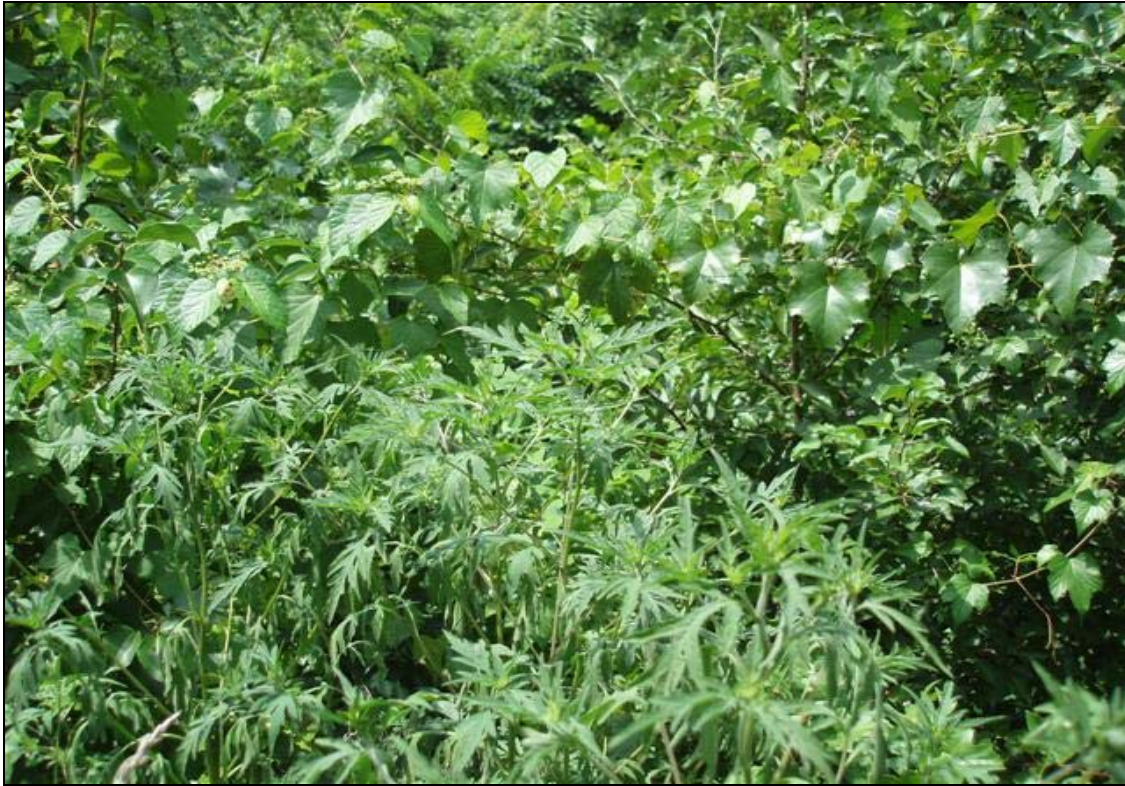
Plot 1 Photo – Taken looking at center of plot on right bank from top of left bank. 8/5/08 - MY 05.

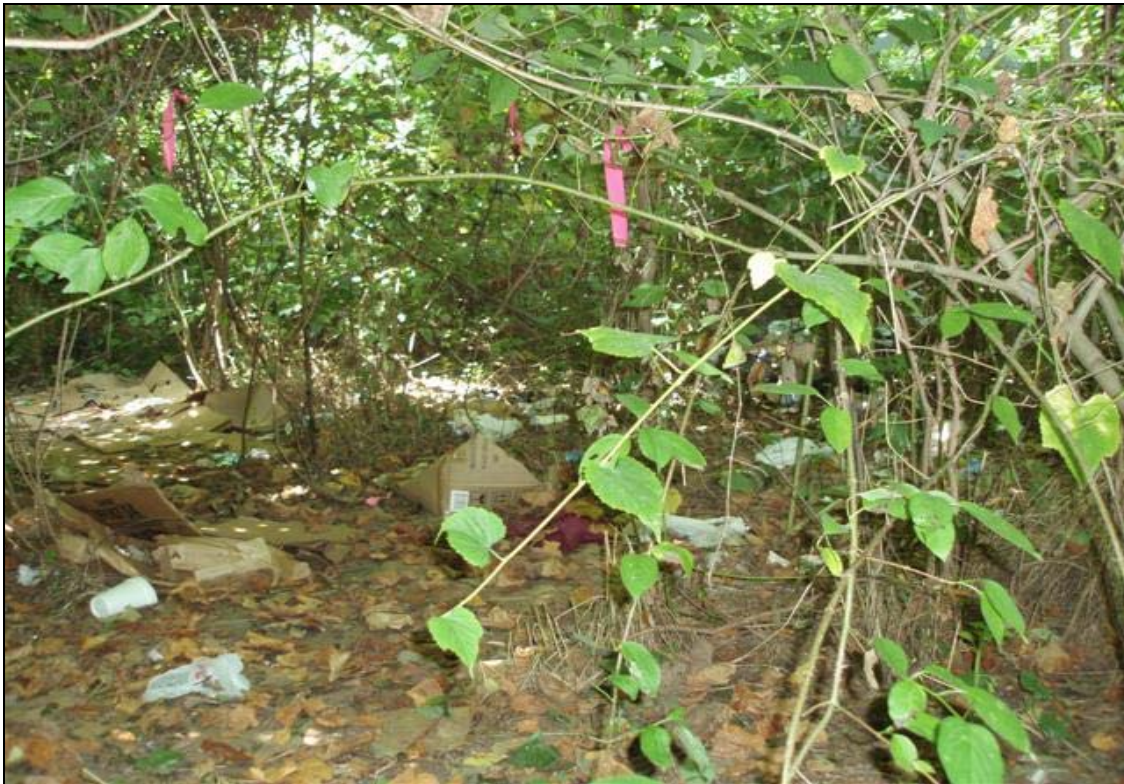
Plot 1 Supplemental Photo – Taken looking at the center of plot from southwest corner. 8/5/08 – MY 05.

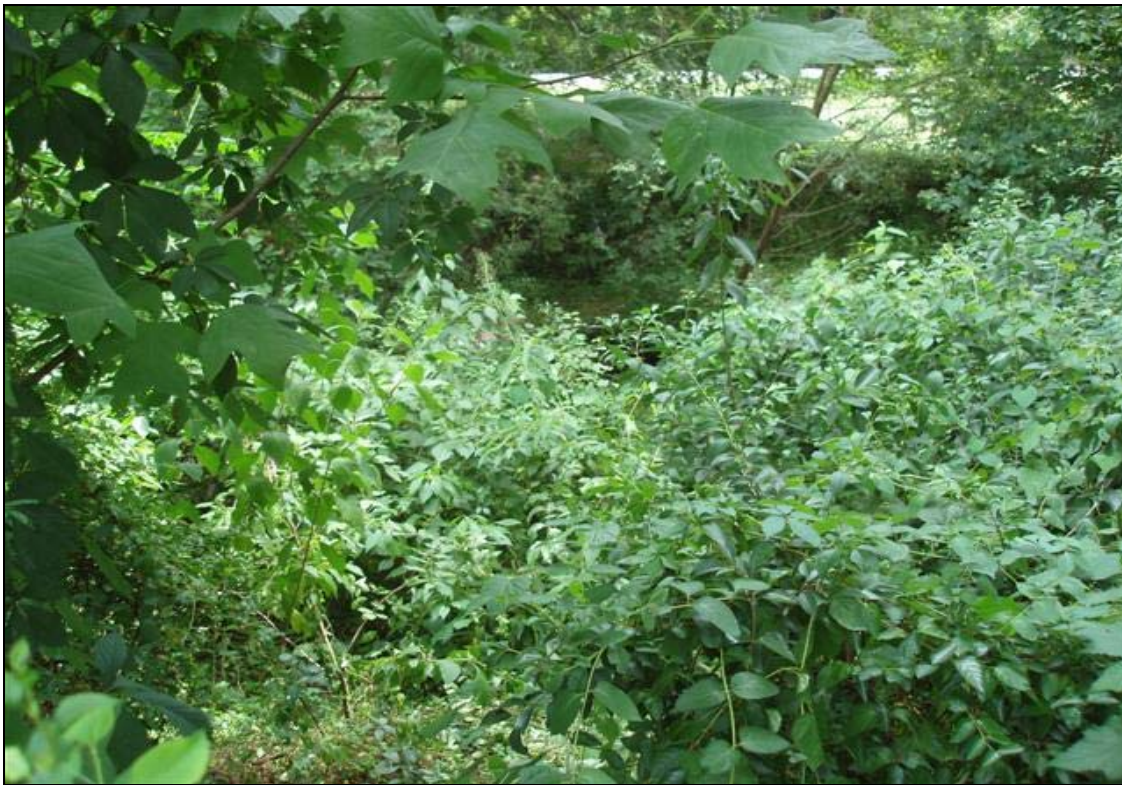
Plot 2 Photo – Taken looking at center of plot from top of right bank. 8/5/08 - MY 05.

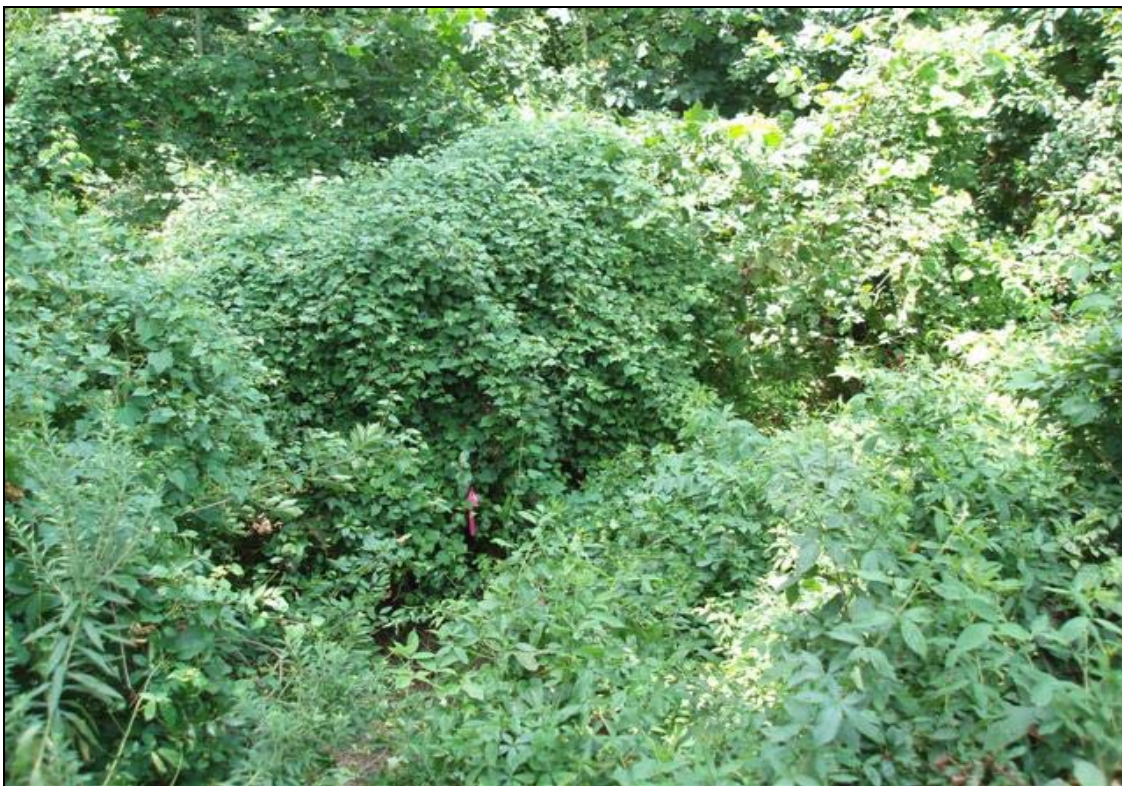
Plot 3 Photo – Taken looking at center of plot from top of left bank. 8/5/08 - MY 05.

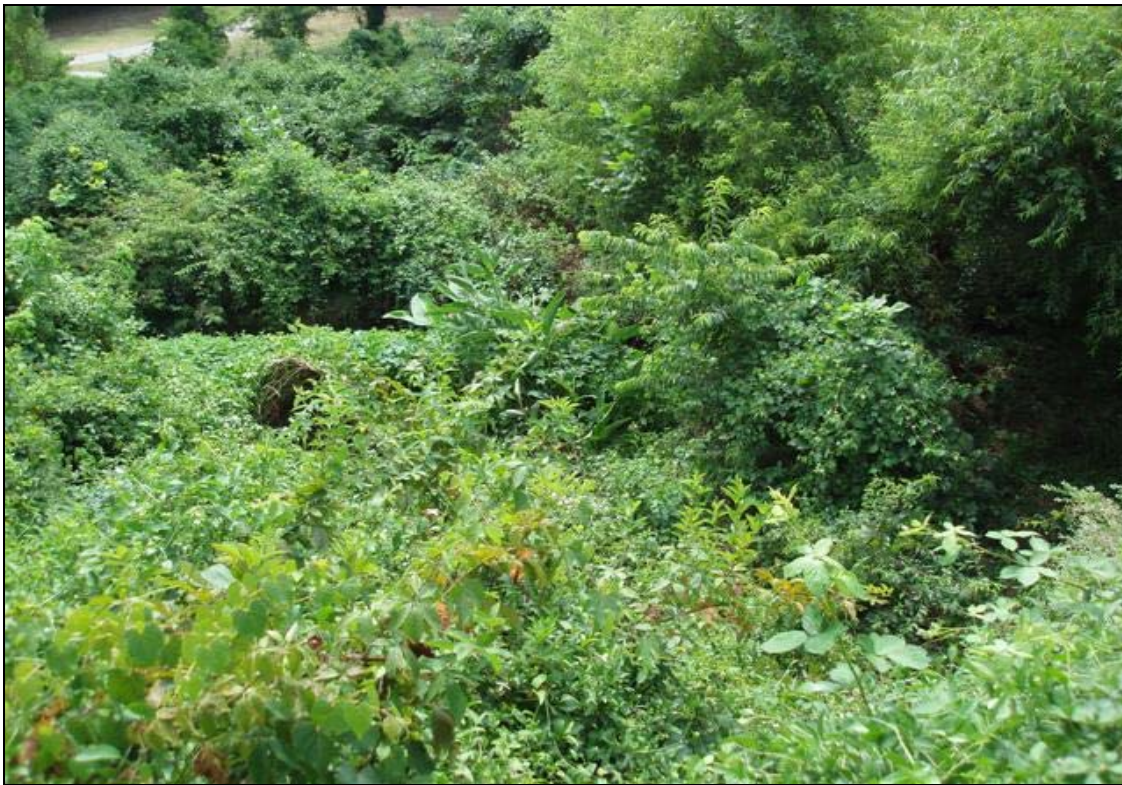
Plot 4 Photo – Taken looking at center of plot from top of left bank. 8/5/08 - MY 05.

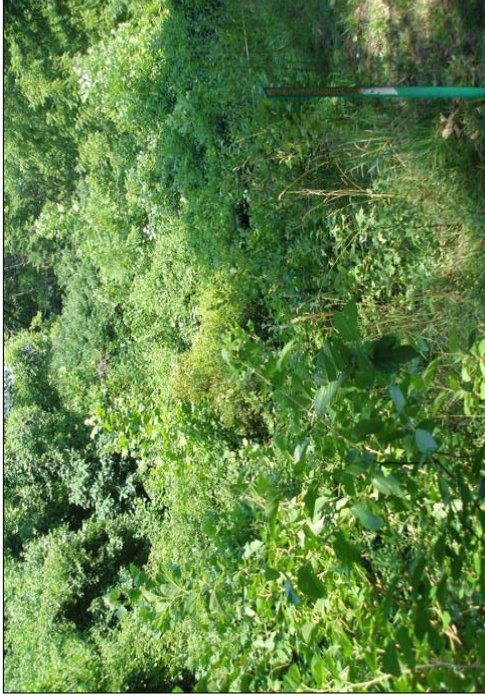
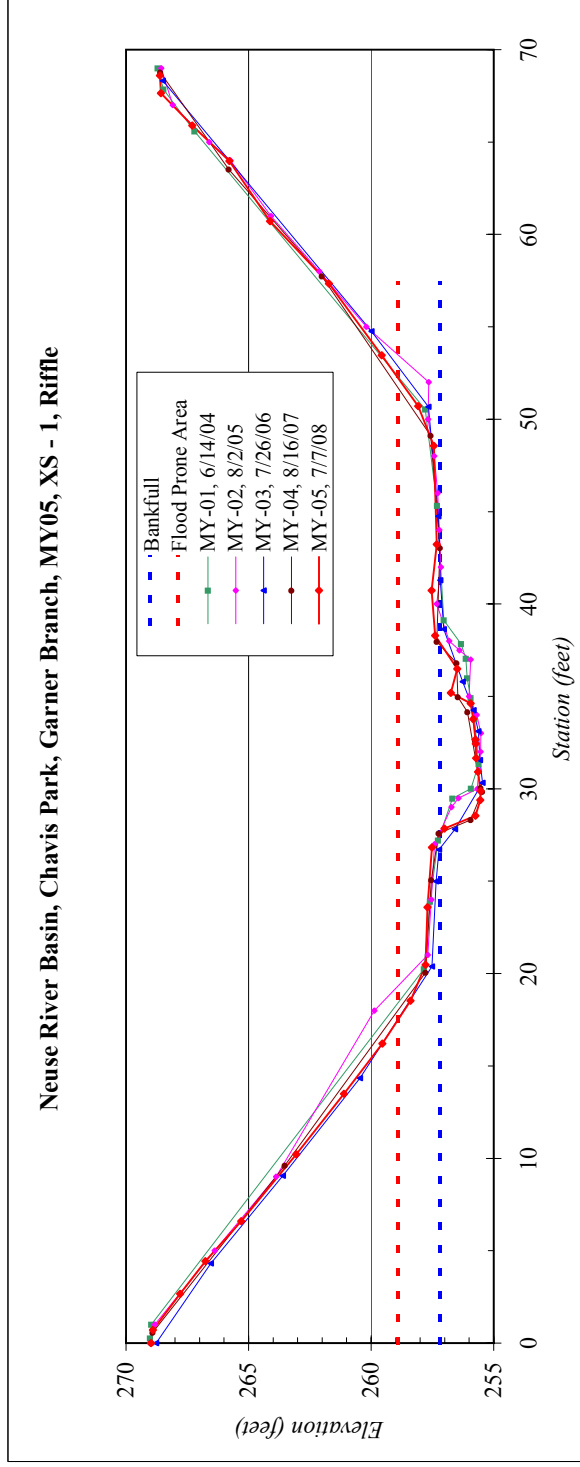
River Basin:	Neuse
Watershed:	Chavis Park, Garner Branch, MY05
XS ID	XS - 1, Riffle
Drainage Area (sq mb):	0.54
Date:	7/7/2008
Field Crew:	B. Roberts, K. Vaughan

SUMMARY DATA	
Bankfull Elevation:	257.2
Bankfull Cross-Sectional Area:	11.4
Bankfull Width:	10.4
Flood Prone Area Elevation:	258.9
Flood Prone Width:	35
Max Depth at Bankfull:	1.7
Mean Depth at Bankfull:	1.1
W / D Ratio:	9.5
Entrenchment Ratio:	3.3
Bank Height Ratio:	1.0

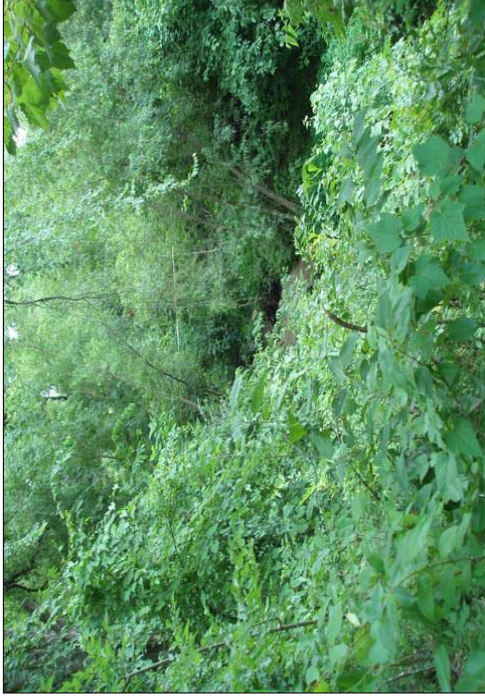
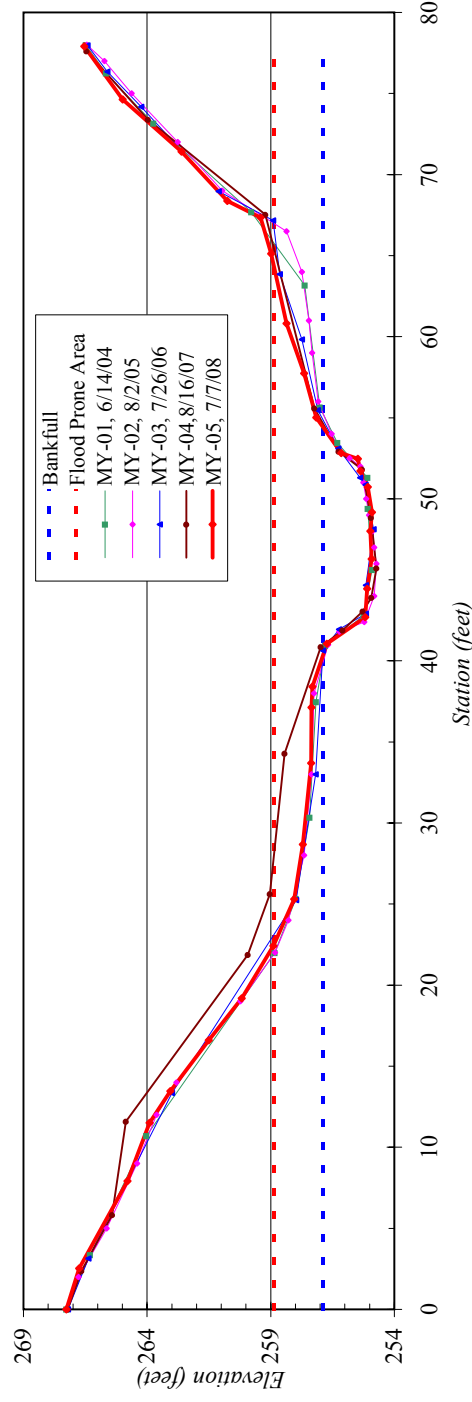
River Basin:	Neuse
Watershed:	Chavis Park, Garner Branch, MY05
XS ID	XS - 2, Pool
Drainage Area (sq mb):	0.54
Date:	7/7/2008
Field Crew:	B. Roberts, K. Vaughan

SUMMARY DATA	
Bankfull Elevation:	256.9
Bankfull Cross-Sectional Area:	20.5
Bankfull Width:	14.2
Flood Prone Area Elevation:	258.9
Flood Prone Width:	42
Max Depth at Bankfull:	2.0
Mean Depth at Bankfull:	1.5
W / D Ratio:	9.8
Entrenchment Ratio:	3.0
Bank Height Ratio:	1.0

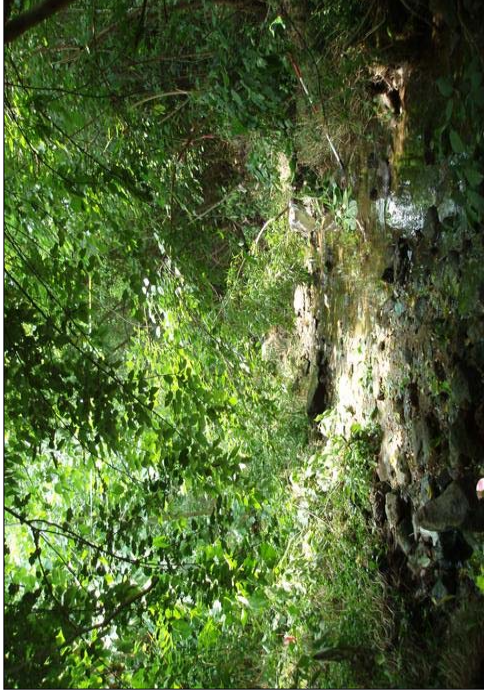
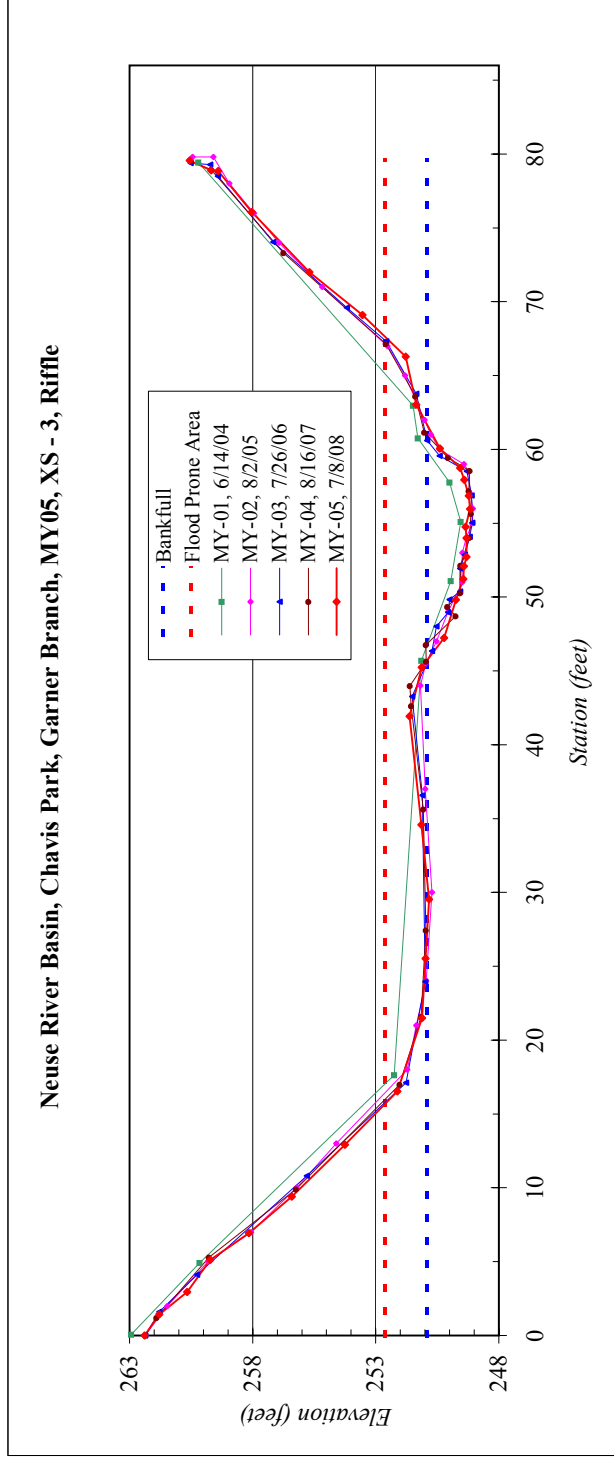
River Basin:	Neuse
Watershed:	Chavis Park, Garner Branch, MY05
XS ID	XS - 3, Riffle
Drainage Area (sq mb):	0.54
Date:	7/8/2008
Field Crew:	B. Roberts, K. Vaughan

SUMMARY DATA	
Bankfull Elevation:	250.9
Bankfull Cross-Sectional Area:	18.1
Bankfull Width:	15.9
Flood Prone Area Elevation:	252.6
Flood Prone Width:	52
Max Depth at Bankfull:	1.7
Mean Depth at Bankfull:	1.1
W / D Ratio:	14.0
Entrenchment Ratio:	3.3
Bank Height Ratio:	1.0

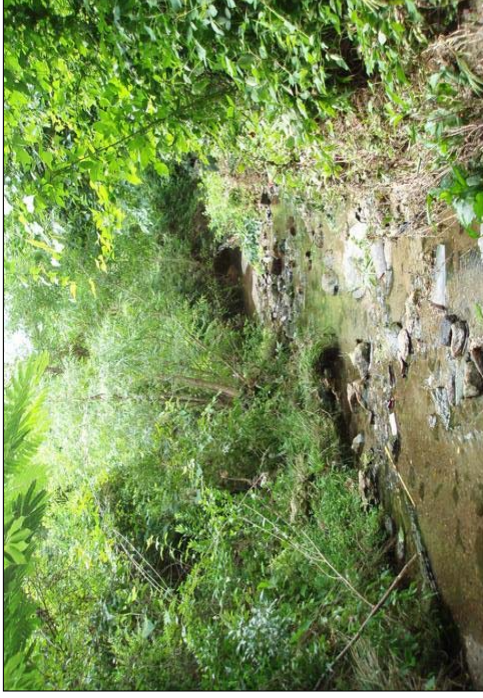
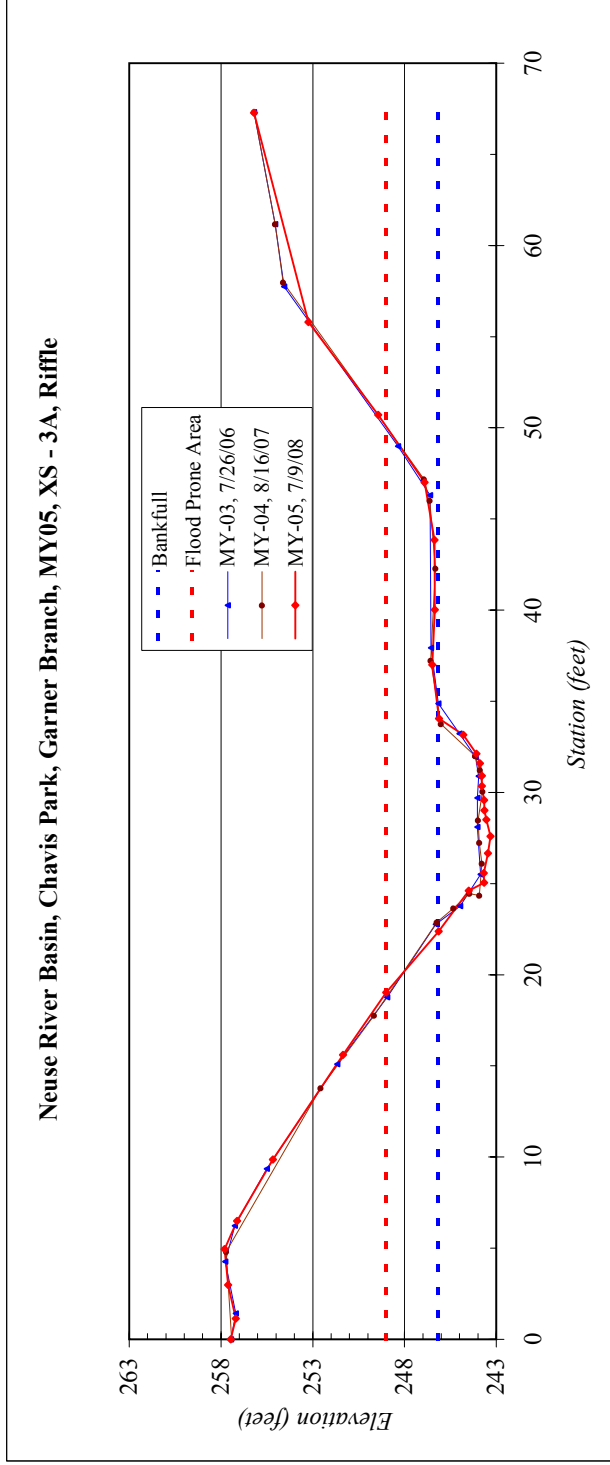
River Basin:	Neuse
Watershed:	Chavis Park, Garner Branch, MY05
XS ID	XS - 3A, Riffle
Drainage Area (sq mb):	0.54
Date:	7/9/2008
Field Crew:	B. Roberts, K. Vaughan

SUMMARY DATA	
Bankfull Elevation:	246.2
Bankfull Cross-Sectional Area:	23.6
Bankfull Width:	12.4
Flood Prone Area Elevation:	249.0
Flood Prone Area Width:	31
Max Depth at Bankfull:	2.9
Mean Depth at Bankfull:	1.9
W / D Ratio:	6.5
Entrenchment Ratio:	2.5
Bank Height Ratio:	1.0

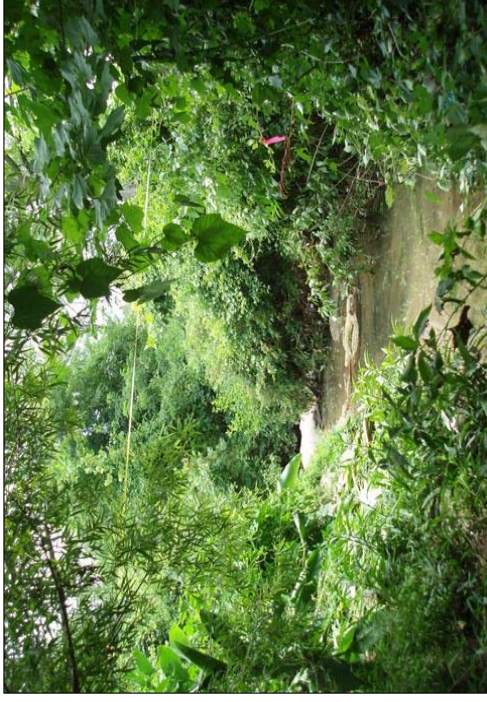
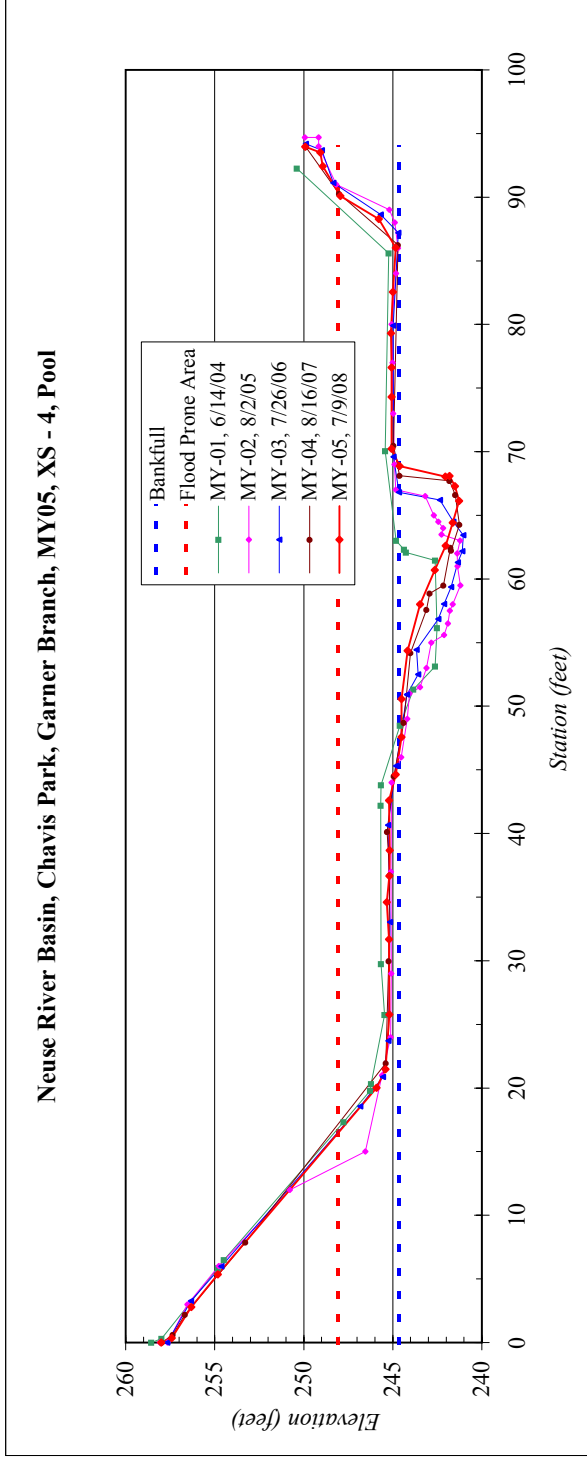
River Basin:	Neuse
Watershed:	Chavis Park, Garner Branch, MY05
XS ID	XS - 4, Pool
Drainage Area (sq mb):	0.54
Date:	7/9/2008
Field Crew:	B. Roberts, K. Vaughan

SUMMARY DATA	
Bankfull Elevation:	244.7
Bankfull Cross-Sectional Area:	32.2
Bankfull Width:	23.3
Flood Prone Area Elevation:	248.0
Flood Prone Width:	74
Max Depth at Bankfull:	3.4
W / D Ratio:	1.4
Entrenchment Ratio:	16.8
Bank Height Ratio:	3.2
	1.0

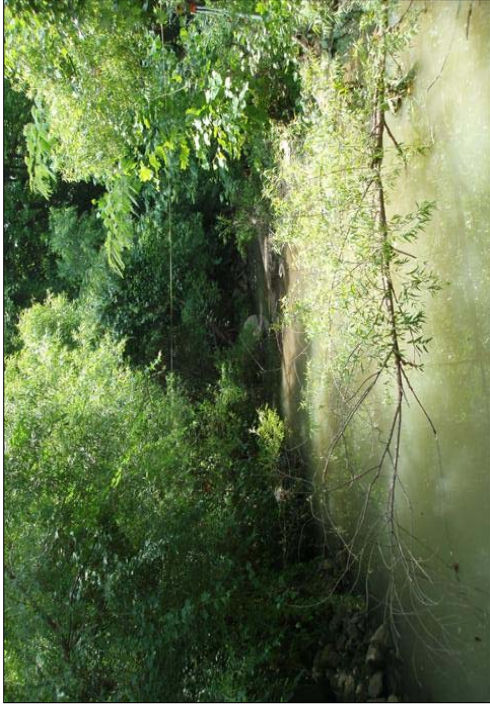
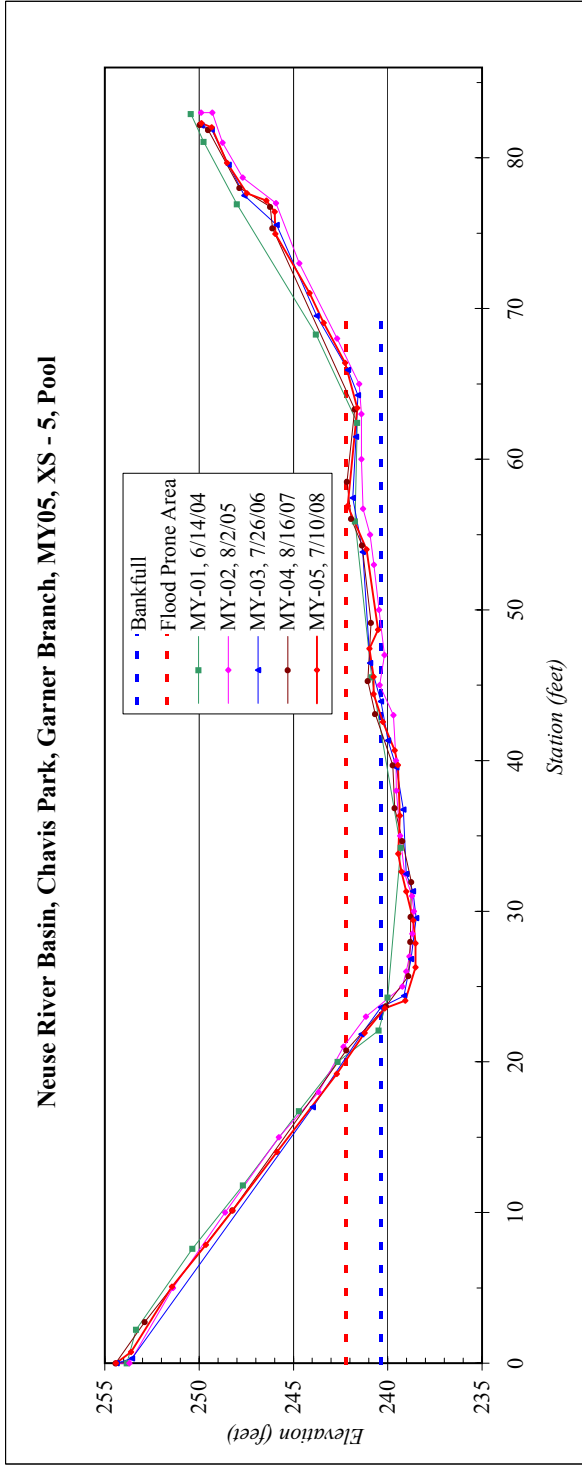
River Basin:	Neuse
Watershed:	Chavis Park, Garner Branch, MY05
XS ID	XS - 5, Pool
Drainage Area (sq mi):	0.54
Date:	7/10/2008
Field Crew:	B. Roberts, K. Vaughan

SUMMARY DATA	
Bankfull Elevation:	240.4
Bankfull Cross-Sectional Area:	23.2
Bankfull Width:	19.9
Flood Prone Area Elevation:	242.2
Flood Prone Area Width:	46
Max Depth at Bankfull:	1.9
Mean Depth at Bankfull:	1.2
W / D Ratio:	17.1
Entrenchment Ratio:	2.3
Bank Height Ratio:	1.0

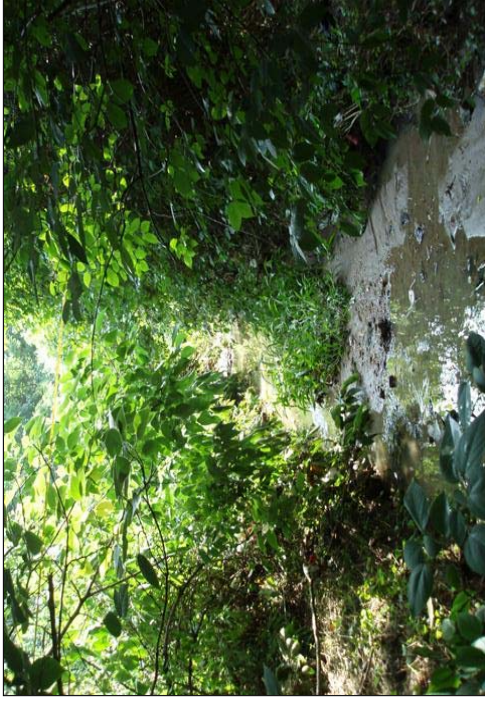
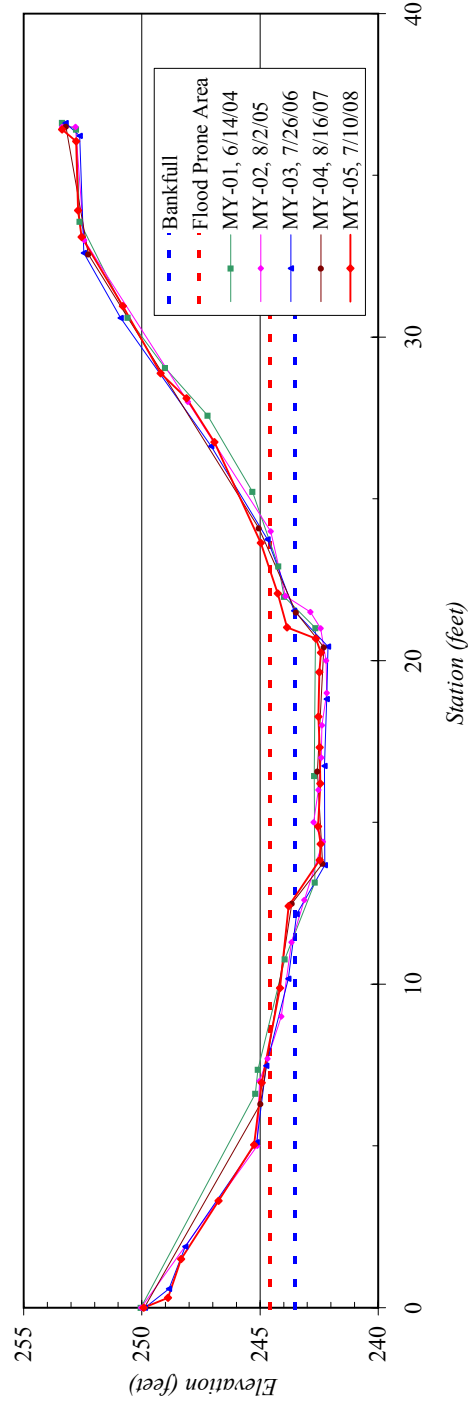
River Basin:	Neuse
Watershed:	Chavis Park, UT to Garner Branch, MY05
XS ID	XS - UT, Riffle
Drainage Area (sq mi):	0.2
Date:	7/10/2008
Field Crew:	B. Roberts, K. Vaughan

SUMMARY DATA	
Bankfull Elevation:	243.5
Bankfull Cross-Sectional Area:	7.6
Bankfull Width:	8.2
Flood Prone Area Elevation:	244.6
Flood Prone Width:	15
Max Depth at Bankfull:	1.1
W / D Ratio:	0.9
Entrenchment Ratio:	8.9
Bank Height Ratio:	1.8
	1.1
