**City Pond Mitigation Project
Anson County, North Carolina**

Year 4 Monitoring Report

November 2008

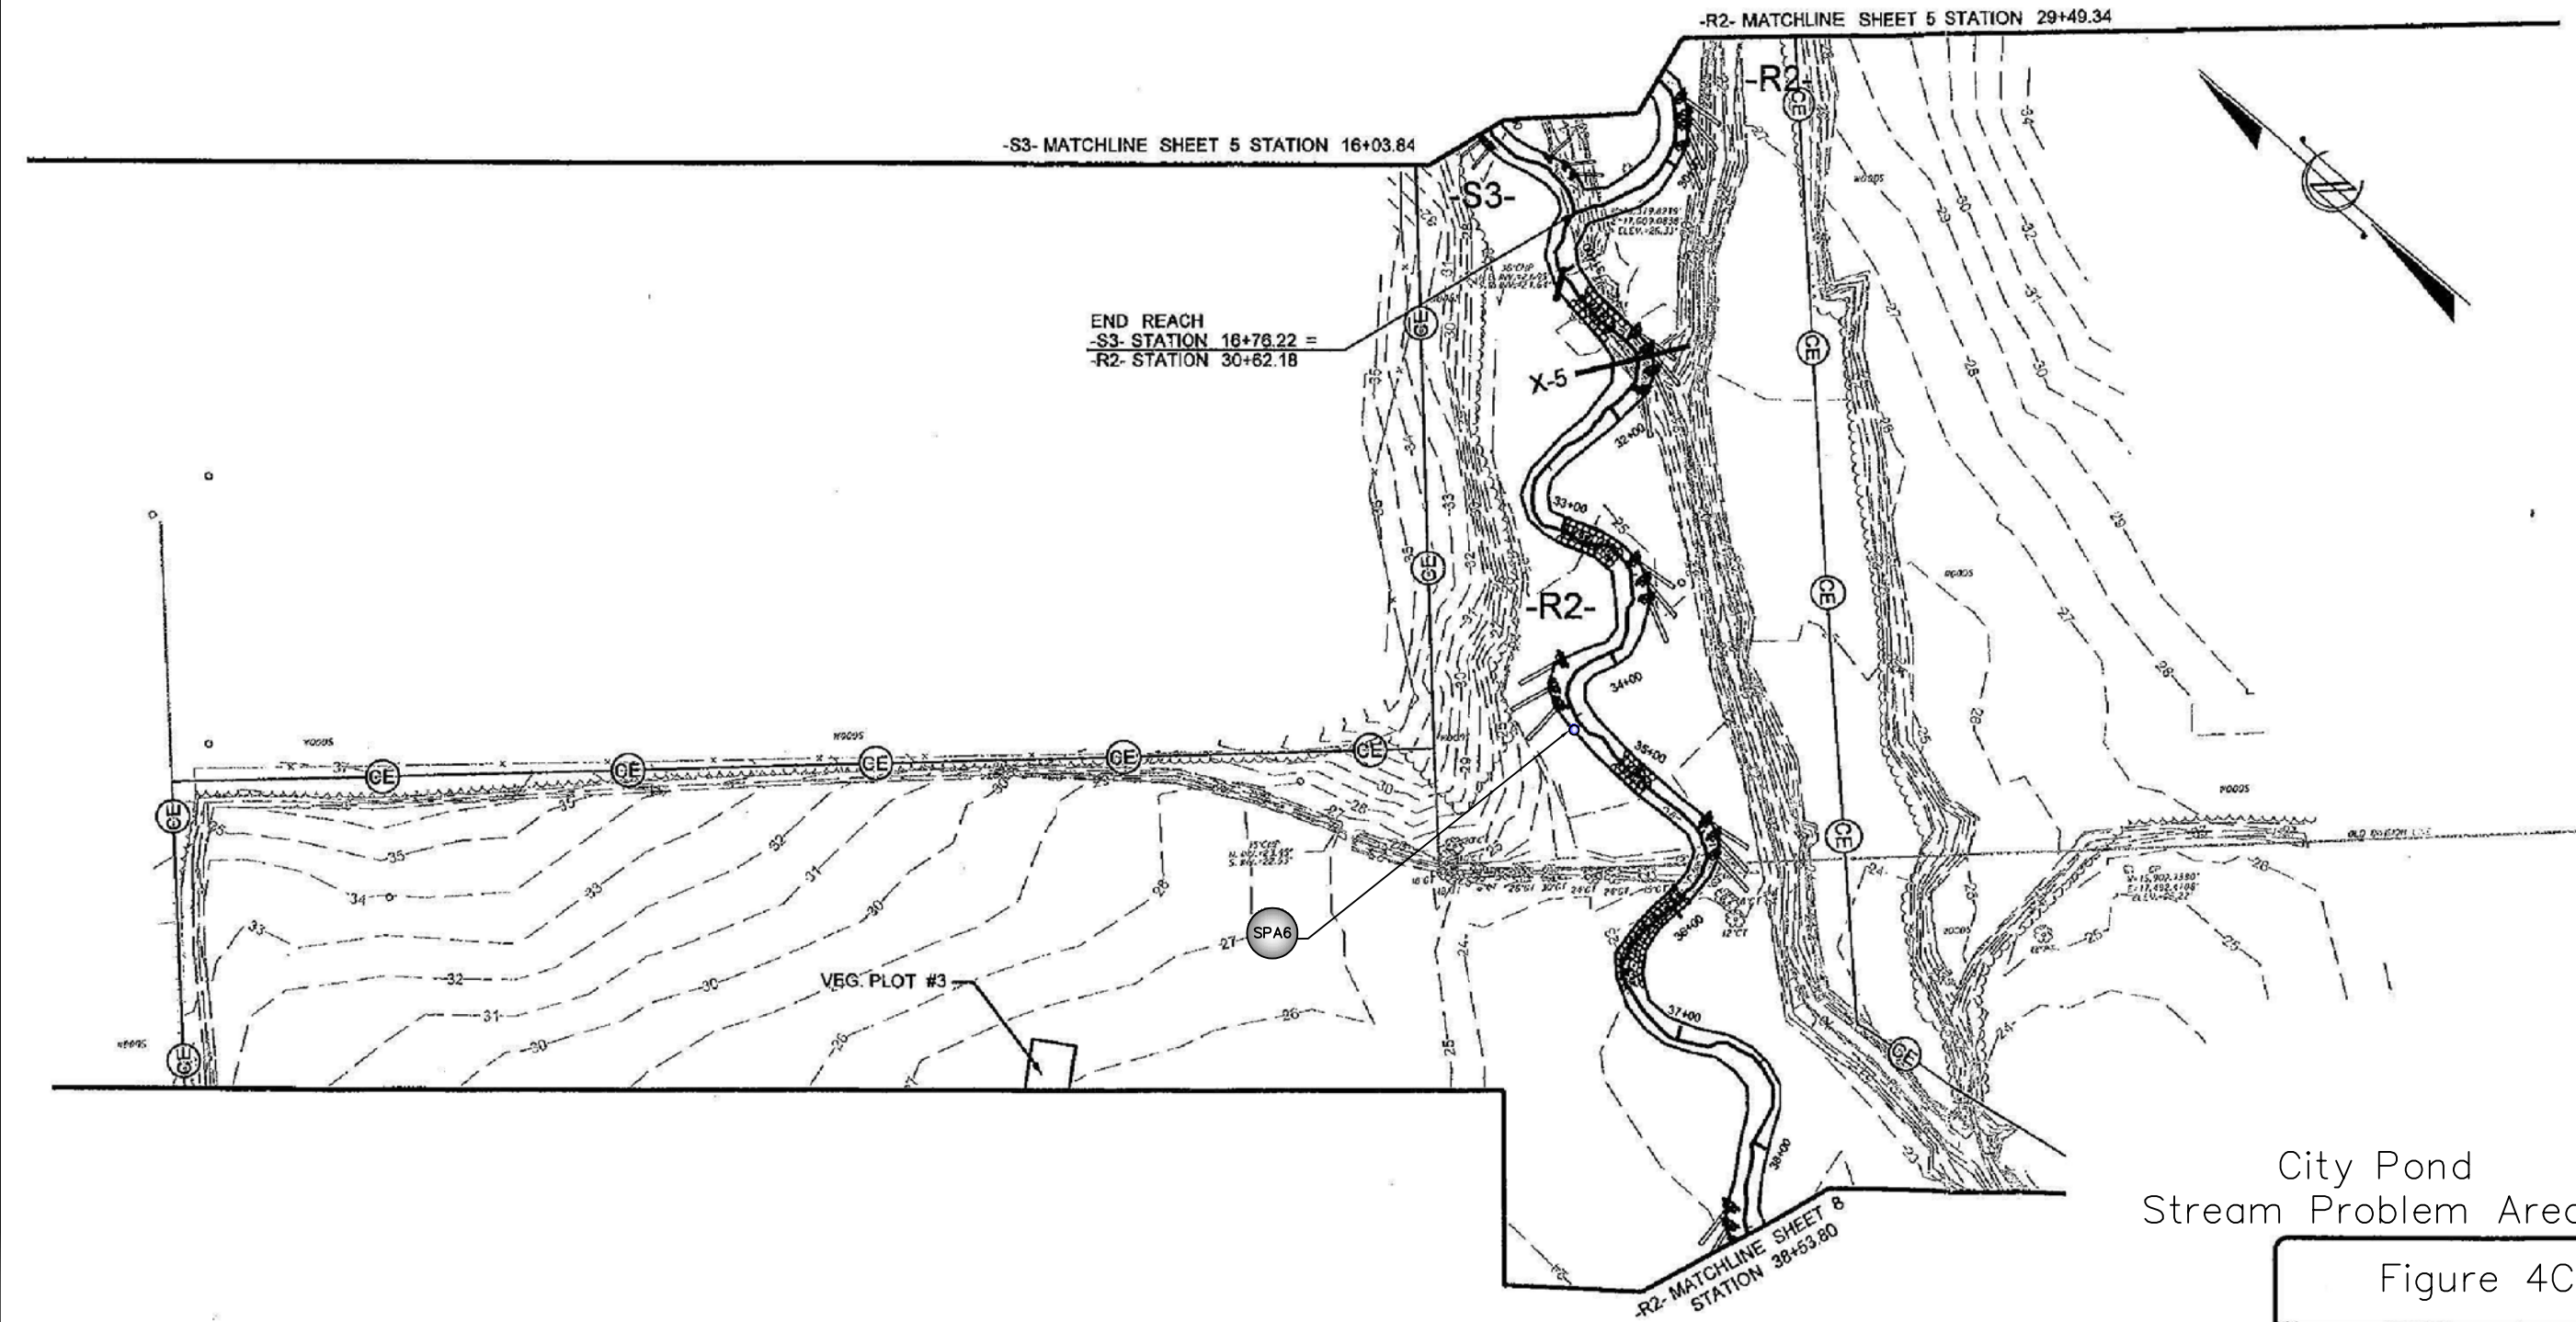
Figure 4B

ID	Station	Feature	Problem	Severity	Recommended Action
SPA1	R1 10+20	Culvert	Left bank erosion at culvert outlet	Moderate	Monitor
SPA2	S1 11+80	Log weir	Erosion US of structure	Minor	Monitor
SPA3	S1 15+30	Log weir	Headcut	Minor	Monitor
SPA4	S1 15+80	Log weir	Erosion, potential problem	Minor	Monitor
SPA5	S5 18+50	Left bank	Erosion behind matting	Minor	None
SPA6	R2 23+90	Left bank	Undercut, approx. 15' long	Moderate	Monitor
SPA7	R2 34+50	Right bank	Erosion behind matting	Minor	None
SPA8	R3 47+80	Left bank	Erosion	Minor	Monitor
SPA9	R3 48+50	Floodplain	Lack of vegetation on right bank	Moderate	None
SPA10	S3 13+20	Left bank	Erosion behind matting	Heavy	Monitor
