**City Pond Mitigation Project
Anson County, North Carolina**

Year 5 Monitoring Report

February 2010

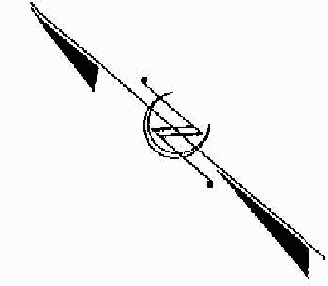
Figure 4B

Table 6 summarizes stream areas requiring observation. **Figures 4a-4e** shows the locations of the stream problem areas observed. All of the problem areas observed are minor and localized. SPA2 and SPA3 are localized and are expected to stabilize and become vegetated. Problem area SPA5, SPA6, and SPA7 are not affecting channel stability and have good vegetative cover on the adjacent banks and floodplain. SPA10 is a small head-cut that is expected to stabilize. Upstream of this are a number of stable grade control structures that will halt progression if necessary. Vegetation along the banks at this area is still filling in and is expected to provide additional stabilization. No remedial actions are necessary.

ID	Station	Feature	Problem	Severity	Recommended Action
SPA1	R1 11+50	Channel	Small headcut	Minor	None
SPA2	R1 13+80 to R1 14+10	Left Bank	Lack of vegetation and erosion	Minor	None
SPA3	R1 16+30	Left Bank	Lack of vegetation	Minor	None
SPA4	R1 16+75	Channel	Aggradation of sand in channel	Minor	None
SPA5	R2 33+00	Channel	Beaver dam across channel	Minor	None
SPA6	R2 34+50	Channel	Beaver dam across channel	Minor	None
SPA7	R2 38+20	Channel	Beaver dam across channel	Minor	None
SPA8	R2 43+15	Channel	ATV Crossing	Minor	None
SPA9	S1 12+00	Log Weir	Erosion behind structure	Minor	None
SPA10	S1 15+85	Rock Vane	Erosion behind structure	Minor	None
