# ANNUAL MONITORING REPORT FOR 2006 CLAYHILL FARMS

**CLAYHILL FARMS MITIGATION SITE**  
**JONES COUNTY, NORTH CAROLINA**  
**TIP No. R-2105 WM**  
**(EEP Project Number .00018)**  
2006 Annual Monitoring Report (Year 1 of 5)

April 2007

Prepared by:  
Axiom Environmental, Inc.  
2126 Rowland Pond Drive  
Willow Spring, North Carolina 27592

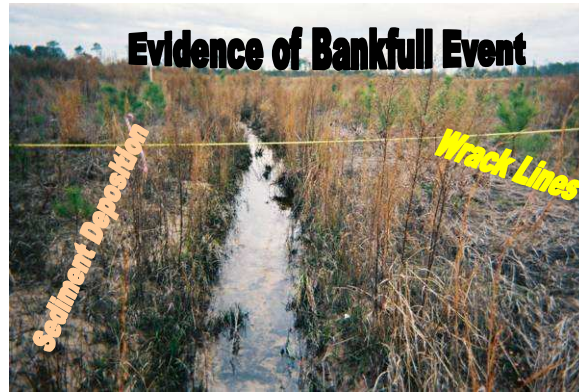
<b>Table 4. Verification of Bankfull Events</b>			
<b>Clayhill Farms (EEP Project Number .00018)</b>			
<b>Date of Data Collection</b>	<b>Date of Occurrence</b>	<b>Method</b>	<b>Photo (if available)</b>
September 1, 2006	September 1, 2006	Total of 4.74 inches of rain documented by the onsite rain gauge over a two-day period from August 31 (4.06 inches) to September 1, 2006 (0.68 inches).	Photo above

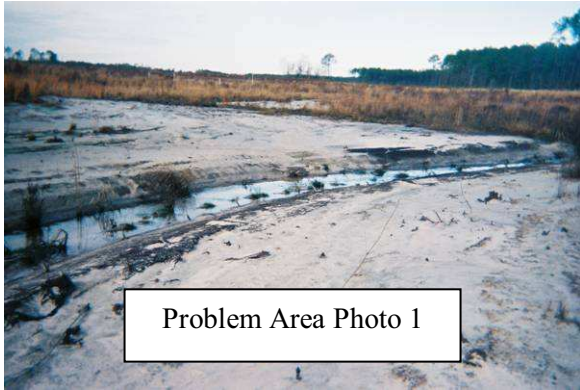
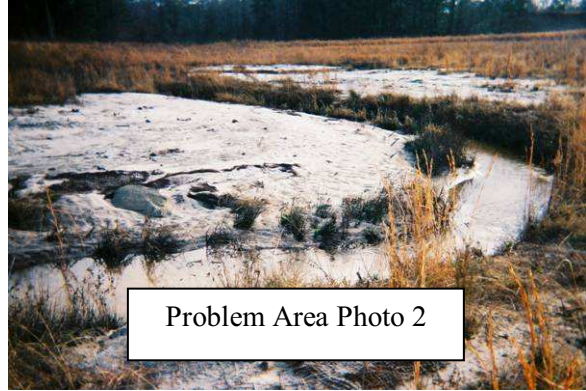
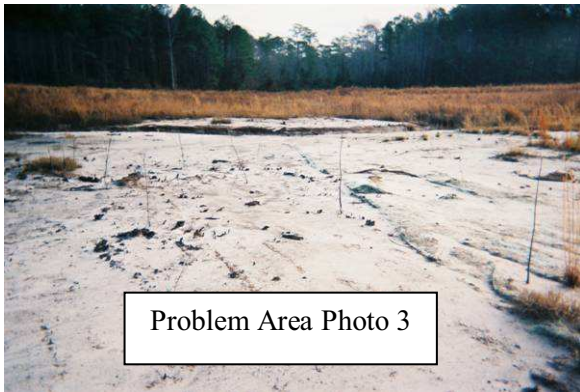
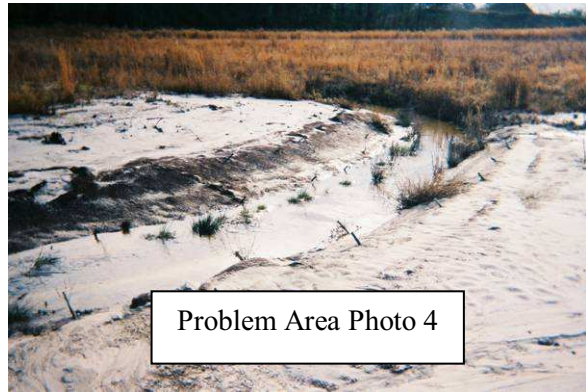
**Clayhill Farms**  
**Vegetation Problem Area Photographs**  
**Year 1 (2006) Annual Monitoring**  
**Pictures Taken November 2006**

The vegetation problem area within the Site is depicted on Figure 2B. A large area of poor planted stem survival was observed adjacent to the restored stream (near Reach 1) during year 1 (2006) monitoring. Poor survival may have resulted from soil infertility or drought.

The vegetation problem area within the Site is a large area of poor planted stem survival observed adjacent to the restored stream (near Reach 1). Poor survival may have resulted from soil infertility or drought. Herbaceous vegetation on the lower half of the Site adjacent to the restored stream is not establishing well most likely due to soil infertility. In addition, willow stakes on the lower half of the Site have been slow to sprout with many of the stakes just starting to put off shoots as of March 2007. Shoot output indicates stakes are alive and establishing a root system to aid in stream bank stabilization.

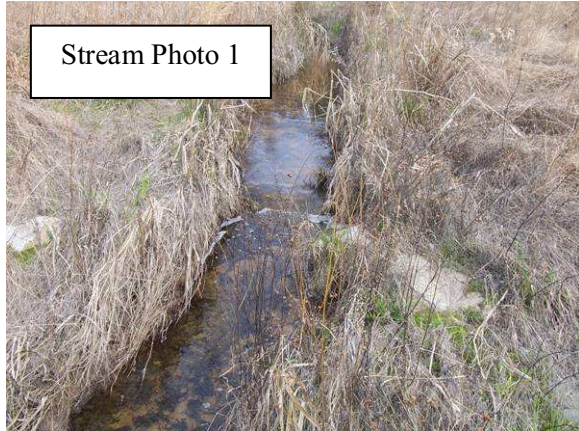
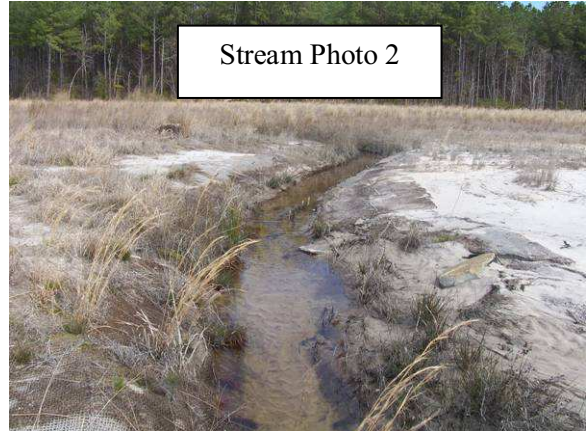
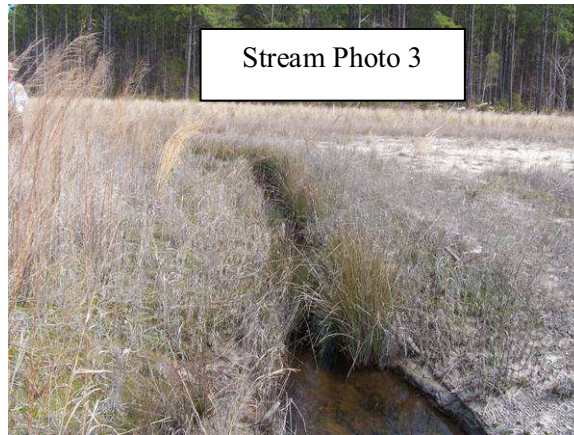
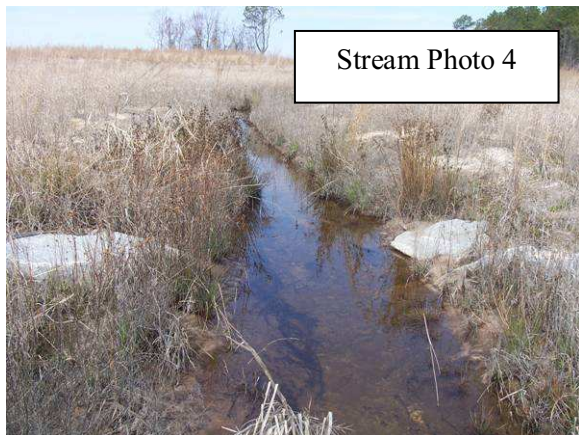
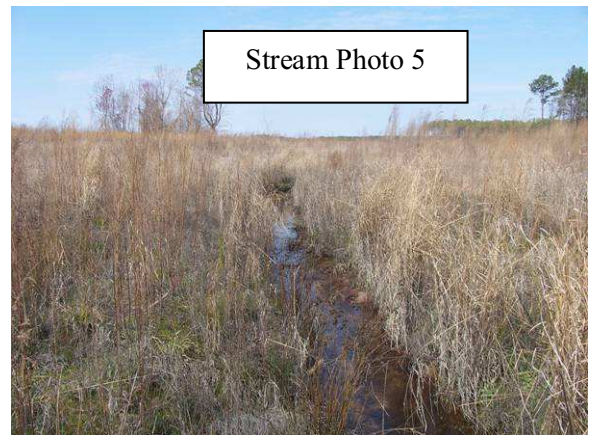
**Clayhill Farms**  
**Stream Monitoring Fixed-Photo and Problem Area Photographs**  
**Year 1 (2006) Annual Monitoring**  
**Pictures Taken March 2007**

Stream problem areas within the Site are depicted on Figures 2A through 2B. Two problem areas were noted for the year 1 (2006) monitoring. Both problem areas are stressed cross-vanes with failing right bank arms resulting from a lack of footers; photographs of each are included in Appendix C. Additional inspections and monitoring of bed and banks up and downstream of compromised structures is recommended prior to initiation of proactive maintenance measures.
