**CLAYHILL FARMS MITIGATION SITE
JONES COUNTY, NORTH CAROLINA
TIP No. R-2105 WM
(EEP Project Number .00018)
2007 Annual Monitoring Report (Year 2 of 5)**

February 2008

Prepared by:
Axiom Environmental, Inc.
2126 Rowland Pond Drive
Willow Spring, North Carolina 27592

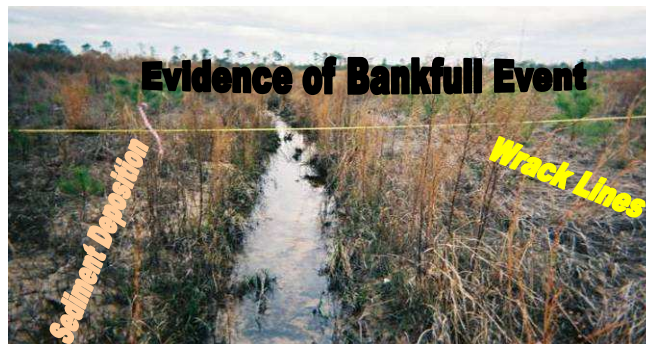
Figure 5. Evidence of September 1, 2006 Bankfull Event

Bankfull event as evidenced by sediment deposition and wrack lines outside of the stream channel.

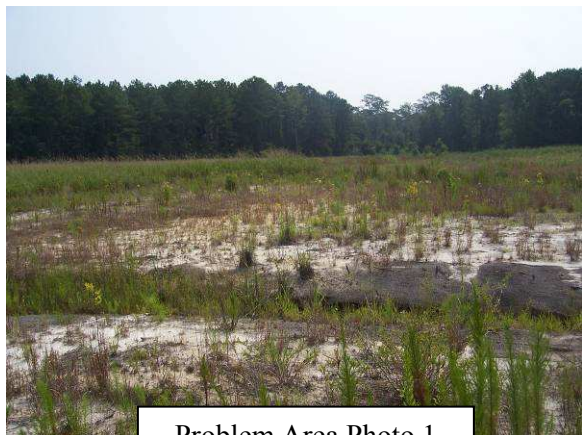
Problem Area Photo 1

The vegetation problem area within the Site is depicted on Figure 3B. A large area of dead stems was observed adjacent to the restored stream (near Reach 1) during year 2 (2007) monitoring. Poor survival may have resulted from soil infertility and/or drought.

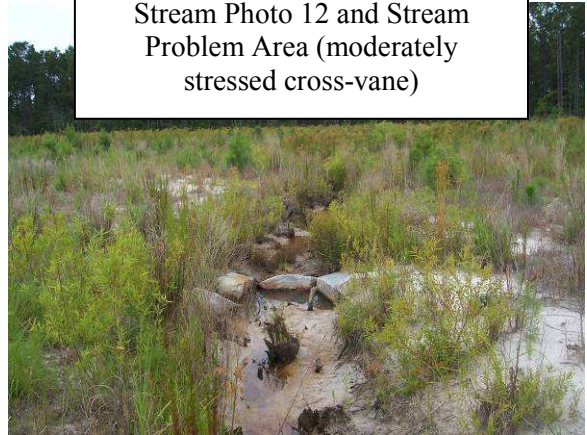
Stream problem areas within the Site are depicted on Figures 3A through 3B. Two problem areas were noted for the year 2 (2007) monitoring. Both problem areas are stressed cross-vanes with failing right bank arms resulting from a lack of footers; photographs of each are included in Appendix D. Additional inspections and monitoring of bed and banks up and downstream of compromised structures is recommended prior to initiation of proactive maintenance measures.

Stream Photo 12 and Stream Problem Area (moderately stressed cross-vane)
