**CLAYHILL FARMS MITIGATION SITE
JONES COUNTY, NORTH CAROLINA
TIP No. R-2105 WM
(EEP Project Number .00018)
2008 Annual Monitoring Report (Year 3 of 5)**

CLAYHILL FARMS MITIGATION SITE
JONES COUNTY, NORTH CAROLINA
TIP No. R-2105 WM
(EEP Project Number .00018)
2008 Annual Monitoring Report (Year 3 of 5)

Prepared by:
Axiom Environmental, Inc.
2126 Rowland Pond Drive
Willow Spring, North Carolina 27592

December 2008

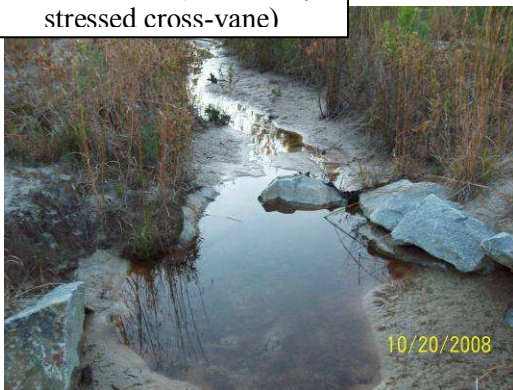
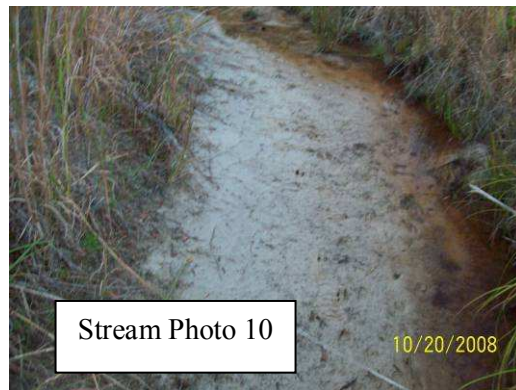
Stream problem areas within the Site are depicted on Figures 3A through 3B. Two problem areas were noted for the year 3 (2008) monitoring period. Both problem areas are stressed cross-vanes with failing right bank arms resulting from a lack of footers; photographs of each are included in Appendix E. Additional inspections and monitoring of bed and banks up and downstream of compromised structures is recommended prior to initiation of proactive maintenance measures.

Stream Photo 9 and Stream
Problem Area (moderately
stressed cross-vane)
