**CLAYHILL FARMS MITIGATION SITE
JONES COUNTY, NORTH CAROLINA
TIP No. R-2105 WM
(EEP Project Number .00018)
2009 Annual Monitoring Report (Year 4 of 5)**

November 2009

Prepared by:
Axiom Environmental, Inc.
20 Enterprise Street, Suite 7
Raleigh, North Carolina 27607

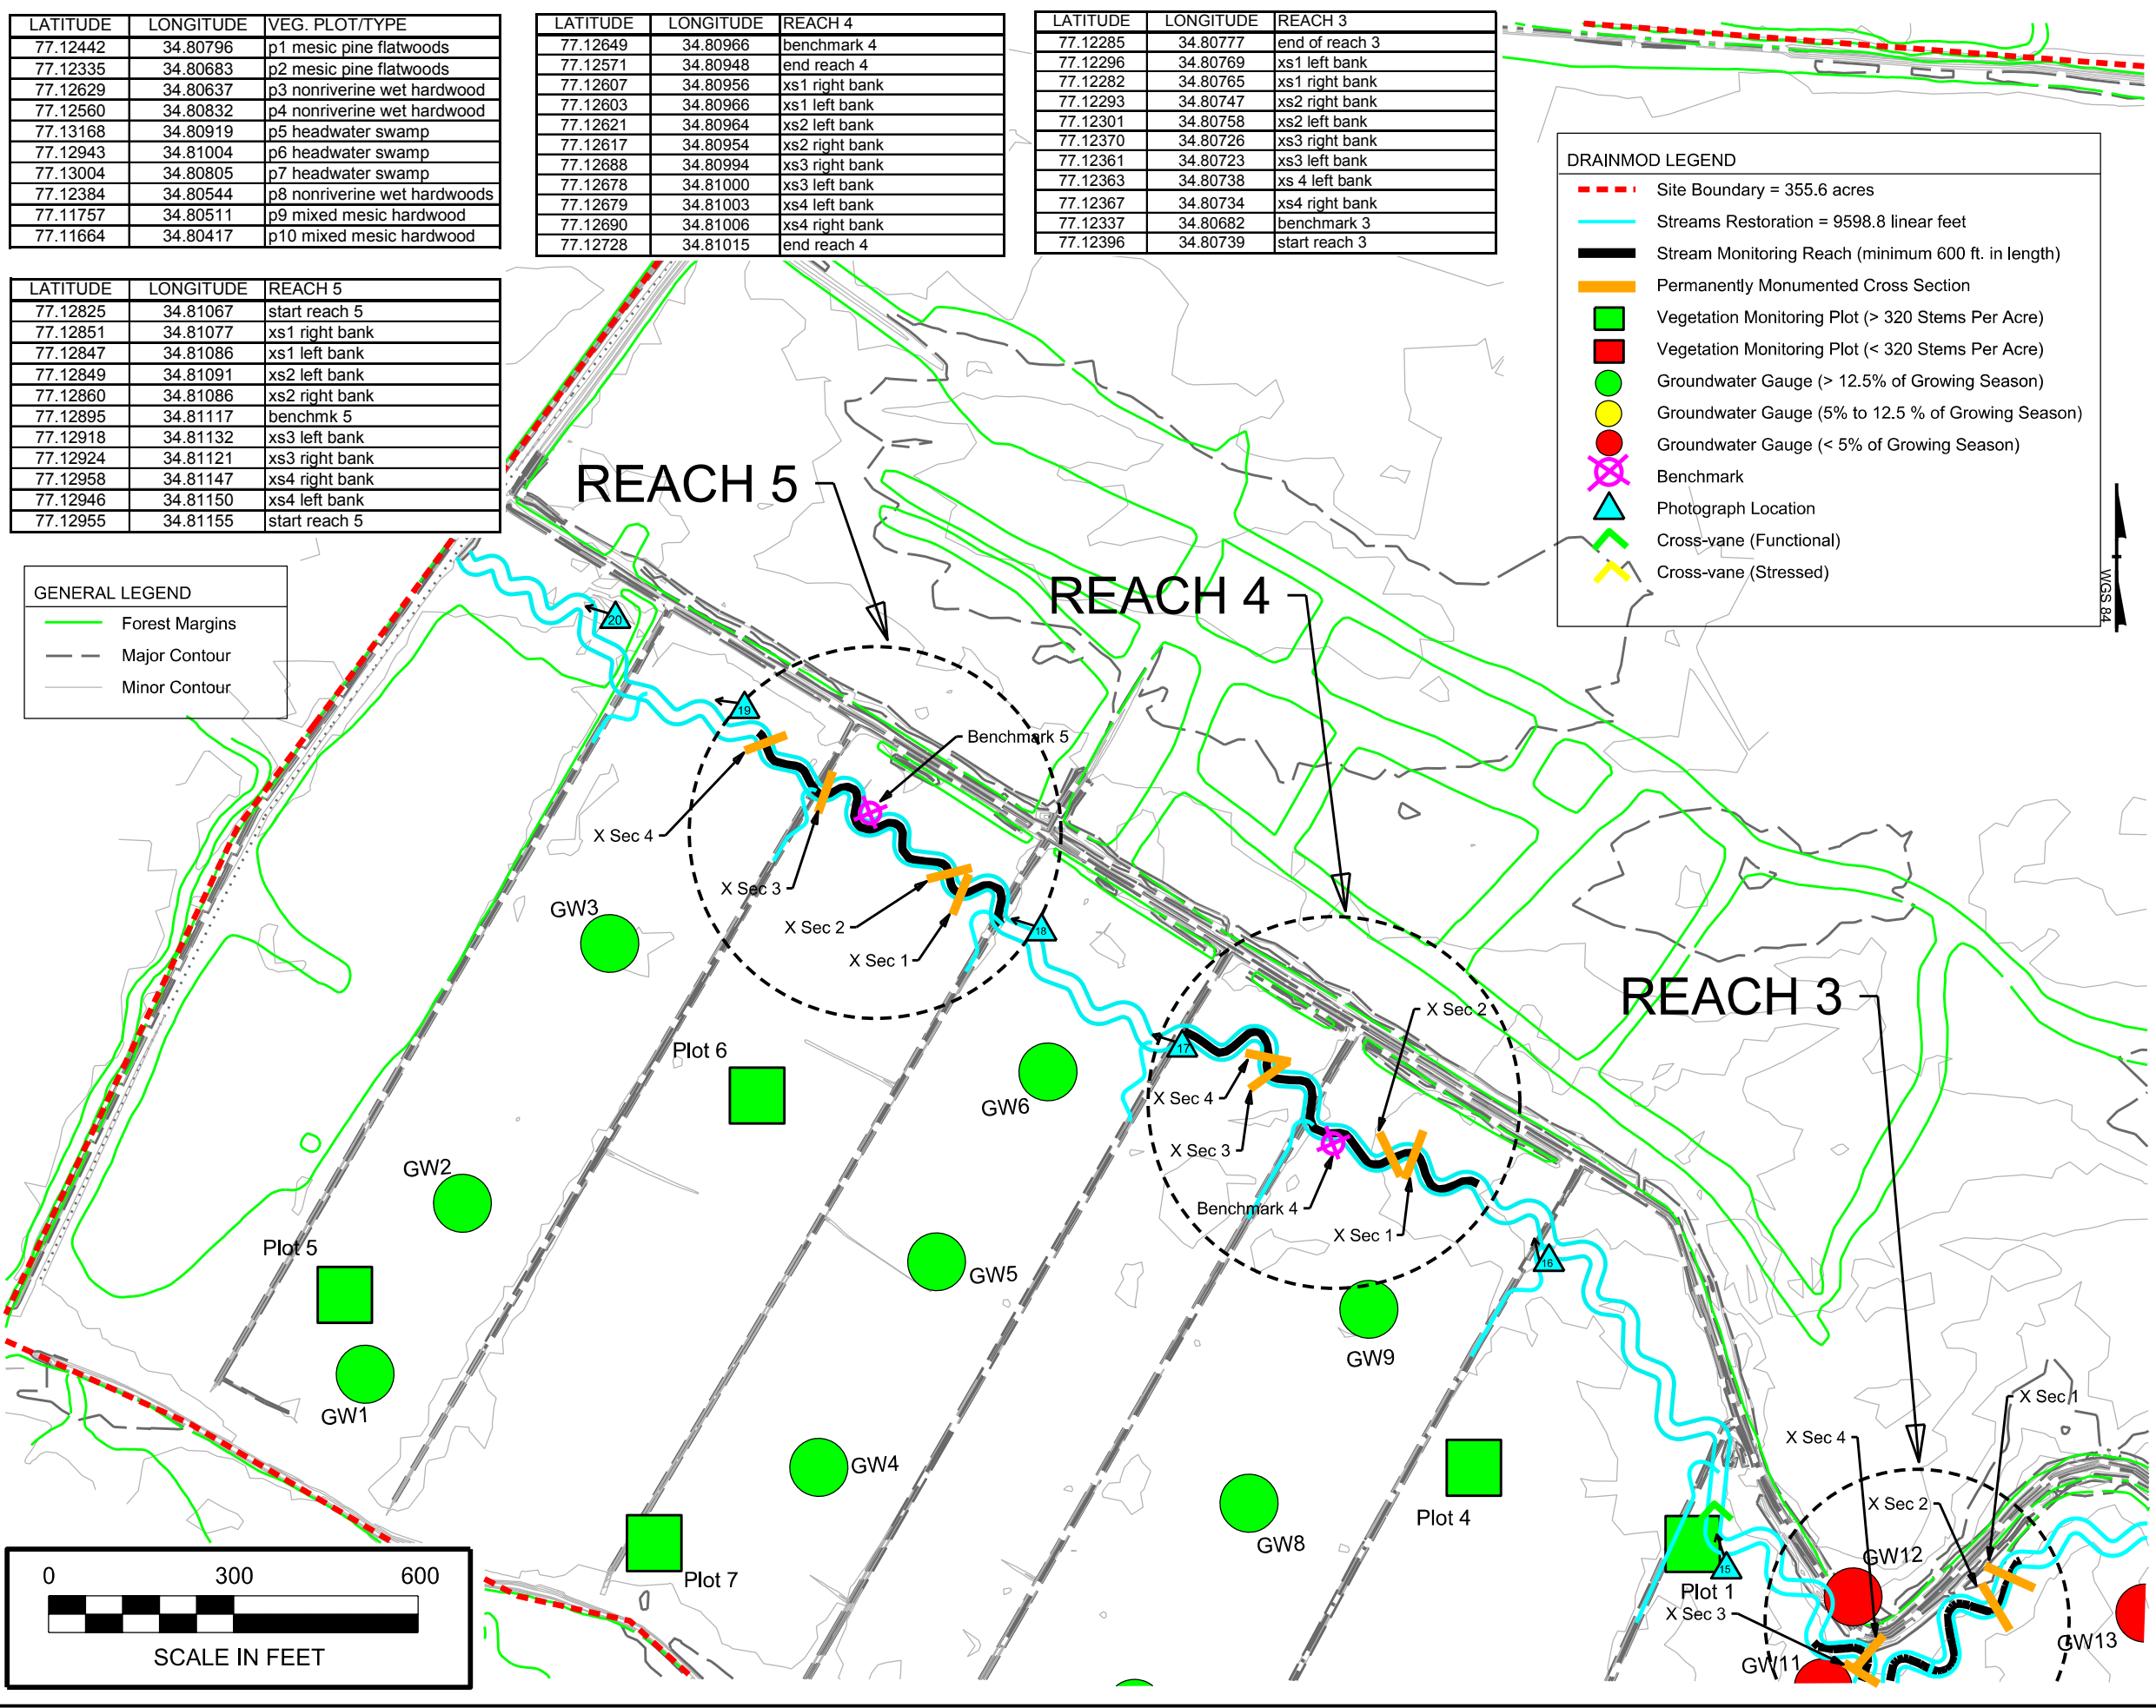
Scale: 1 in. = 270 ft.	FIGURE NO. 3A
Date: Nov 2009	
Project No.: 08-002

One vegetation problem area was documented within the Site and is depicted on Figure 3B. The area consists of poor planted stem survival adjacent to the restored stream (near Reach 1); photographs of this area are included in Appendix B. Poor survival most likely has resulted from soil infertility. In addition, herbaceous vegetation on the lower half of the Site adjacent to the restored stream is not establishing well.

Stream problem areas within the Site are depicted on Figures 3A through 3B. Two problem areas were noted for the year 4 (2009) monitoring period. Both problem areas are stressed cross-vanes with failing right bank arms resulting from a lack of footers; photographs of each are included in Appendix C. Additional inspections and monitoring of bed and banks up and downstream of compromised structures is recommended prior to initiation of proactive maintenance measures.
