**CLAYHILL FARMS MITIGATION SITE
JONES COUNTY, NORTH CAROLINA
TIP No. R-2105 WM
(EEP Project Number .00018)
2010 Annual Monitoring Report (Year 5 of 5)**

Submitted to:
North Carolina Department of Environment and Natural Resources
Ecosystem Enhancement Program
Raleigh, North Carolina

Prepared by:
Axiom Environmental, Inc.
20 Enterprise Street, Suite 7
Raleigh, North Carolina 27607

November 2010

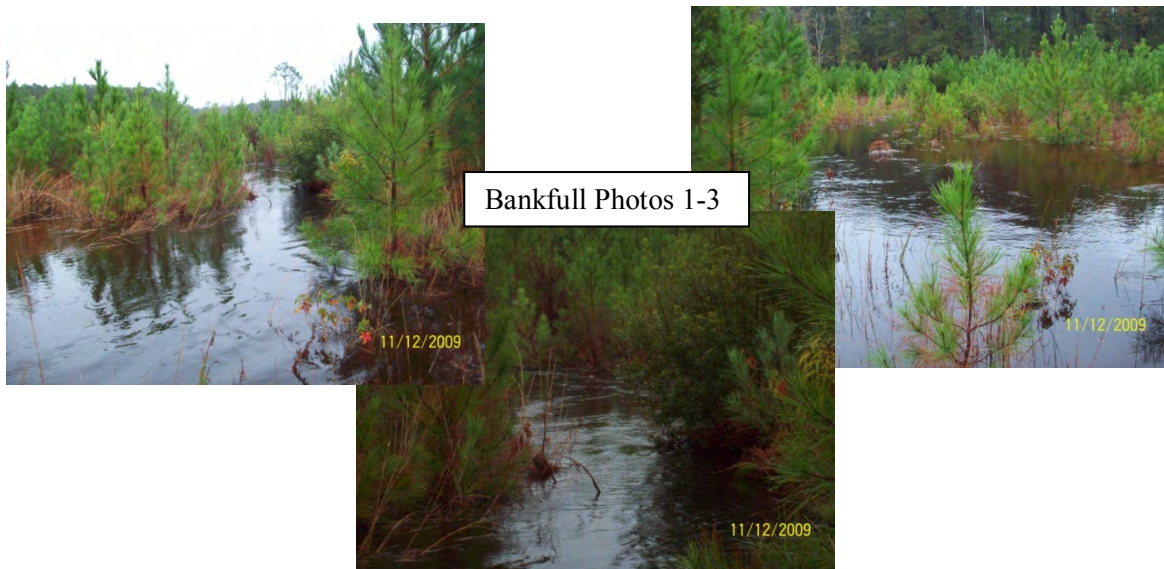
Bankfull Photo 4

October 28, 2010	September 27, 2010	Total of 15 inches of rain documented at a nearby rain station* over a five-day period from September 26-30, 2010.	--
