Clear Creek  
Stream Restoration  
2004-2005 Monitoring Reports  
October 2005

# 2004/2005 Clear Creek Monitoring Report

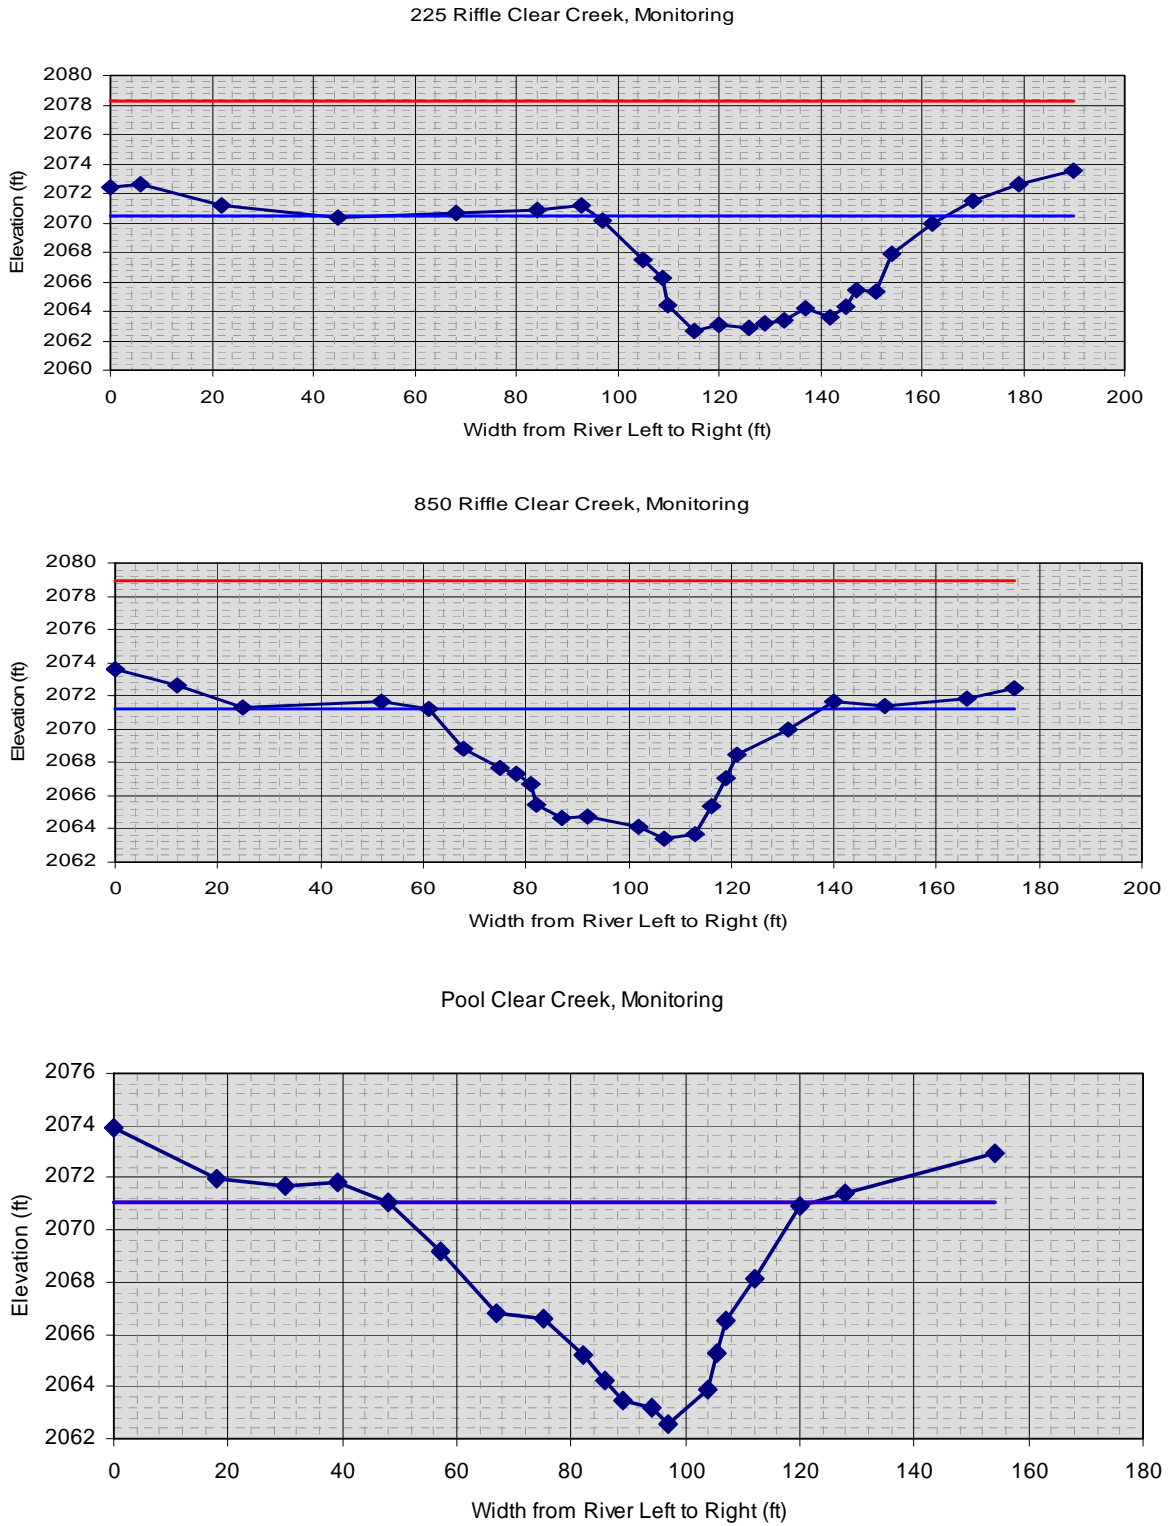
**Figure 8 Clear Creek Longitudinal Profiles**

One problem with the restoration is the cross vanes and j-hooks do not appear to be controlling the thalweg at low to medium flows. The result is that the base flow channel is wide with the thalweg very close to the bank in several locations. The central portions of cross vanes 3 and 4 appear to have shifted and may be sinking into the sandy substrate. In at least one case, a large sunken log appears to have rammed a cross vane rock off its footers. Cross vanes 1 and 2 are performing adequately but should be monitored closely. The rocks at the end of most of the j-hooks have likewise sunken into the bed or have become buried by the high bedload of sand in this low slope, alluvial channel.

The low slope of the reach, controlled by the sewer line crossing at the lower end, promotes the deposition of sand and woody debris throughout the restoration area. The woody debris promotes local scour and deposition, so the bed morphology is dominated by many small holes connected by an irregular and dynamic thalweg.
