Year 3 Monitoring Report

Clear Creek Stream Restoration

February 2006
S&EC Project No. 9446.D1
EEP Project No. 00019

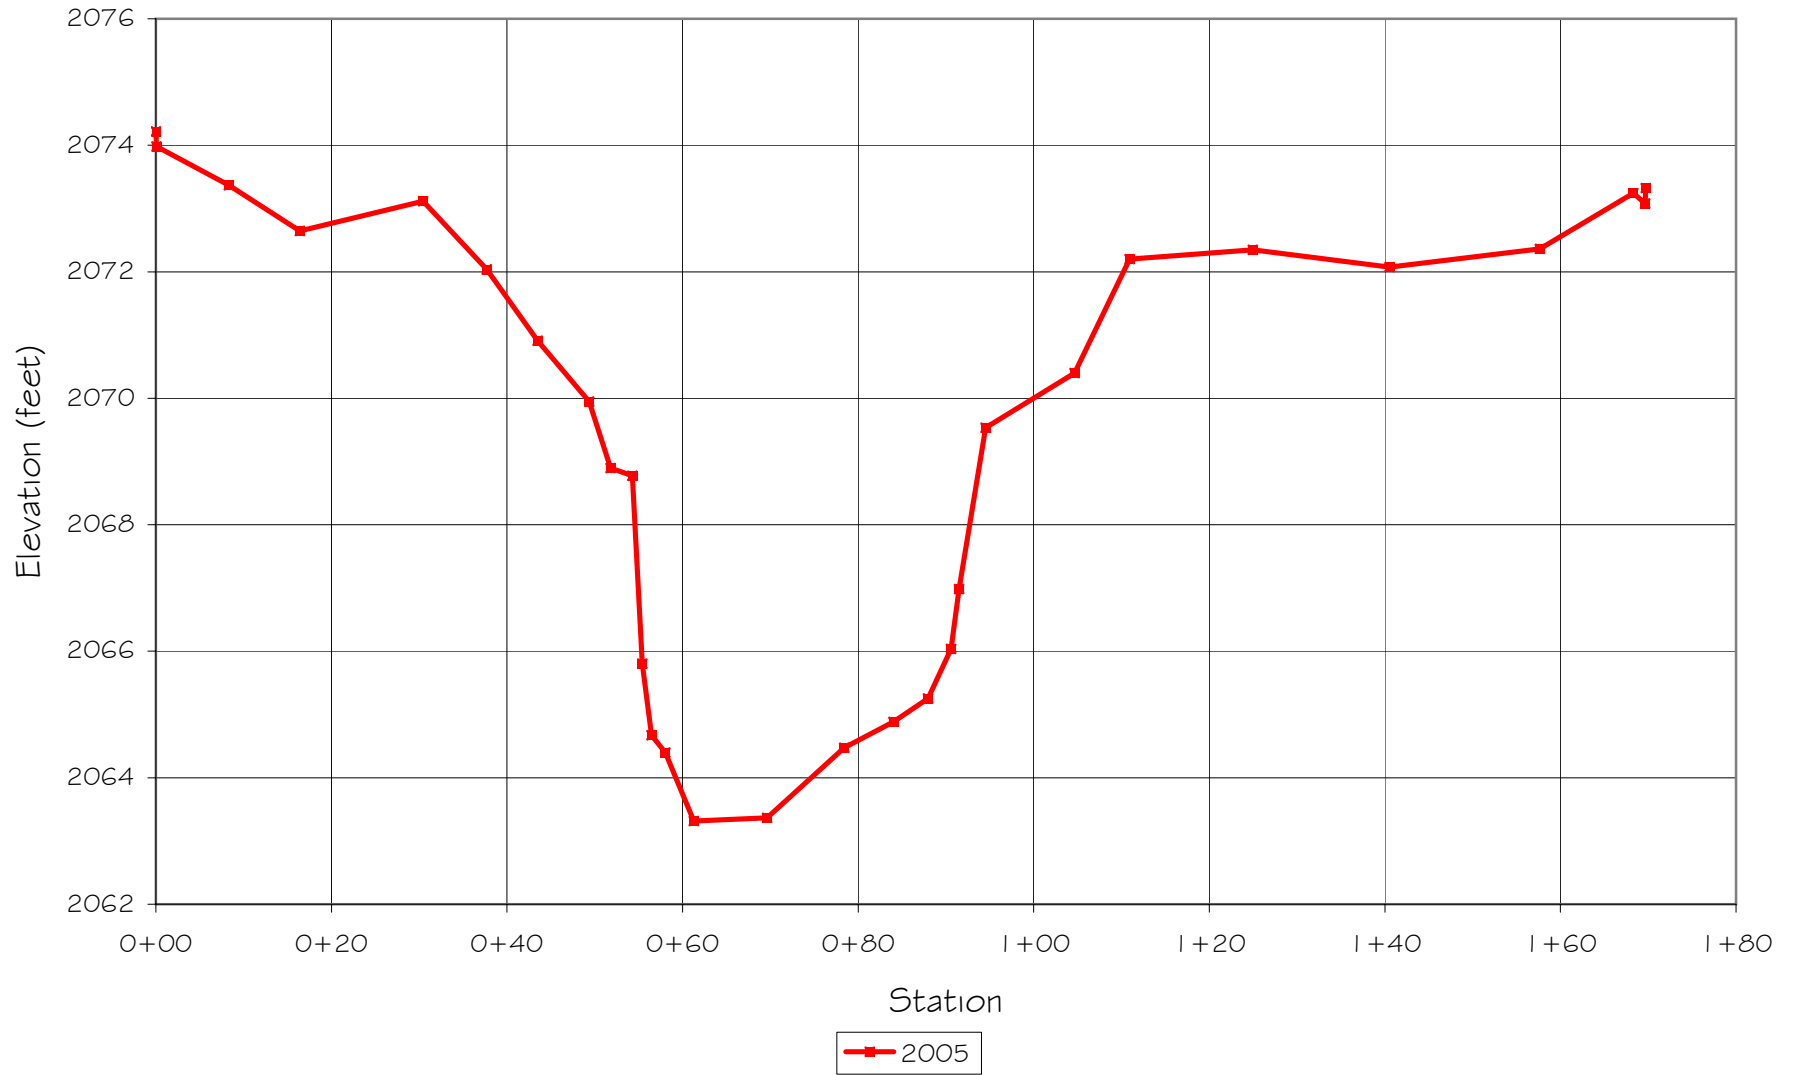
Clear Creek Stream Restoration (2005)
Cross-Section #2 - Pool

Floodprone Elevation (ft) 2079.29
 Bankfull Elevation (ft) 2071.3
 Floodprone Width (ft) 169.72
 Bankfull Width (ft) 66.3
 Entrenchm Ratio 2.56 ----
 Mean Depth (ft) 4.5
 Maximum Depth (ft) 7.99
 Width/Dept Ratio 14.74
 Bankfull Area (sq ft) 298.3
 Wetted Perimeter (ft) 71.09
 Hydraulic Radius (ft) 4.2
 Begin BKF Station 41.48
 End BKF Station 107.78

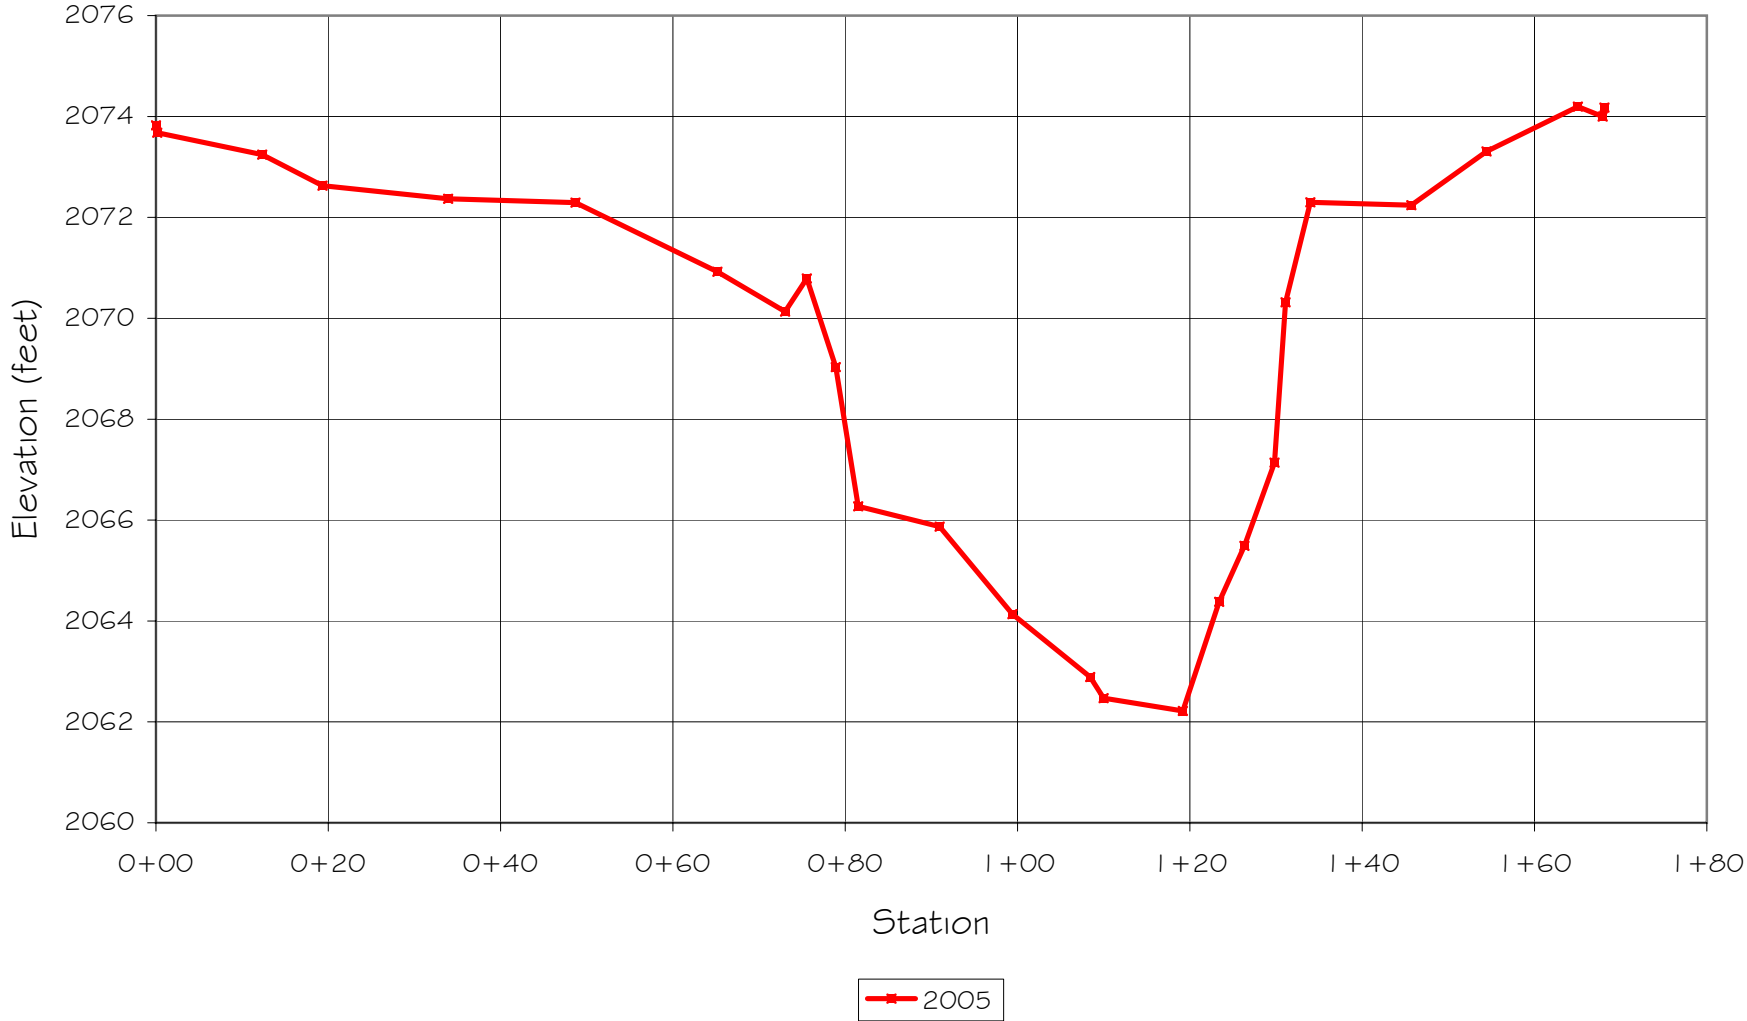
Clear Creek Stream Restoration (2005)
Cross-Section #3 - Riffle

Floodprone Elevation (ft) 2077.62
 Bankfull Elevation (ft) 2069.92
 Floodprone Width (ft) 168.11
 Bankfull Width (ft) 56.8
 Entrenchm Ratio 2.96 ----
 Mean Depth (ft) 4.95
 Maximum Depth (ft) 7.7
 Width/Dept Ratio 11.46
 Bankfull Area (sq ft) 281.43
 Wetted Perimeter (ft) 61.38
 Hydraulic Radius (ft) 4.59
 Begin BKF Station 74.15
 End BKF Station 130.95
