Annual Monitoring Report

Monitoring Year 3 of 7

Cochran Stream and Wetland Restoration Site

NCDMS Project No.: 95720

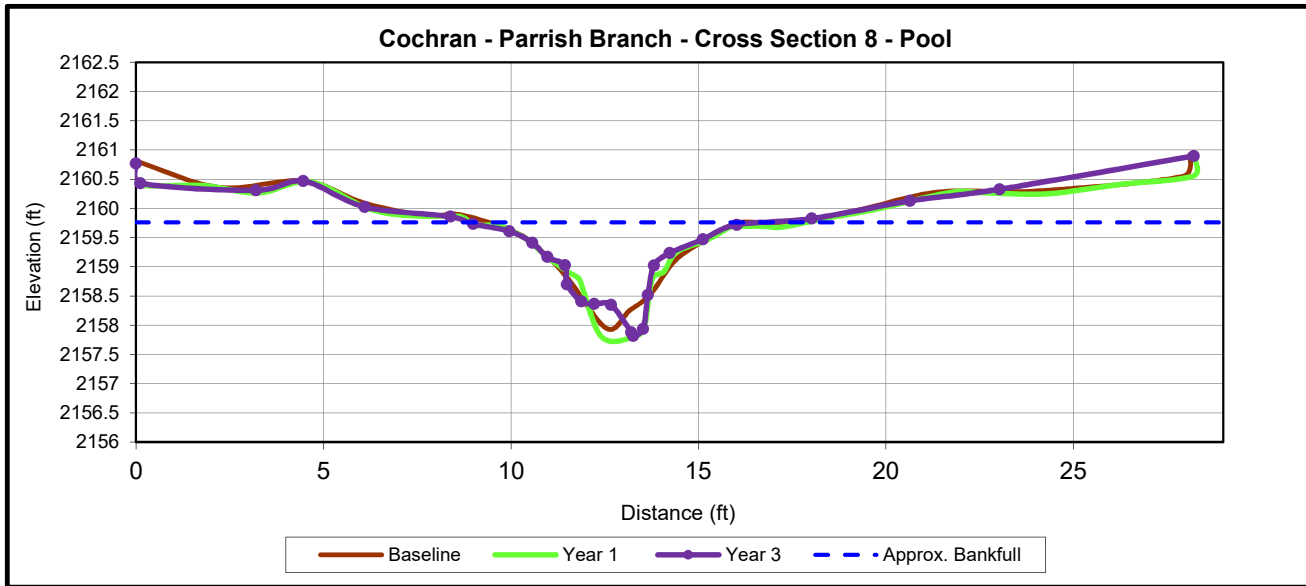
Bank Pin Location	Position	Year 1 Reading (mm)	Year 2 Reading (mm)	Year 3 Reading (mm)
Cross Section 1	Upstream	0.0	-	0.0
	At Cross Section	0.0	-	0.0
	Downstream	0.0	-	0.0
Cross Section 4	Upstream	0.0	-	0.0
	At Cross Section	0.0	-	0.0
	Downstream	0.0	-	0.0
Cross Section 8	Upstream	0.0	-	0.0
	At Cross Section	0.0	-	0.0
	Downstream	0.0	-	0.0
